Technology and Environment in Architecture-

Site Diary

Nottingham Trent University- Enterprise and Innovation Centre

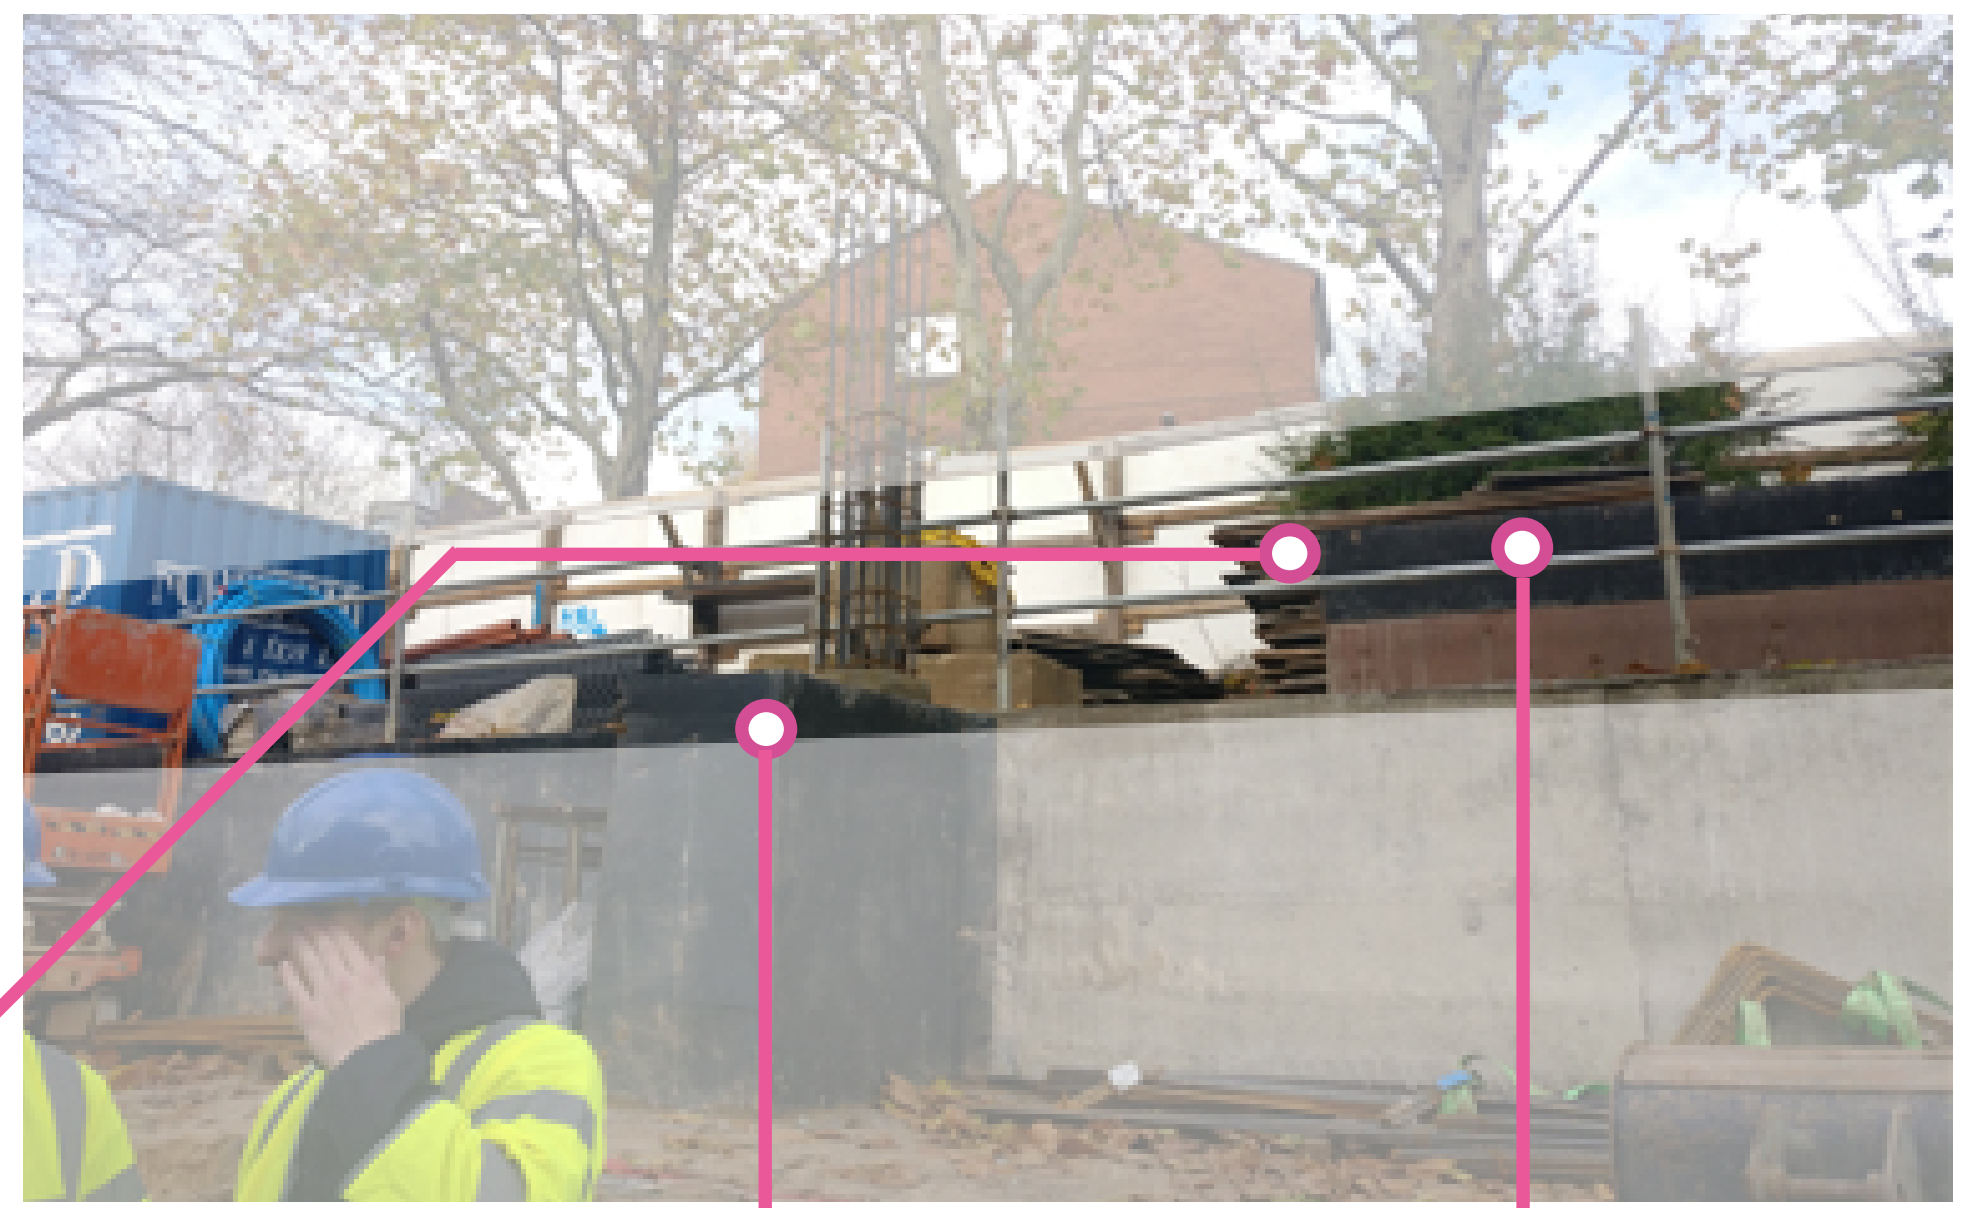
Fig 2.4: Foundation and Railing (Beeley, 2019).

Safety precautions met, to avoid workers falling from ground level into the pad foundation pit, which is still being slowly cutaway.

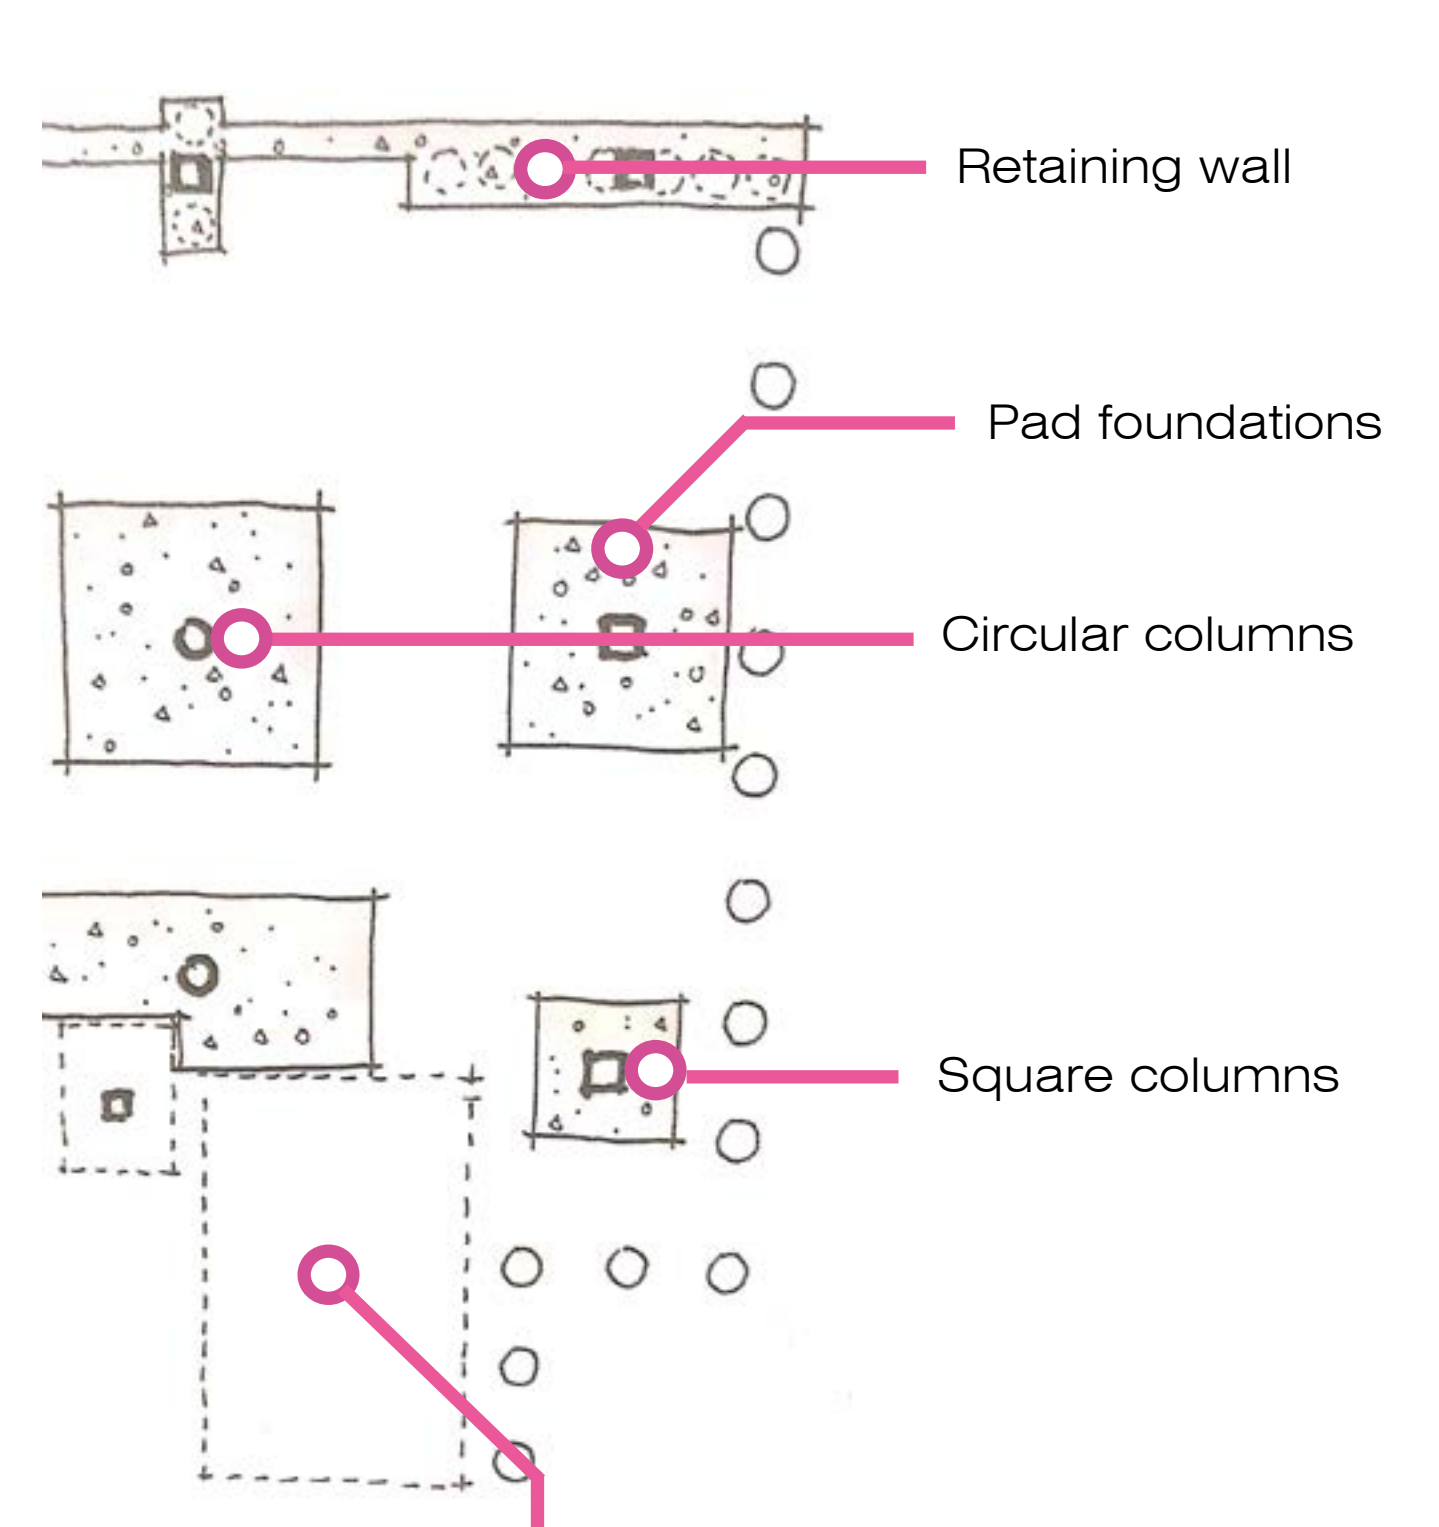
The dashed lines depict the location of the foundation remnants. These of which are being removed to account for the level change. The strength of the material poses a problem under time constraints, I could see the contractors struggle in breaking it up piece by piece.

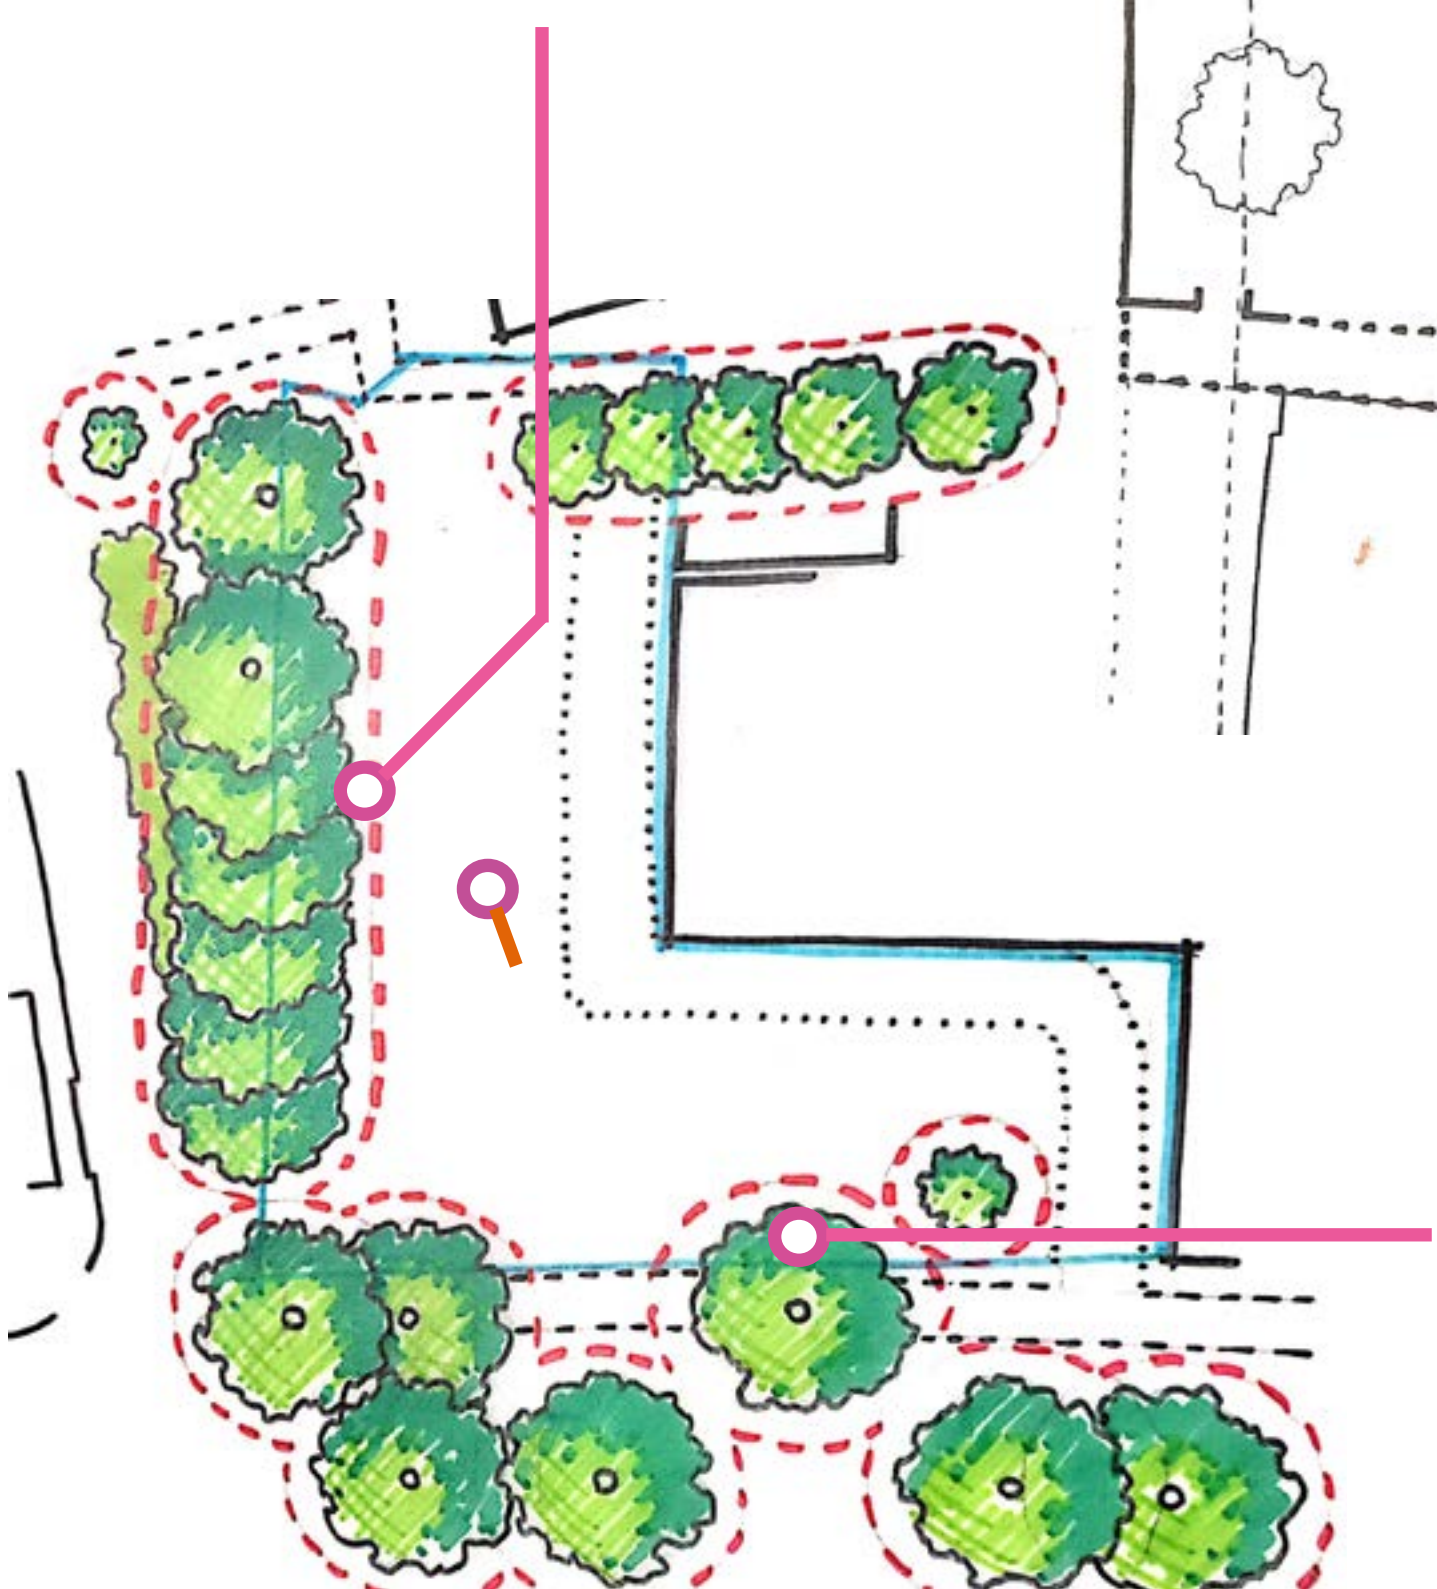
Fig 3.7: Root Radii (Beeley, 2019).

The largest site threat is this line of trees by the rear of the building. The extent/spread of their roots are dashed in red. The space between the building interior and pile foundations on this side also seemingly acting as secondary defence in the case the roots spread further.

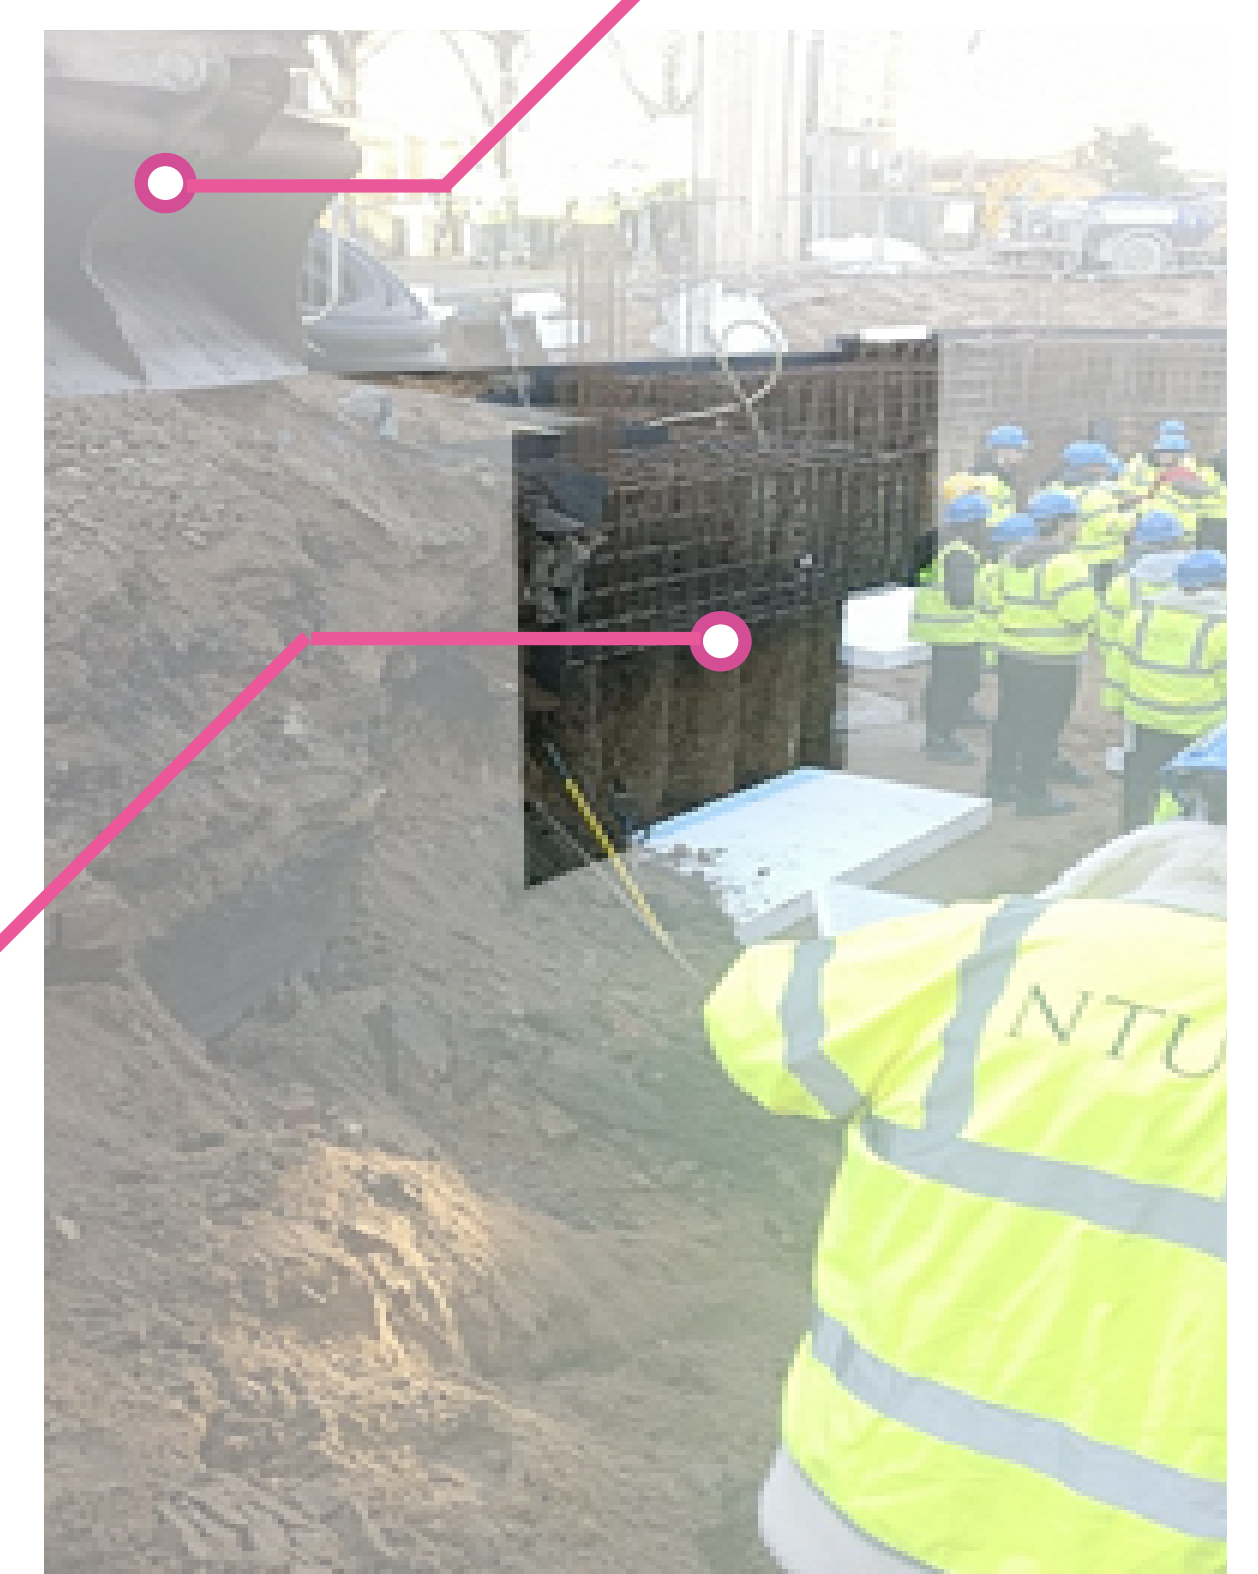
One thing that does concern me is just how they're going to attach the waterproofing to this exterior, as bolts and rivets would surely weaken the structural integrity of the piles. The saving grace is the layer of in-situ concrete to be cast onto this retaining wall.

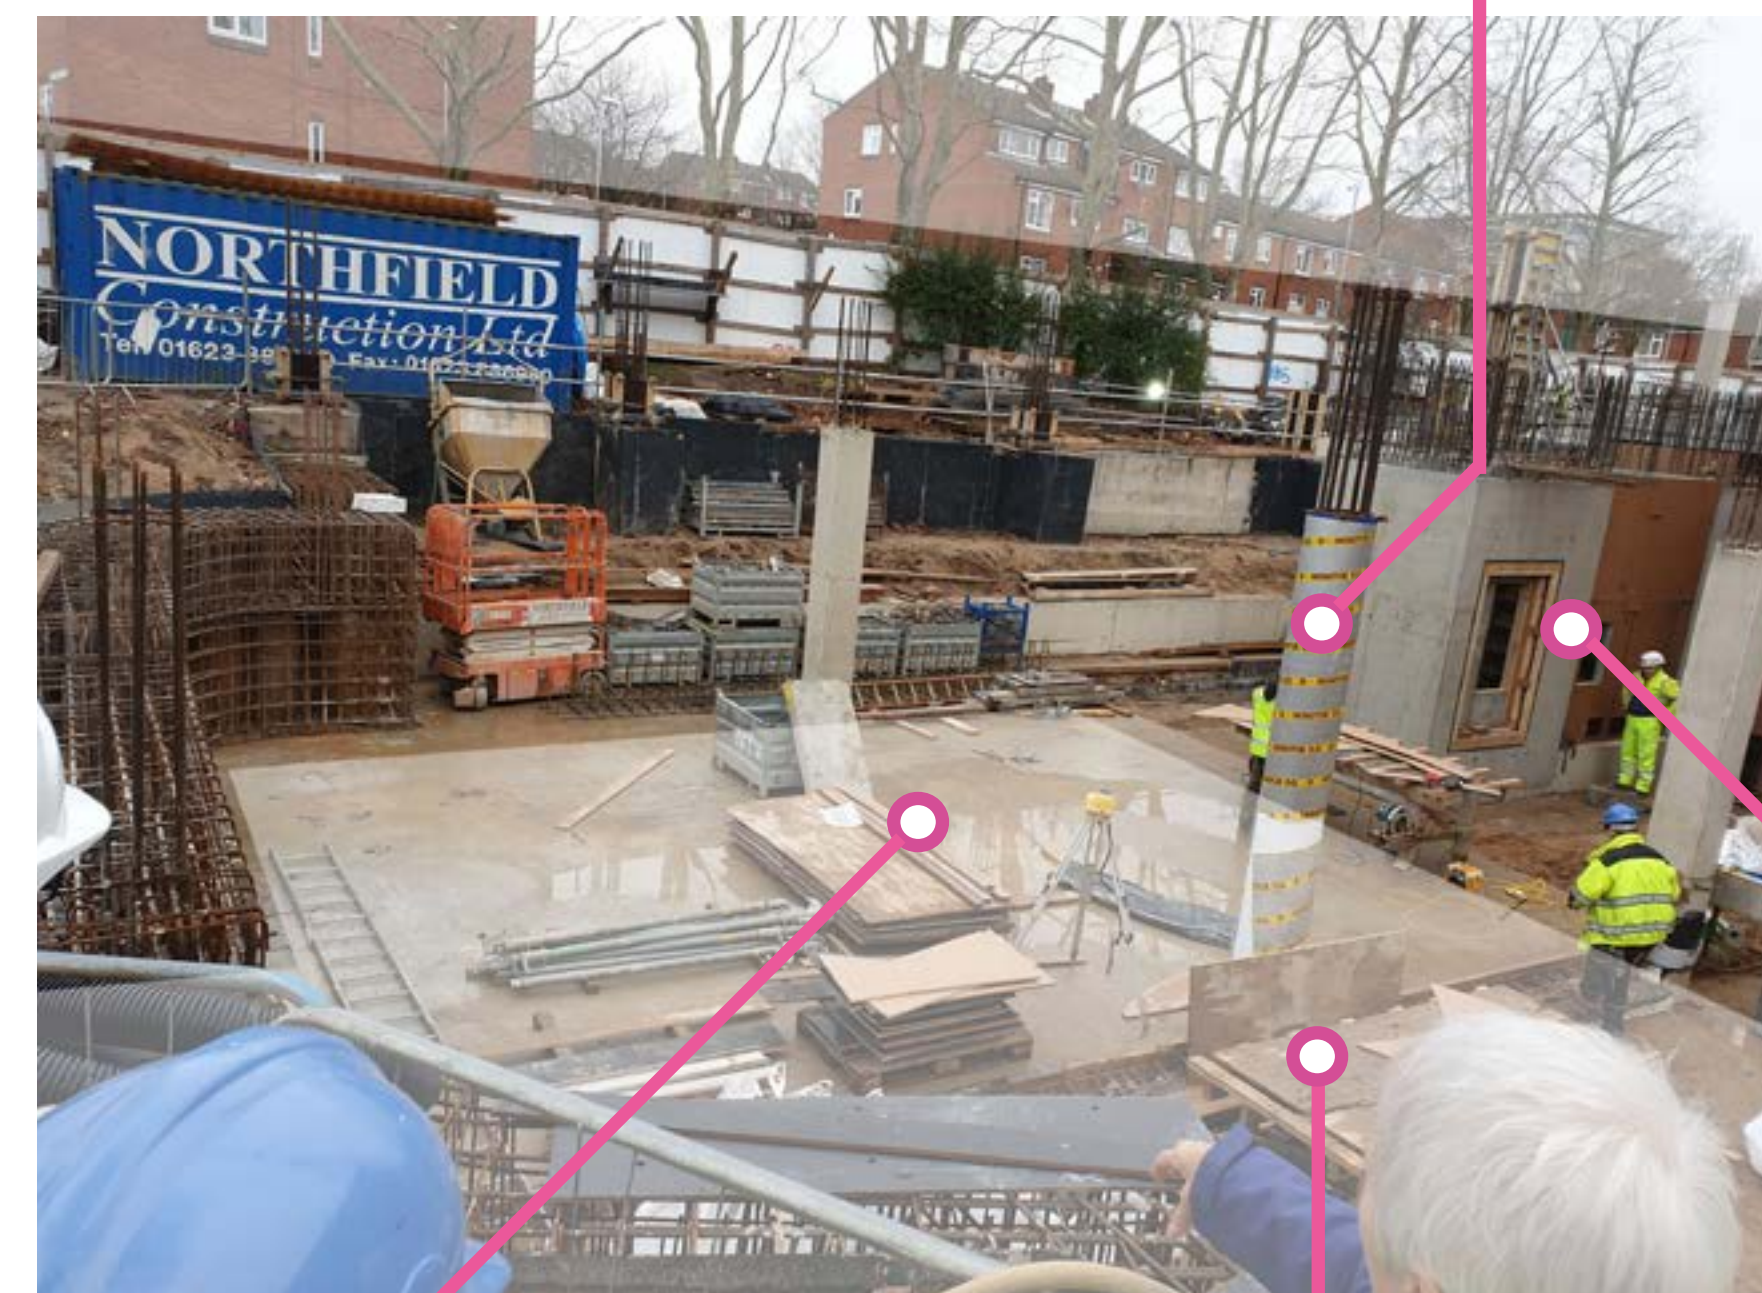
Fig 5.4: Workstation (Kentish-Brade, 2020).

The open space used for small elements of **woodwork has only one caveat in the fact that weather could easily disrupt and fry plug sockets, extension cables, the tools themselves and the generators, on a count of there being no shelter.**

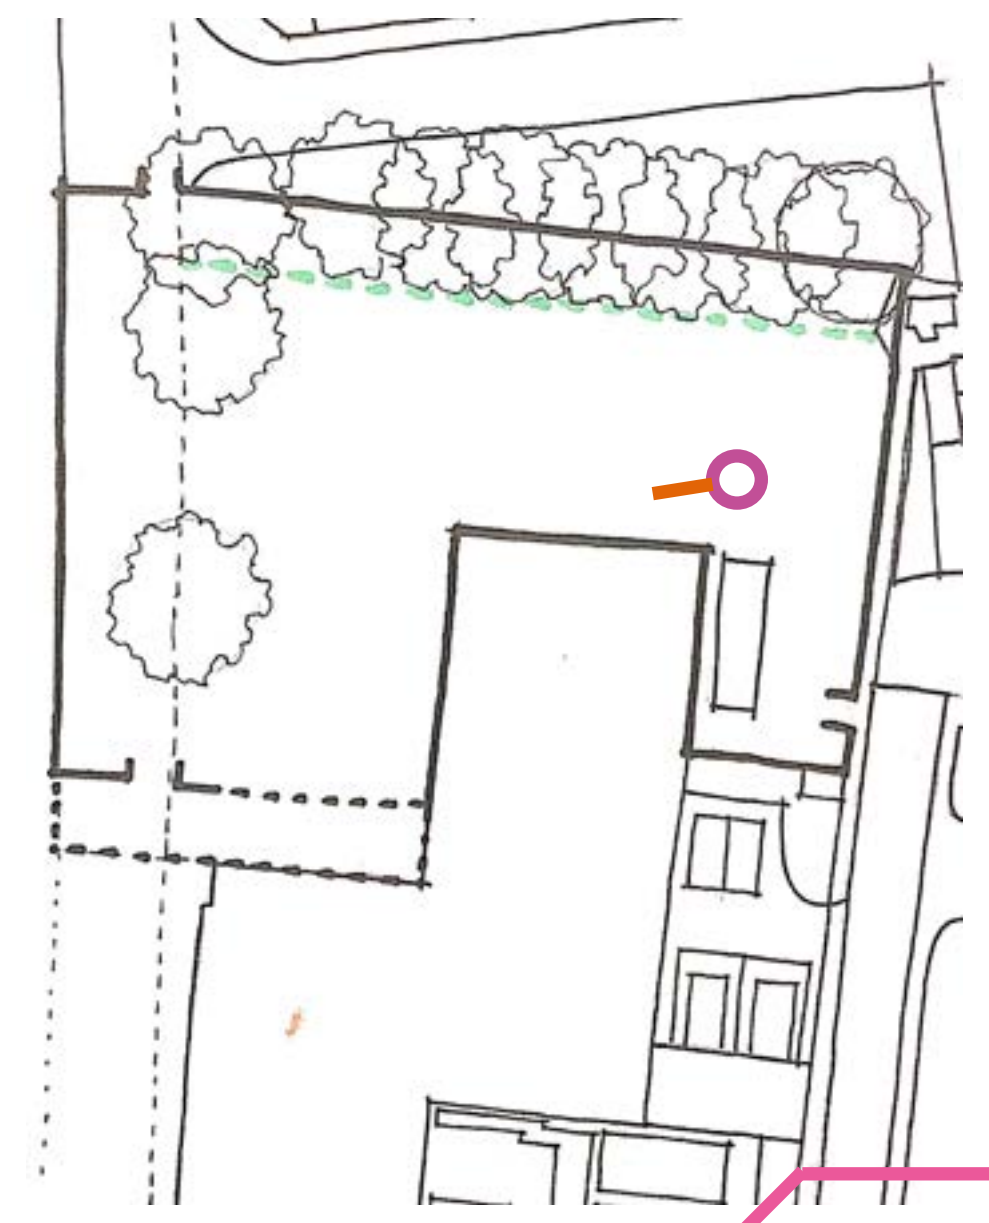
Site of asbestos in old Dryden staircase foundation.
