Technology and Environment in Architecture-

Site Diary

Nottingham Trent University- Enterprise and Innovation Centre

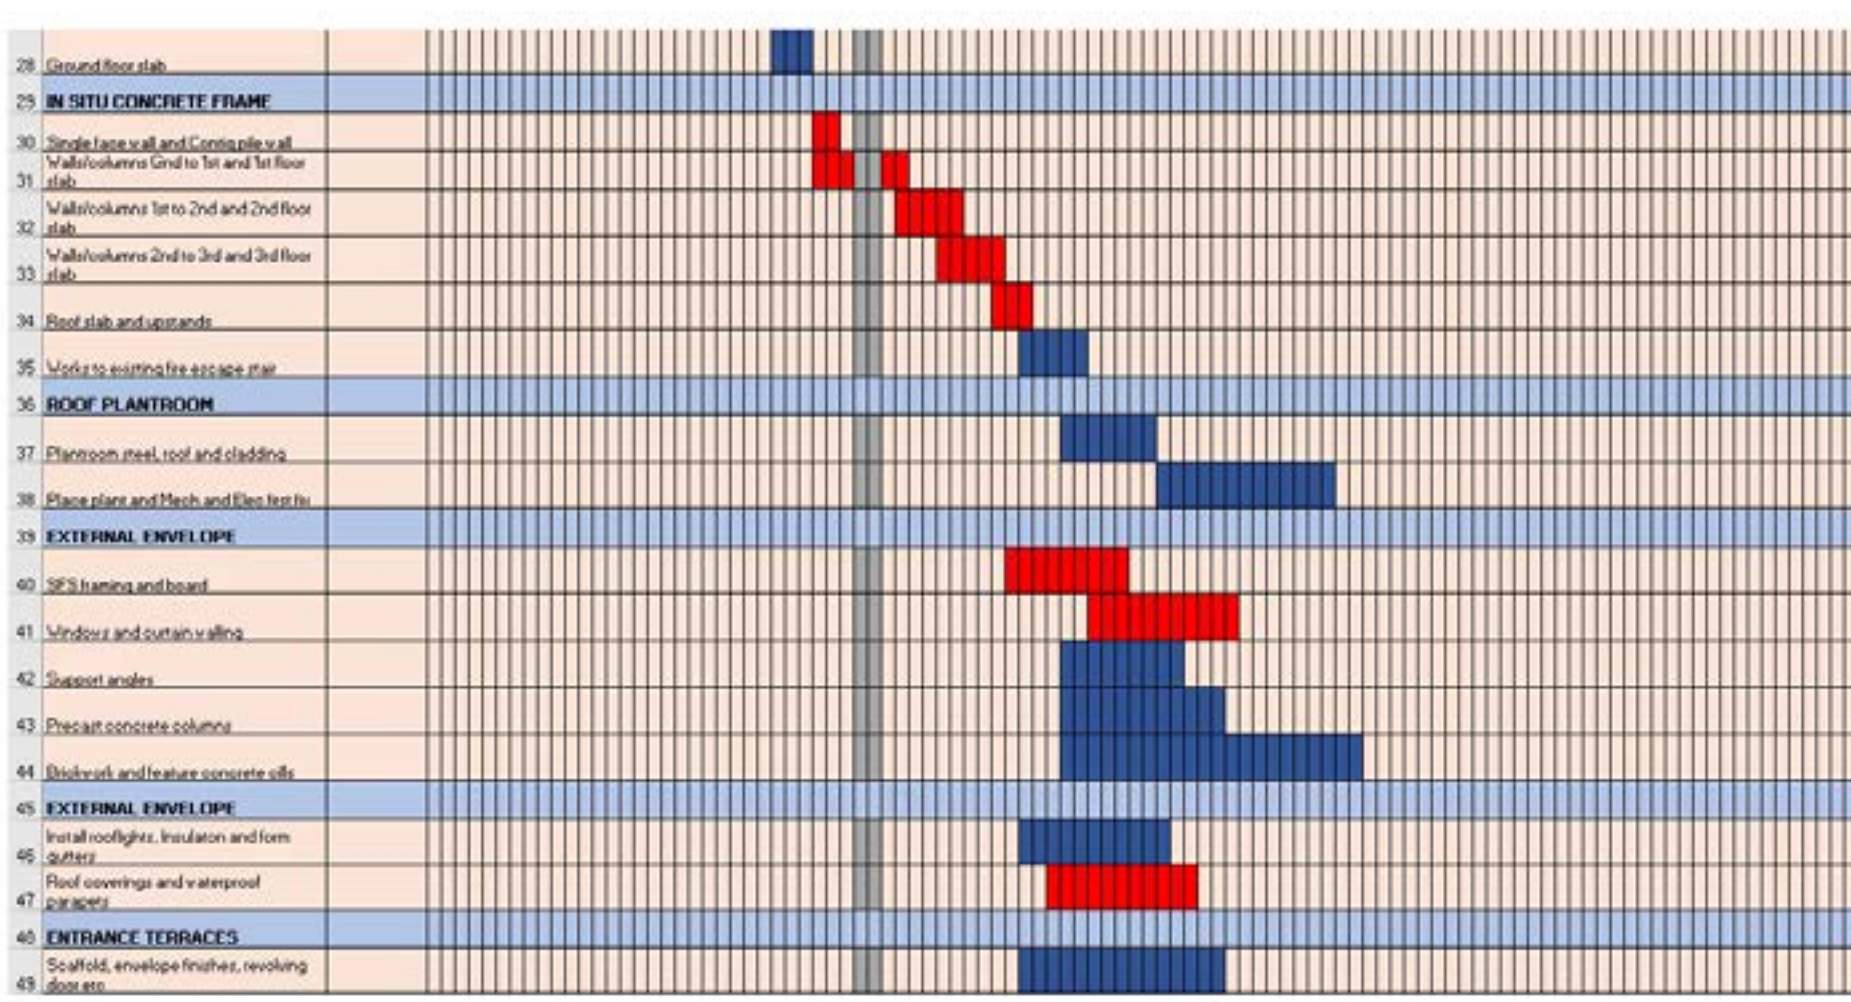
By the end of the week on this visit the pad foundations should have been poured when in fact, the ground hasn't even been excavated for their insertion yet. Work cannot begin on the columns until this is done, which is still a couple of months away but the team have no time to waste and the clawing back of this lost time is necessary to meet the impending construction deadline.

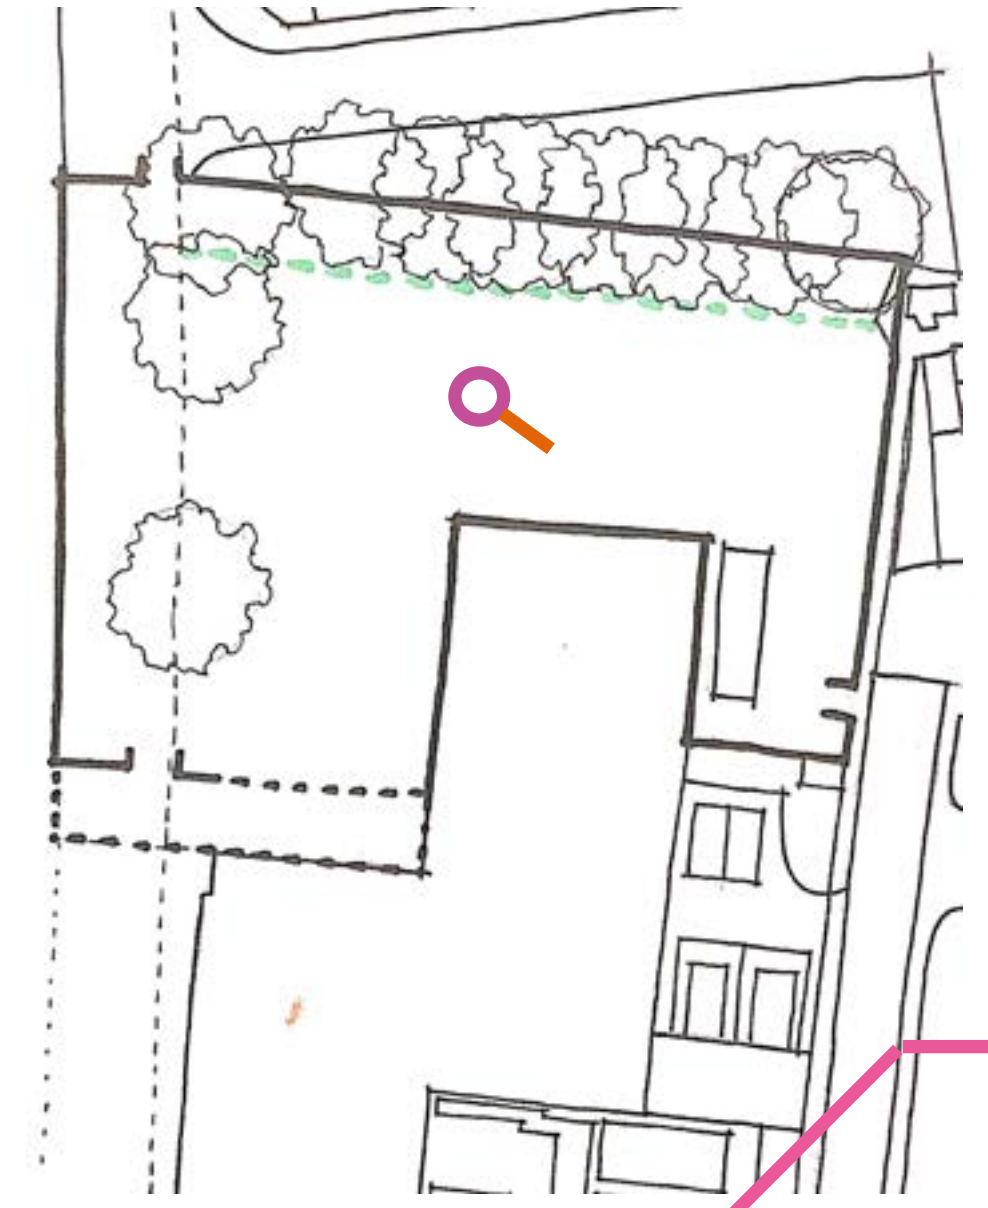
Fig 2.5: (Beeley, 2019).

The dashed lines depict the location of the foundation remnants. These of which are being removed to account for the level change. The strength of the material poses a problem under time constraints, I could see the contractors struggle in breaking it up piece by piece.

Existing Dryden Building foundations.

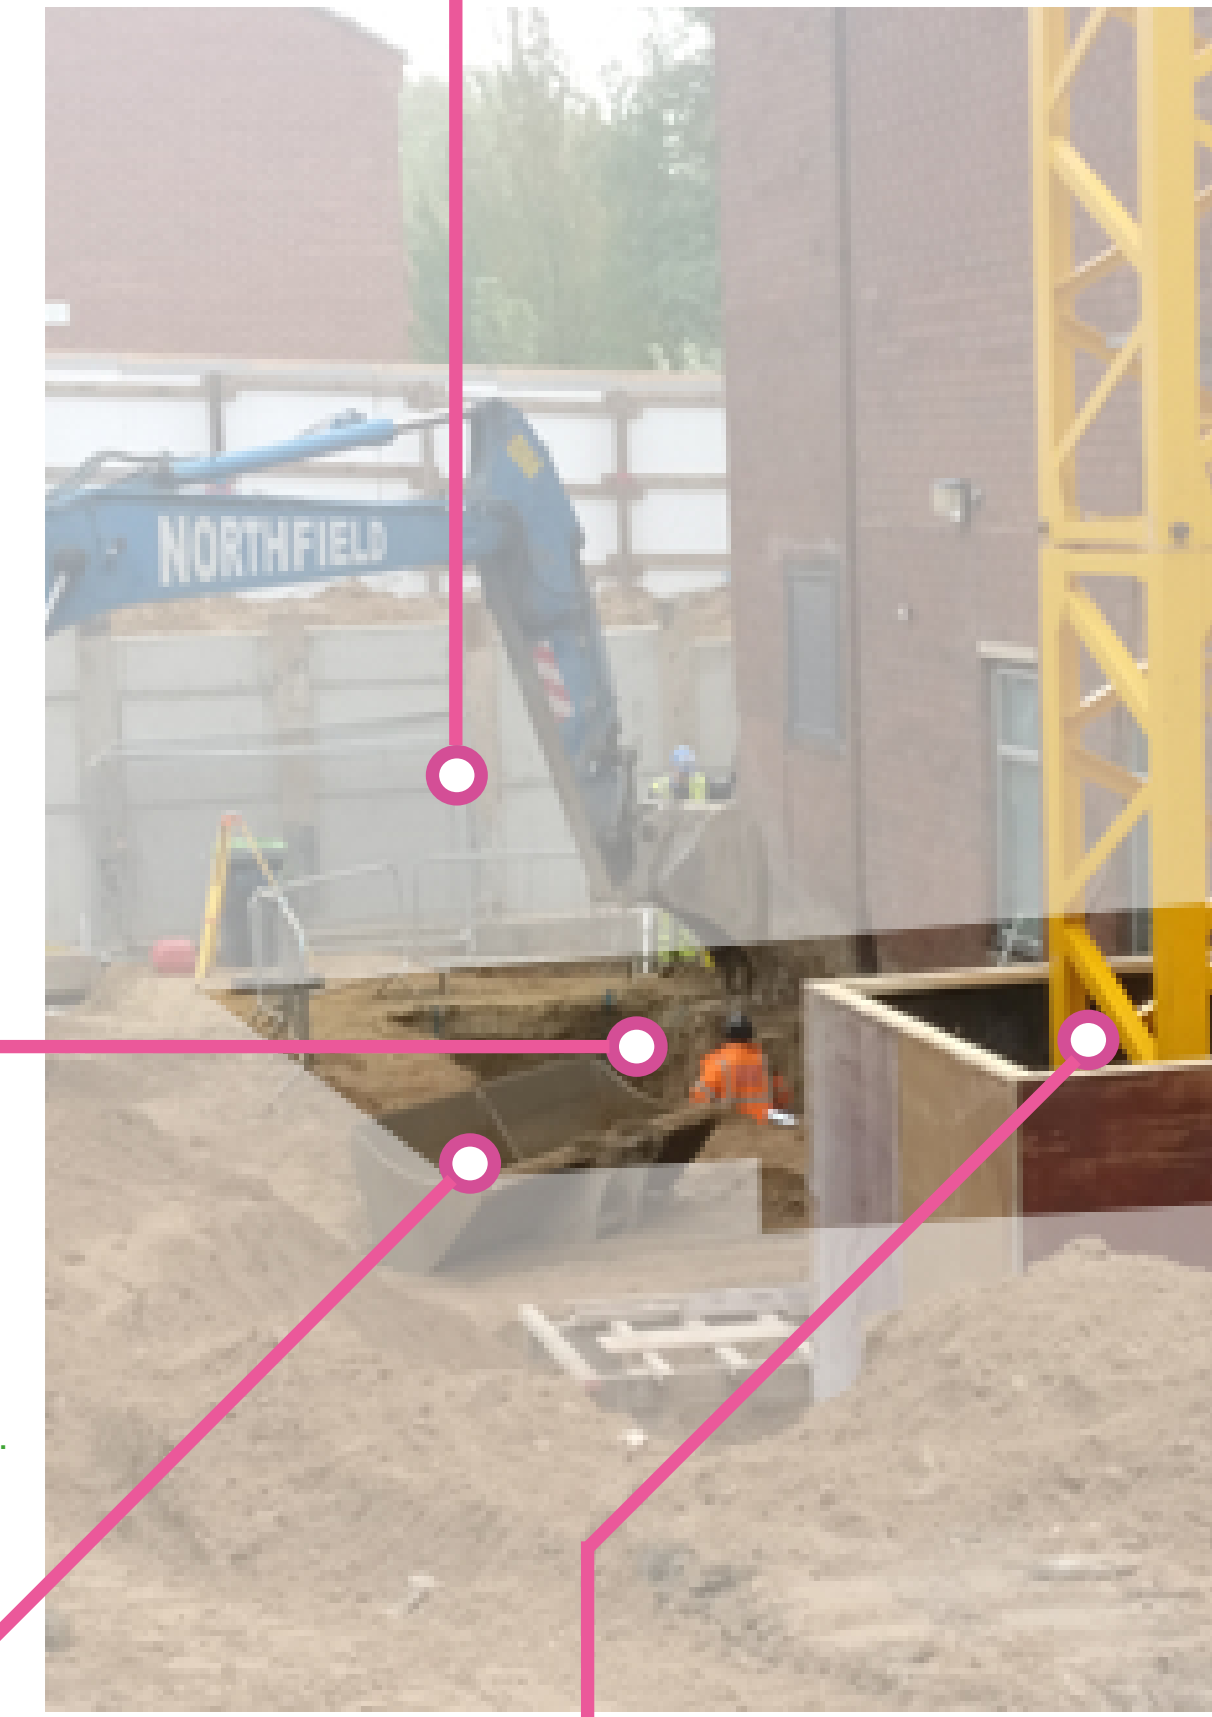
Fig 2.5: (Beeley, 2019).

The changing of component heads to suit the material that needs to be broken or transported. Costs time due to the fact no more that one vehicle can fit in this gully.

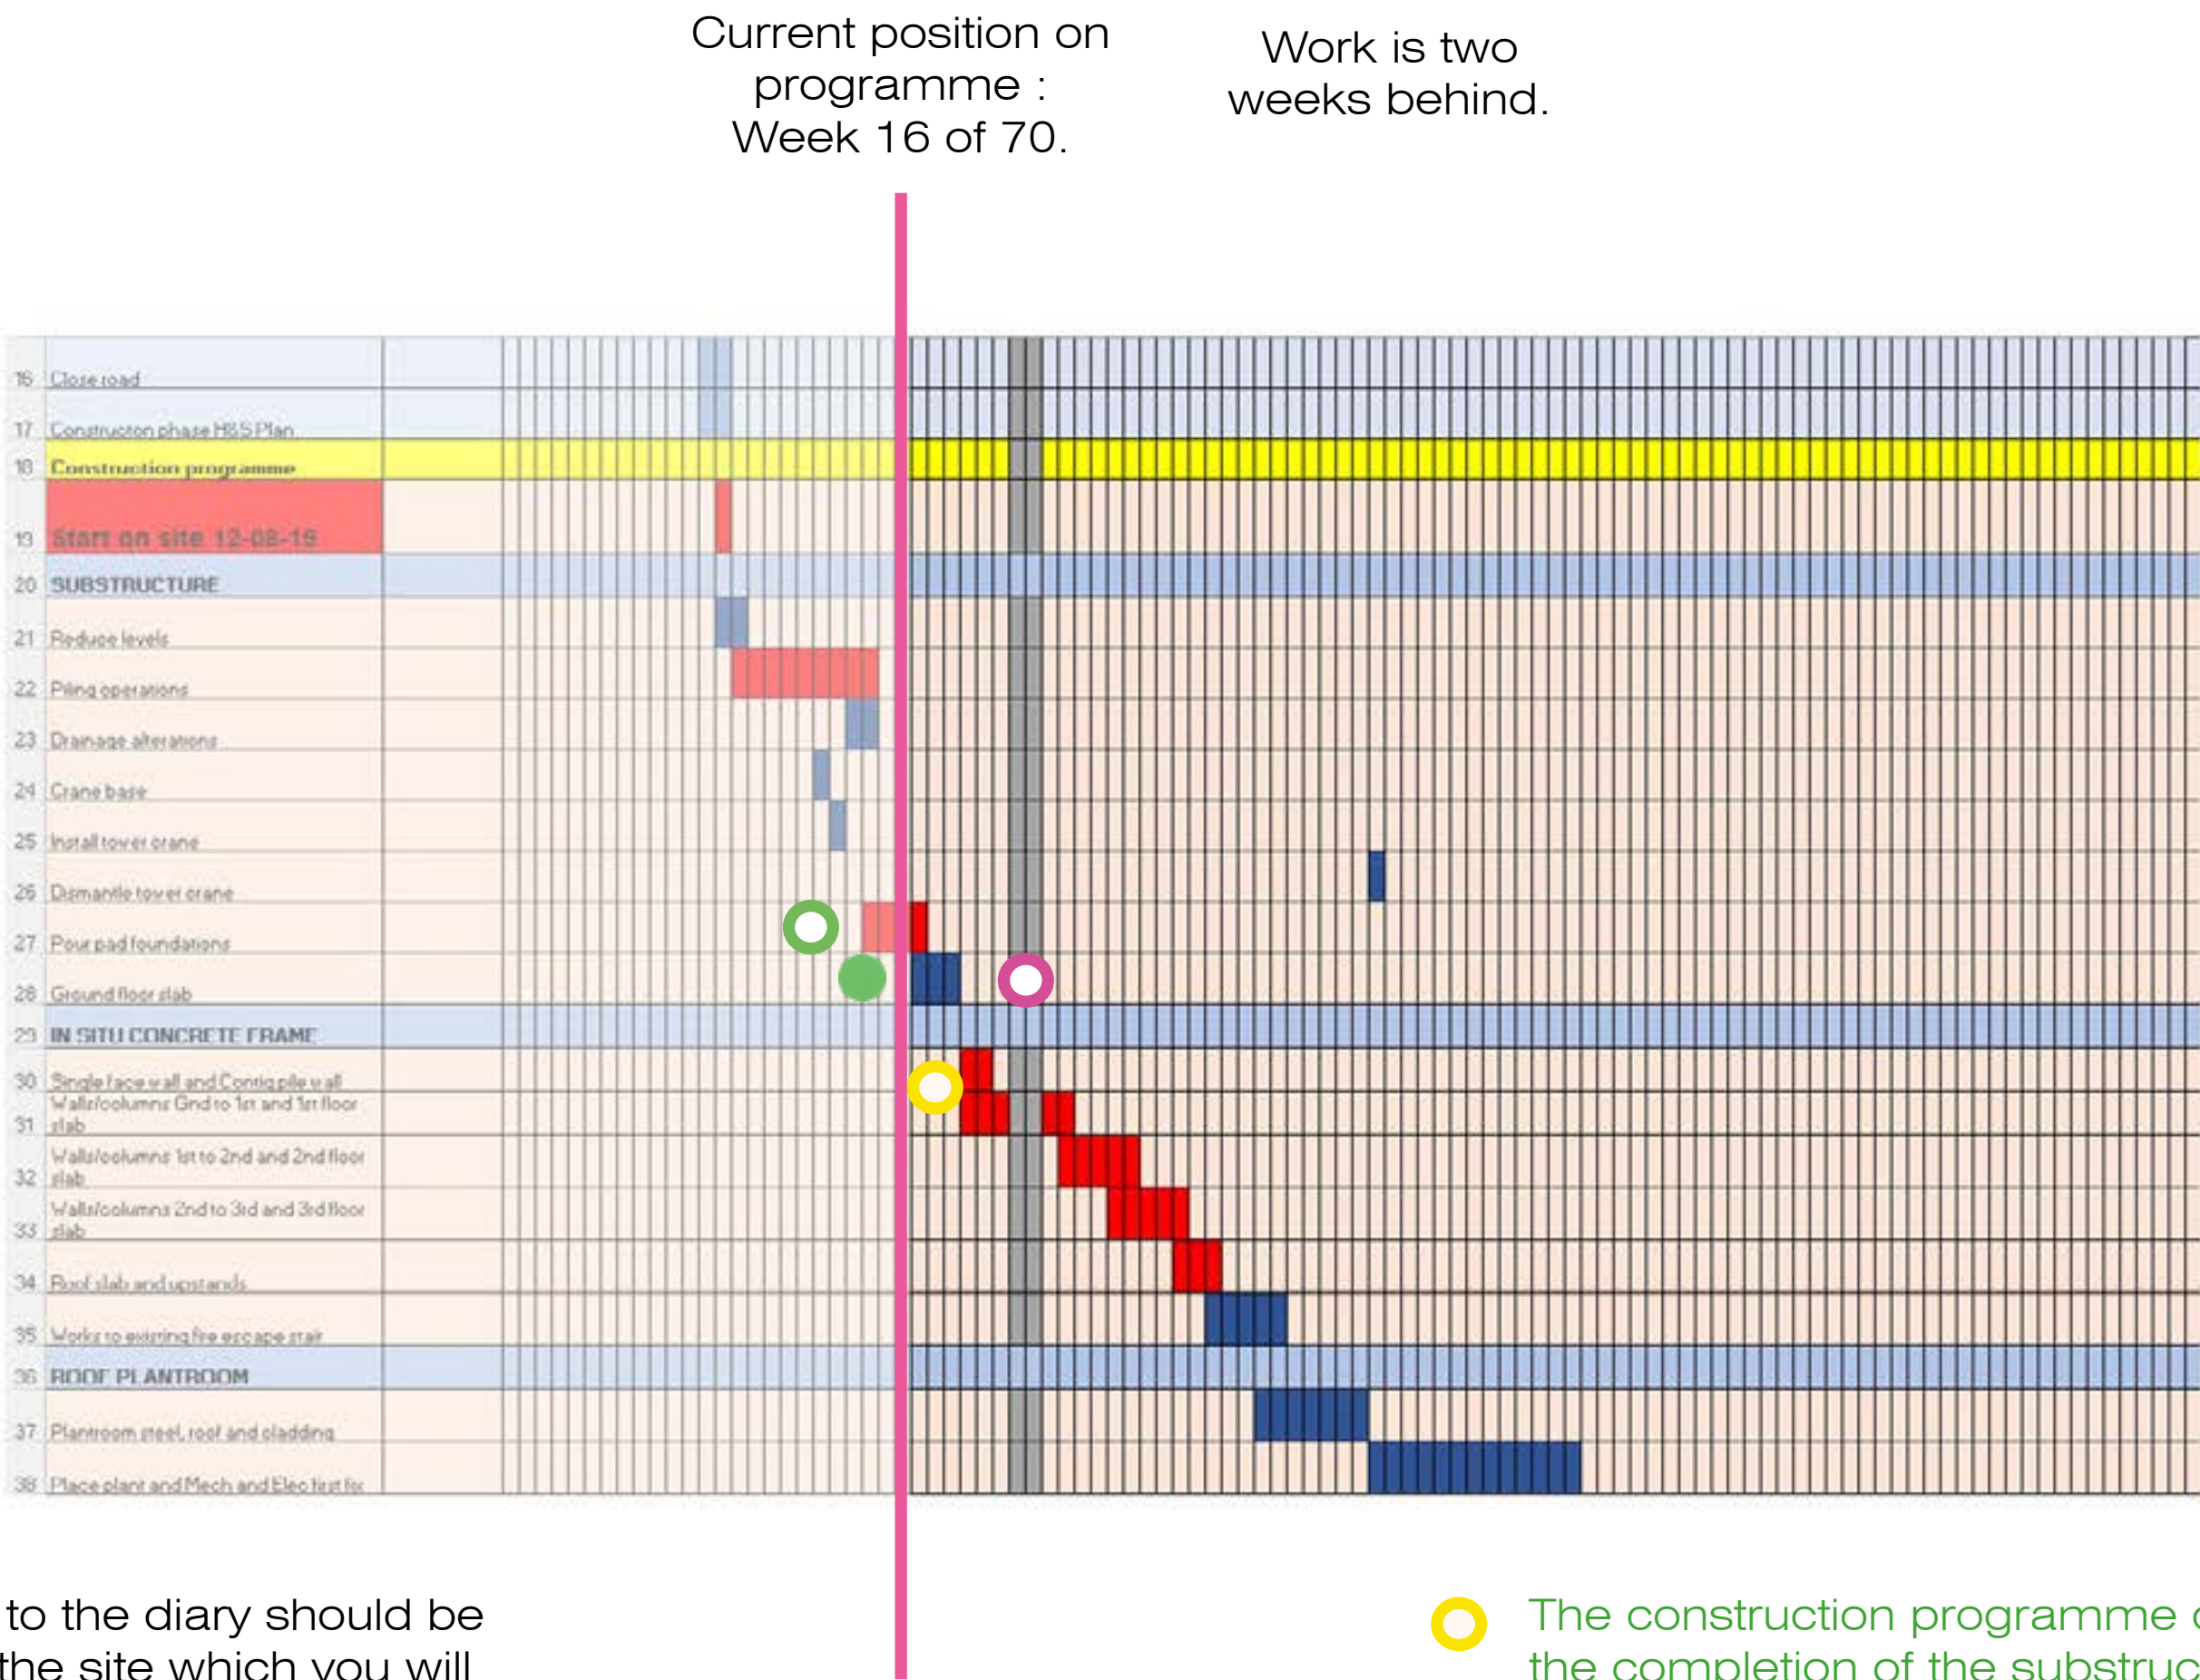
It is no surprise the pad foundations are not complete. In fact minimal change has actually occurred on site that is visible above the ground. The addition of piling at the base of the curved facade, currently topped with a steel reinforcement cage is one of the only changes visible. Not including the beginnings of some formwork in the from of docker shuttering and monotub.

The ground floor slab according to the diary should be just starting. On the evidence of the site which you will later see in my analysis pages, it is not, although the plans implore several individual slabs that surround each on site column. Questions are then raised as to the reason and logic behind the construction of pillars before the pad foundation excavation.

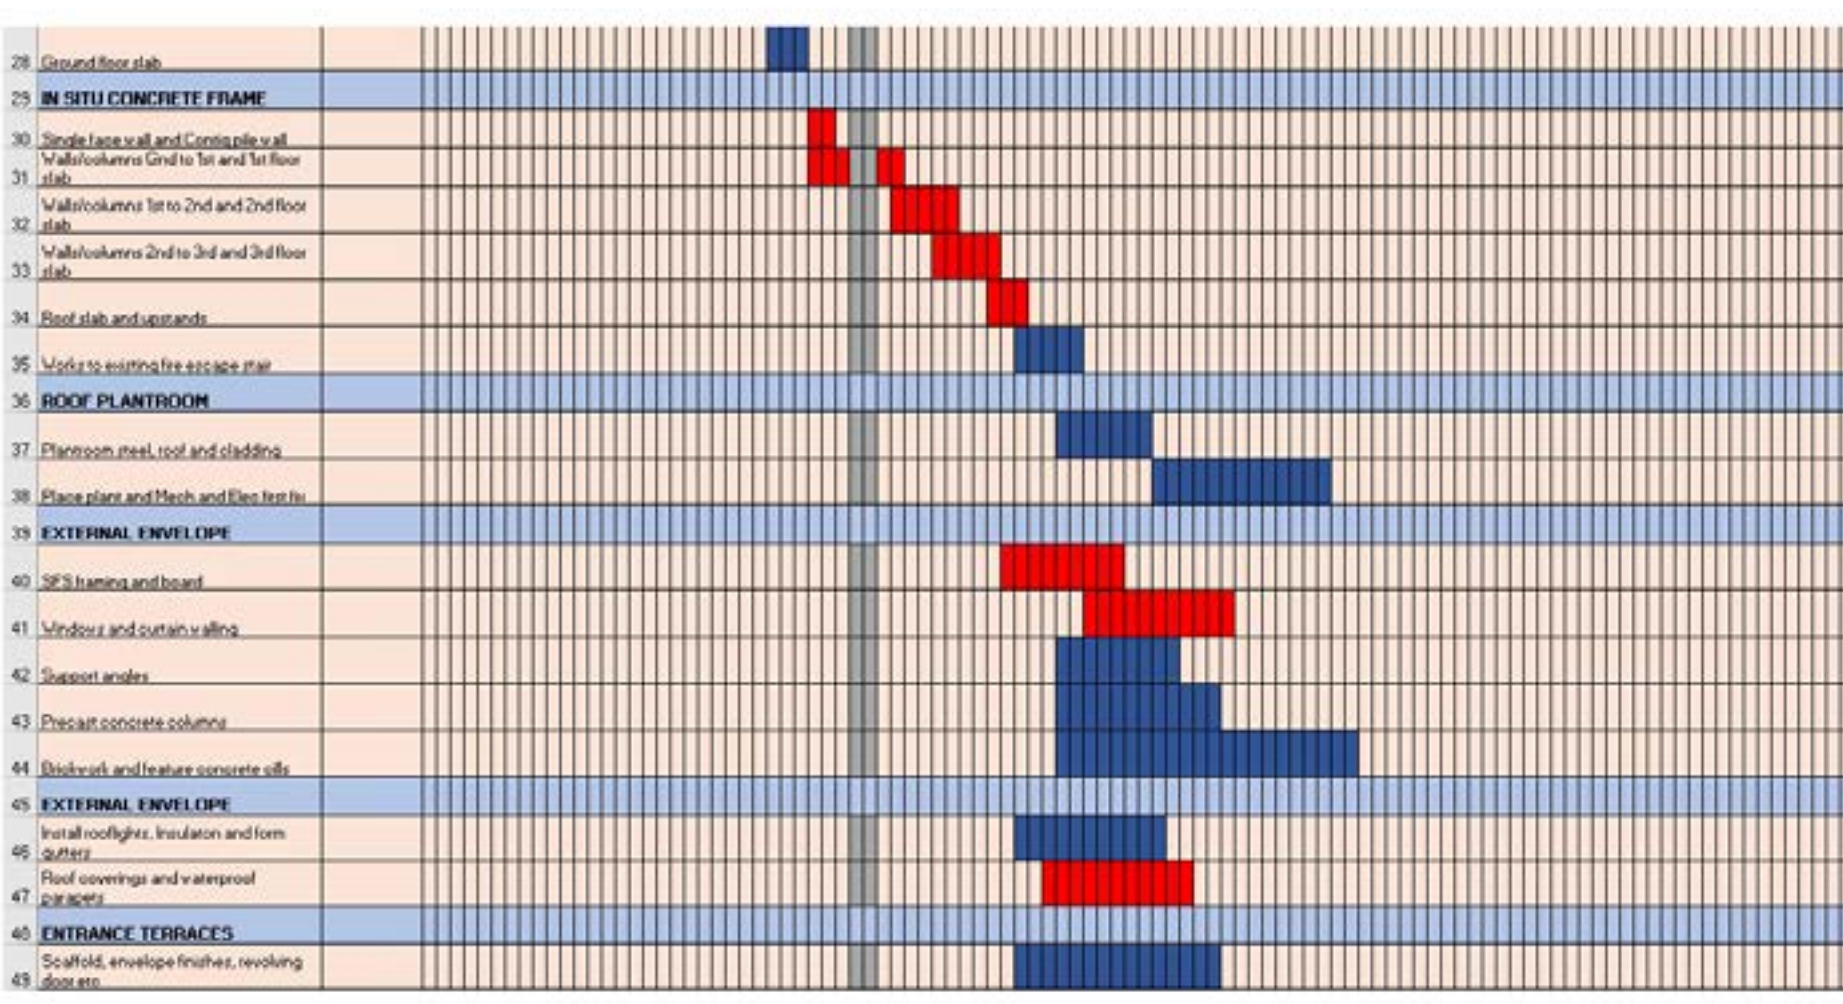
The site manager and other roles of authority on site admitted that they were two weeks behind and finding it difficult to substitute jobs for ones that require previous over-run tasks to be finished in order to start, due to the relatively early and crucial stage of the build they are in. Their aims were to finish the floor slab and all non-intrusive columns to first floor height.

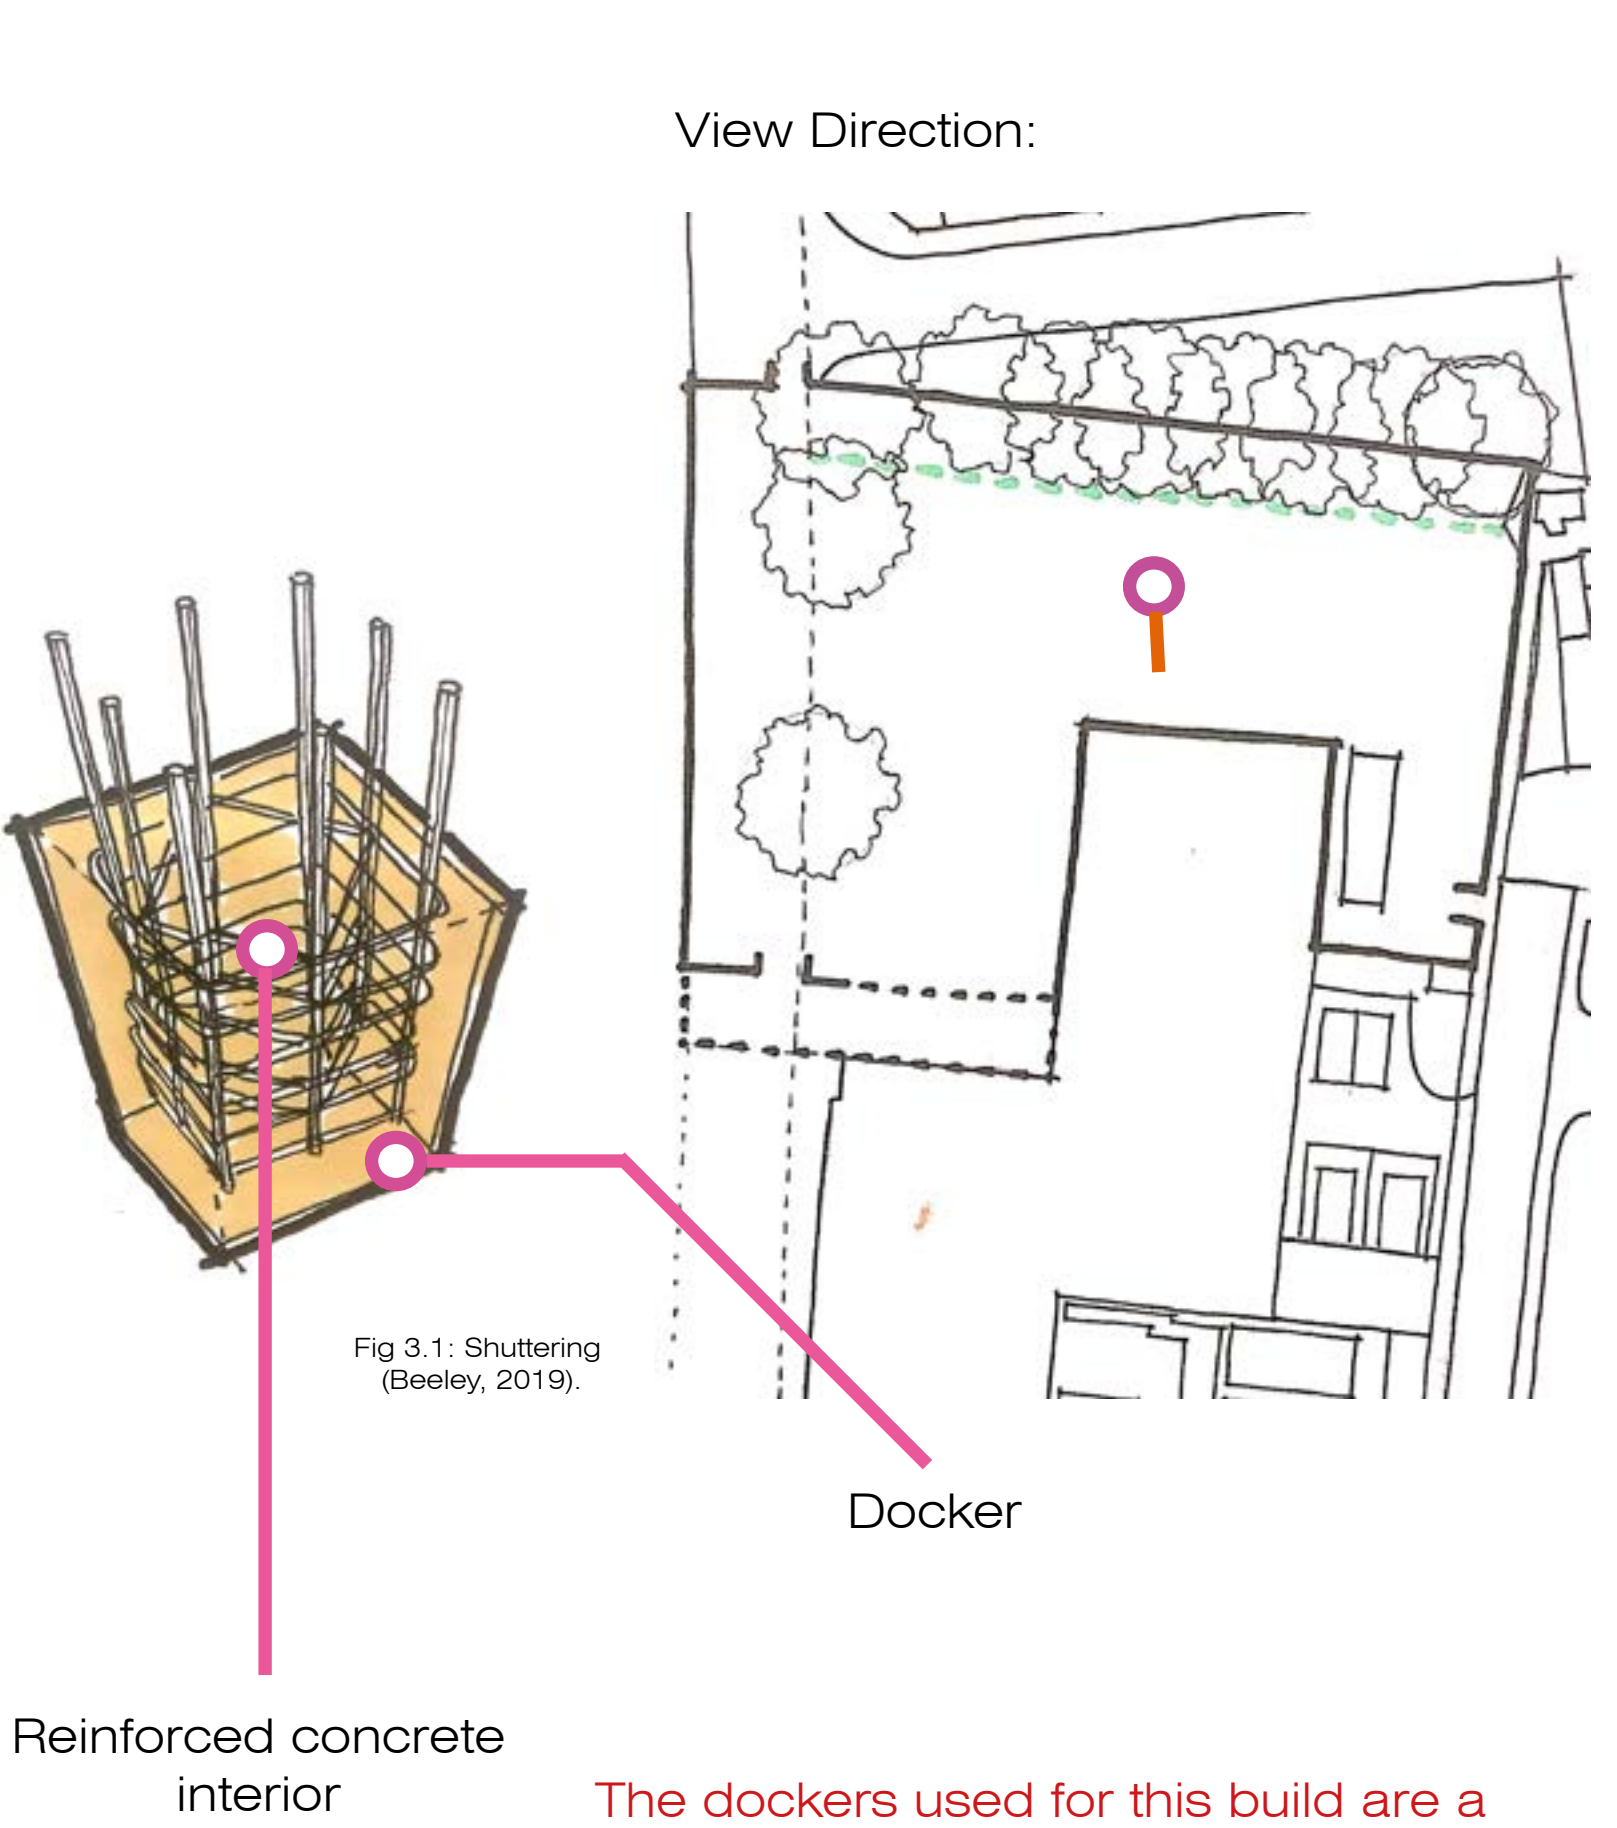
The dockers used for this build are a lot more strenuous in their erection and dismantlement than monotubes, which are made of insulation-like spongy material that can be cutaway. Whereas the docker requires the unscrewing of bolts and other attachments limiting time.

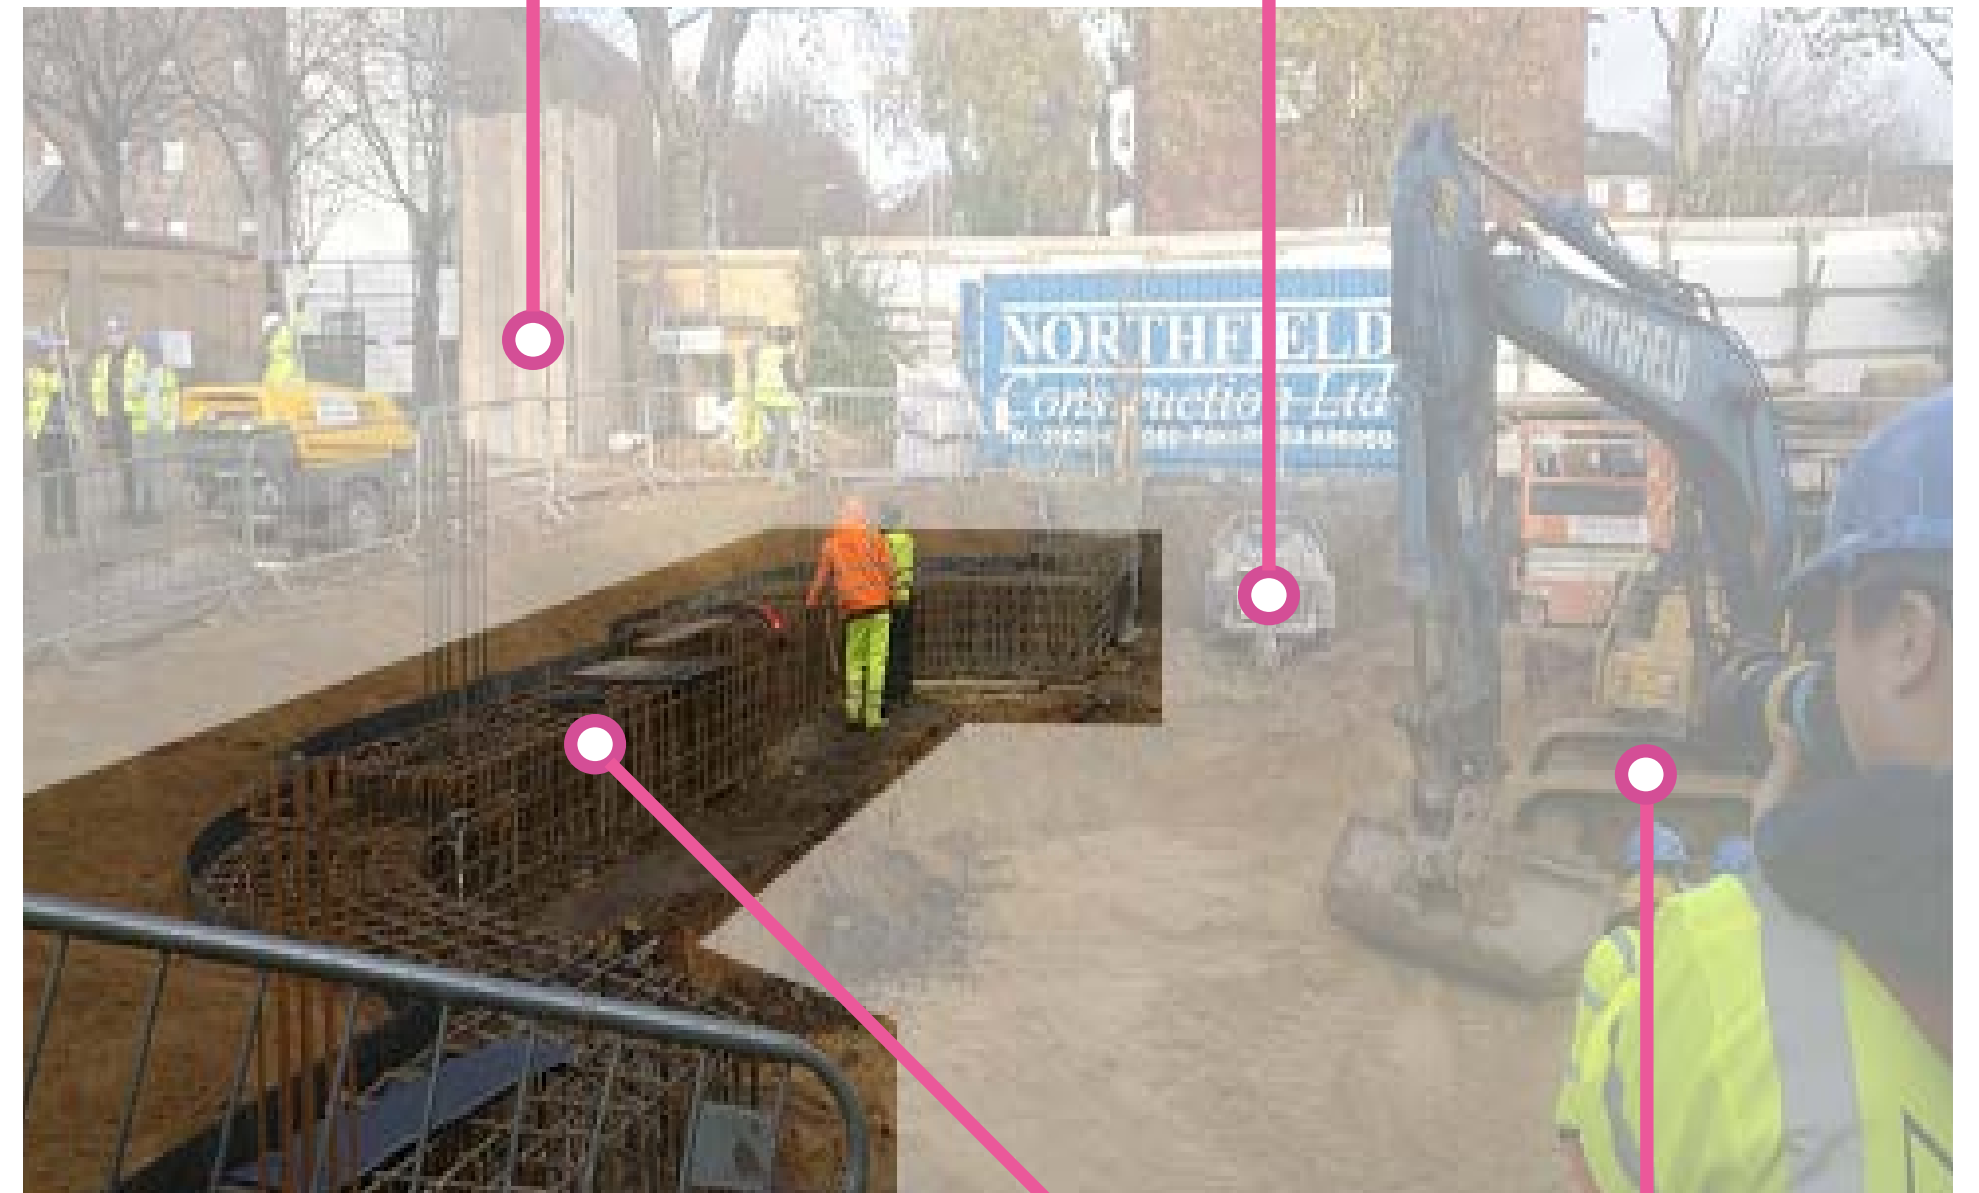
Fig 3.6: Curved Foundation (Beeley, 2019).

The diggers are beginning to struggle in traversal, having to navigate around the reinforced concrete in order to return to the road.

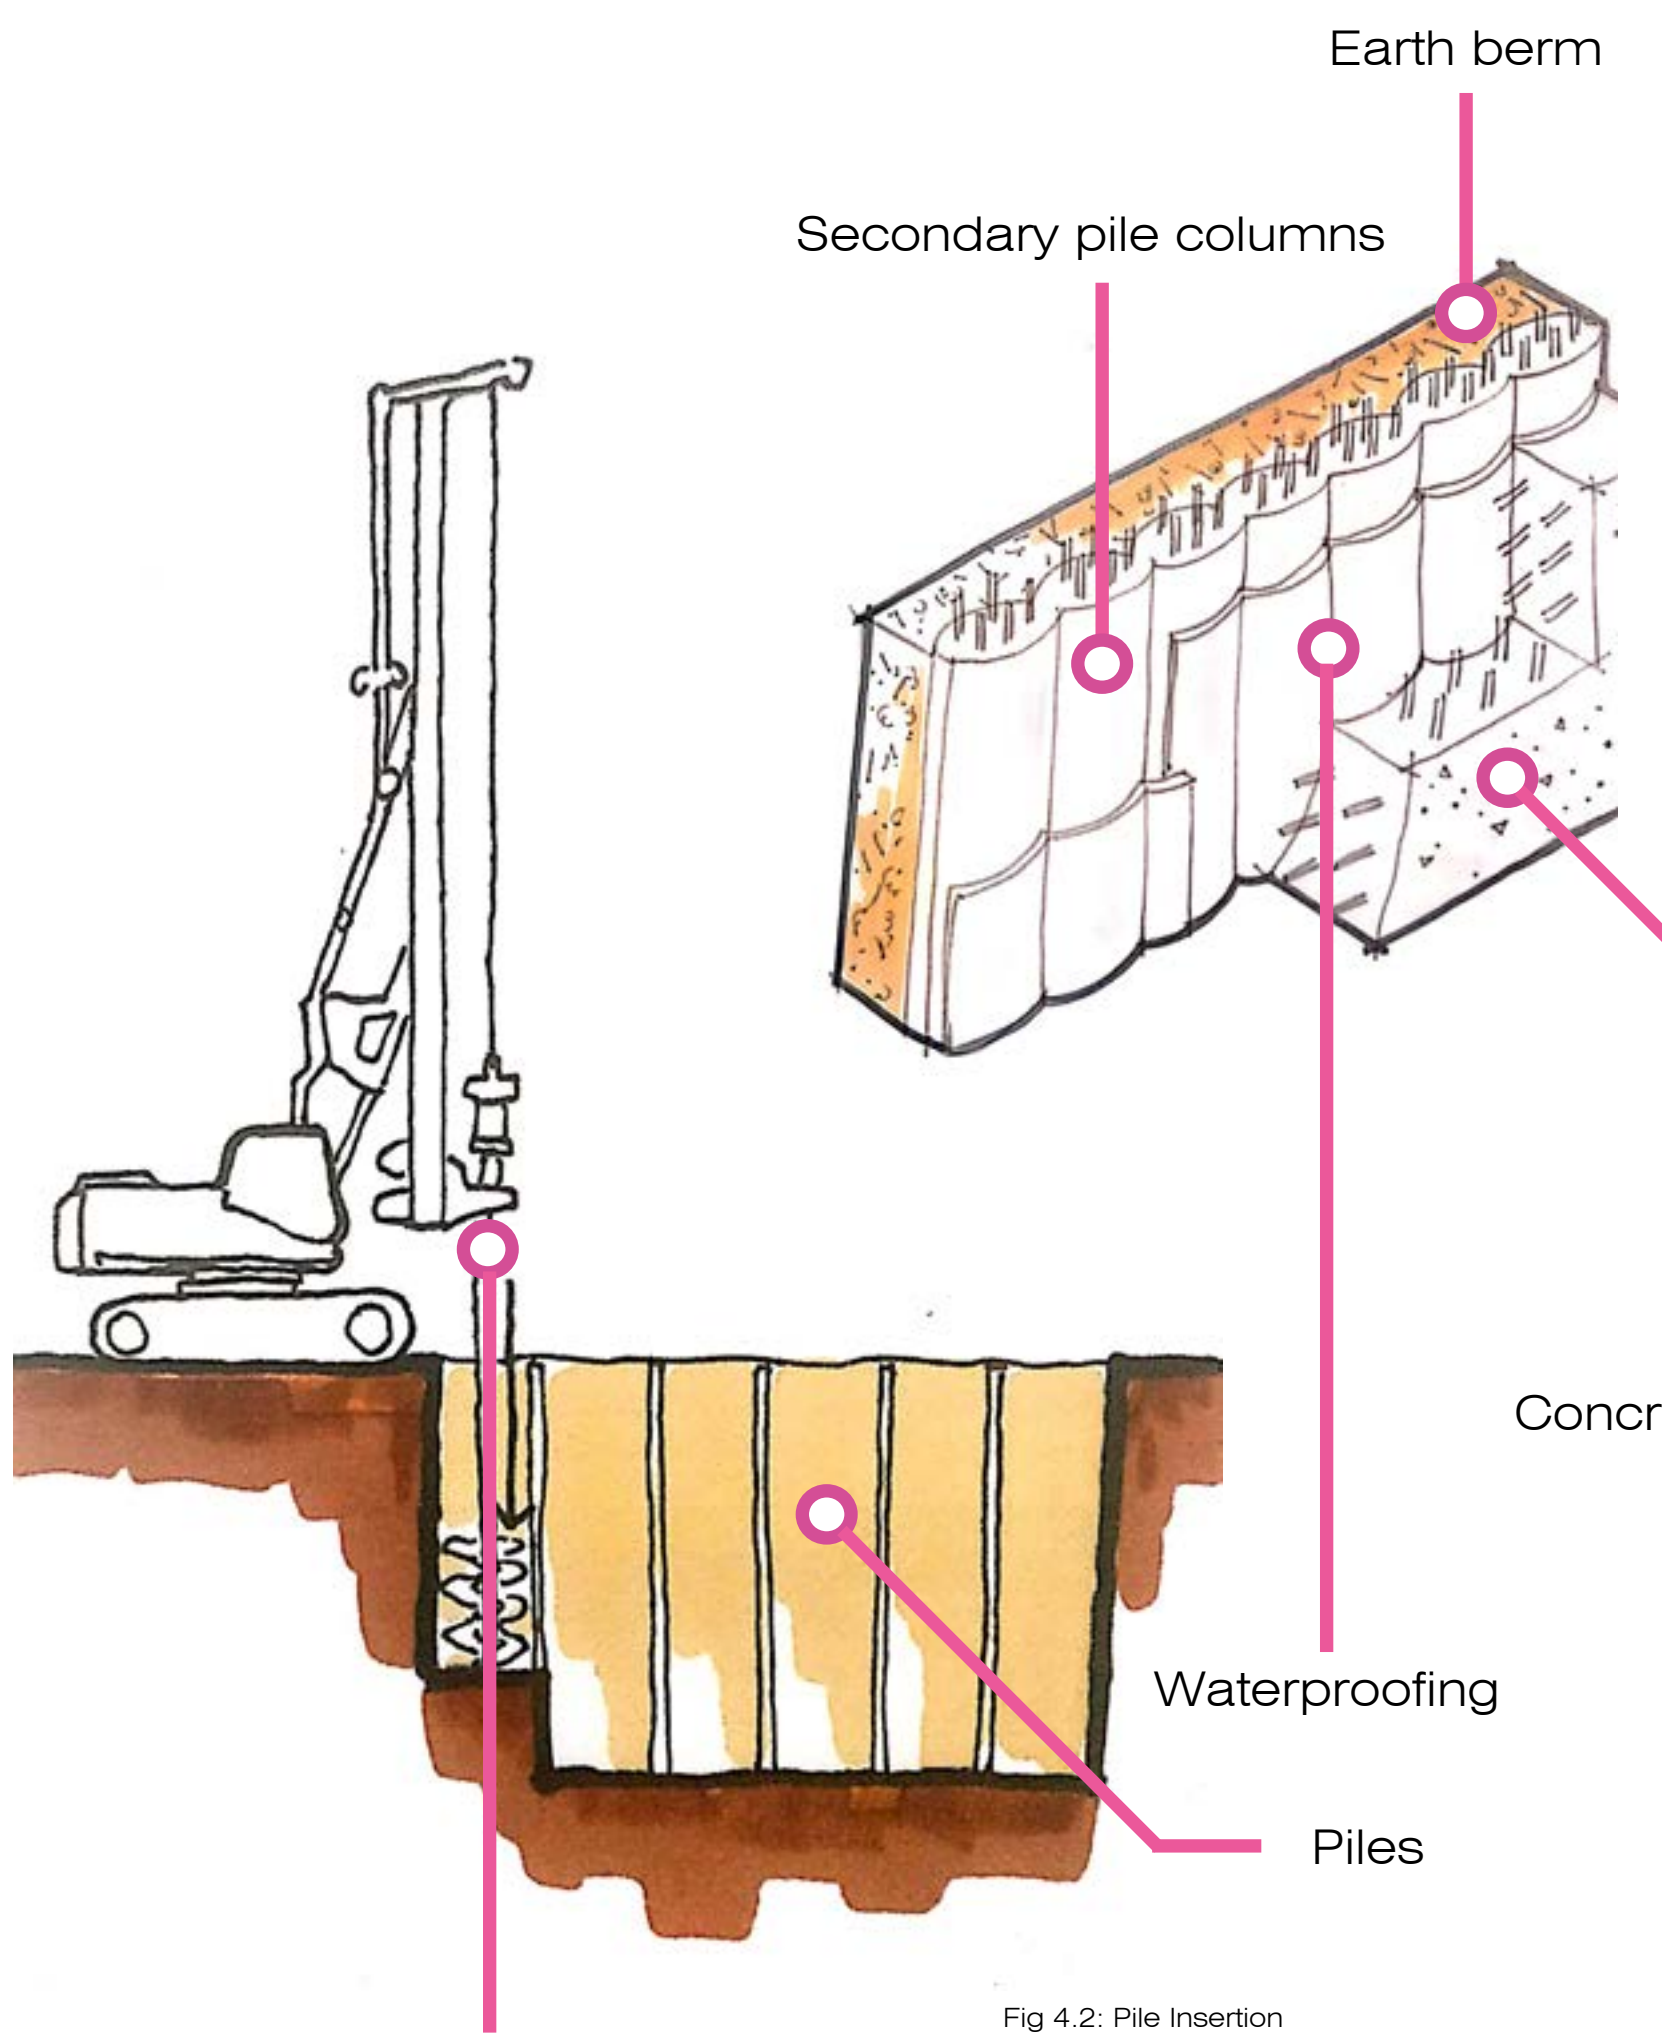
Fig 4.2: Pile Insertion (Beeley, 2019).

Hydraulics for noise and vibration reduction
