Technology and Environment in Architecture-

Site Diary

Nottingham Trent University- Enterprise and Innovation Centre

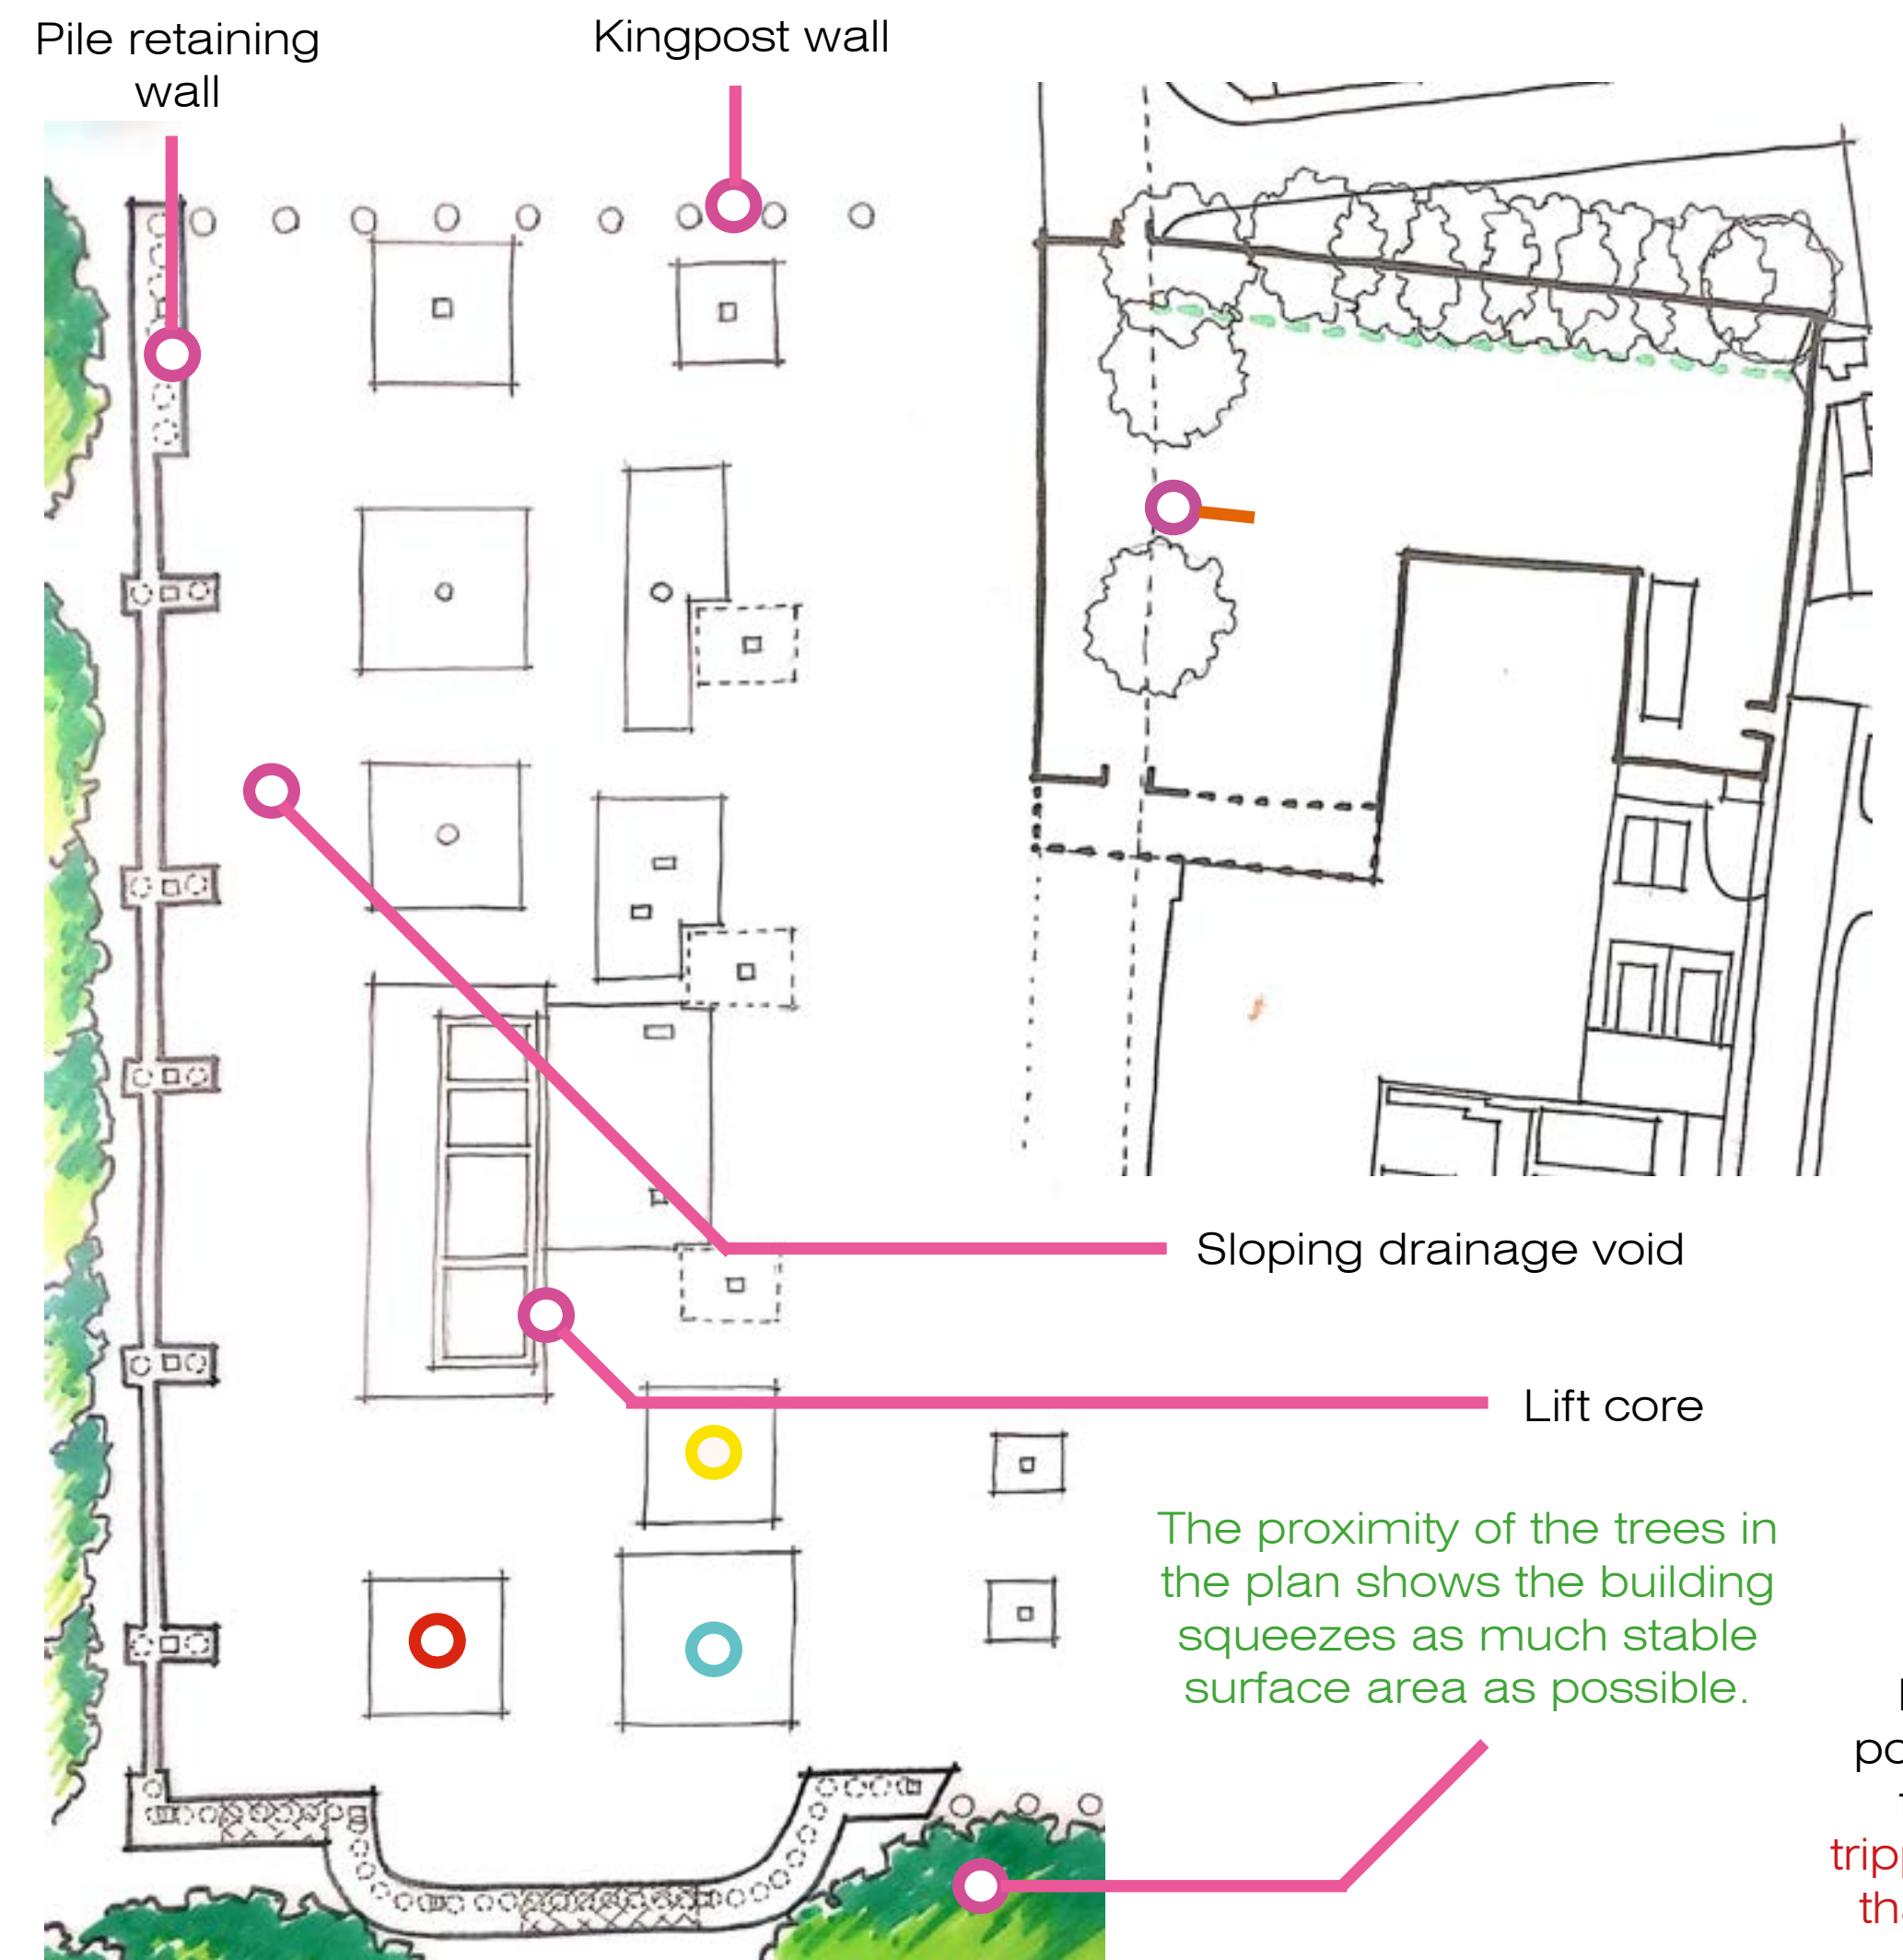
Fig 4.4: Site Slabs (Beeley, 2019).

The shuttering and form-work extends over to the site entrance. The concrete pad foundation bases are finished in the most part, with some being poured on site on the day.

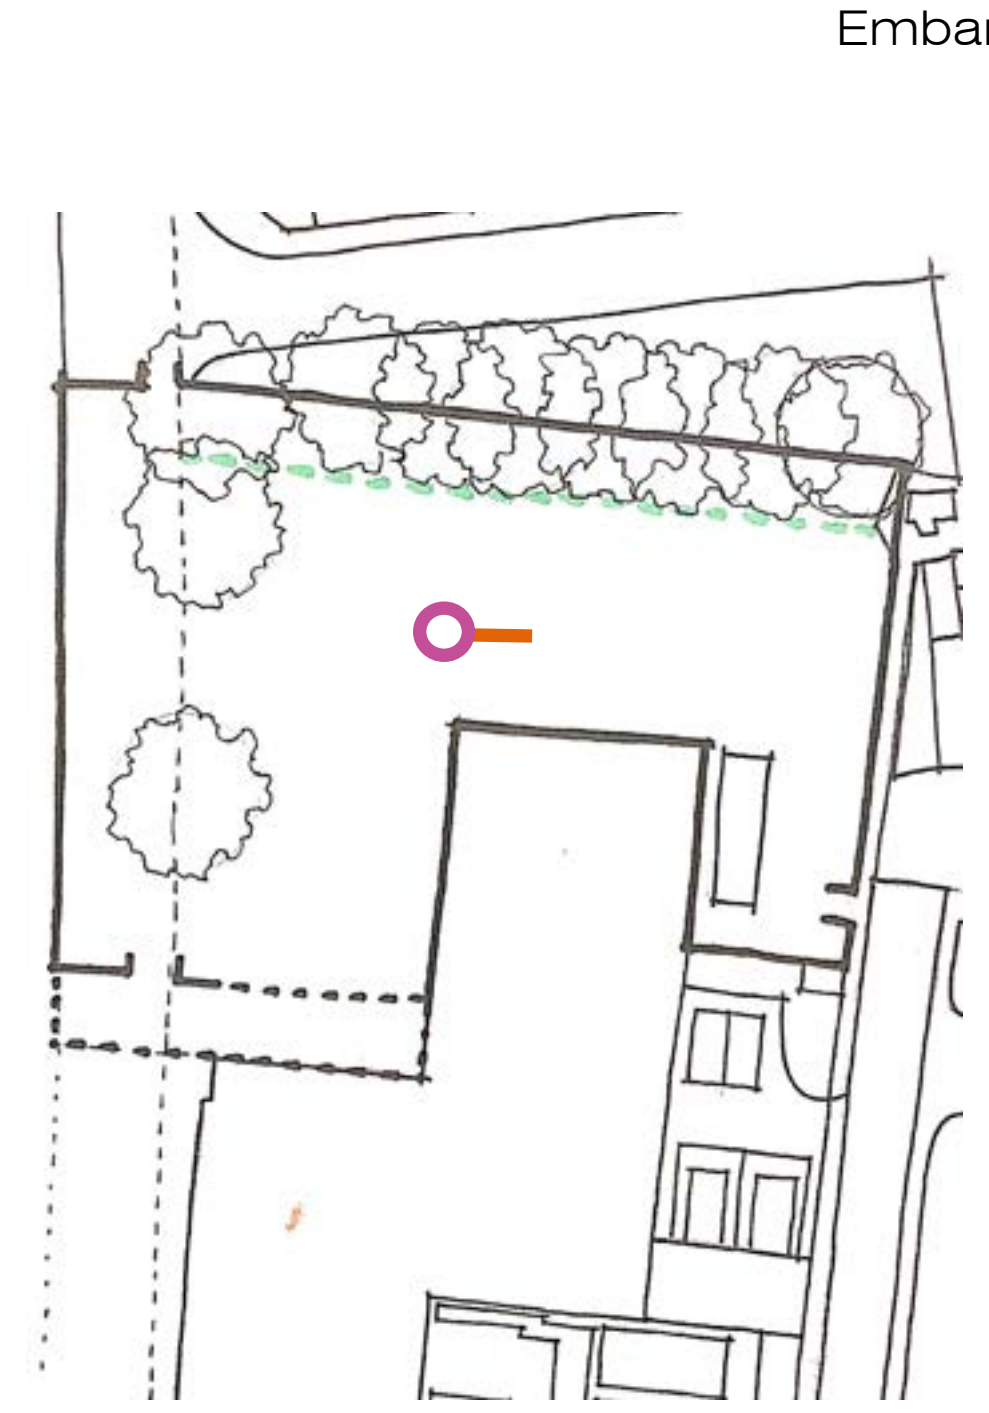
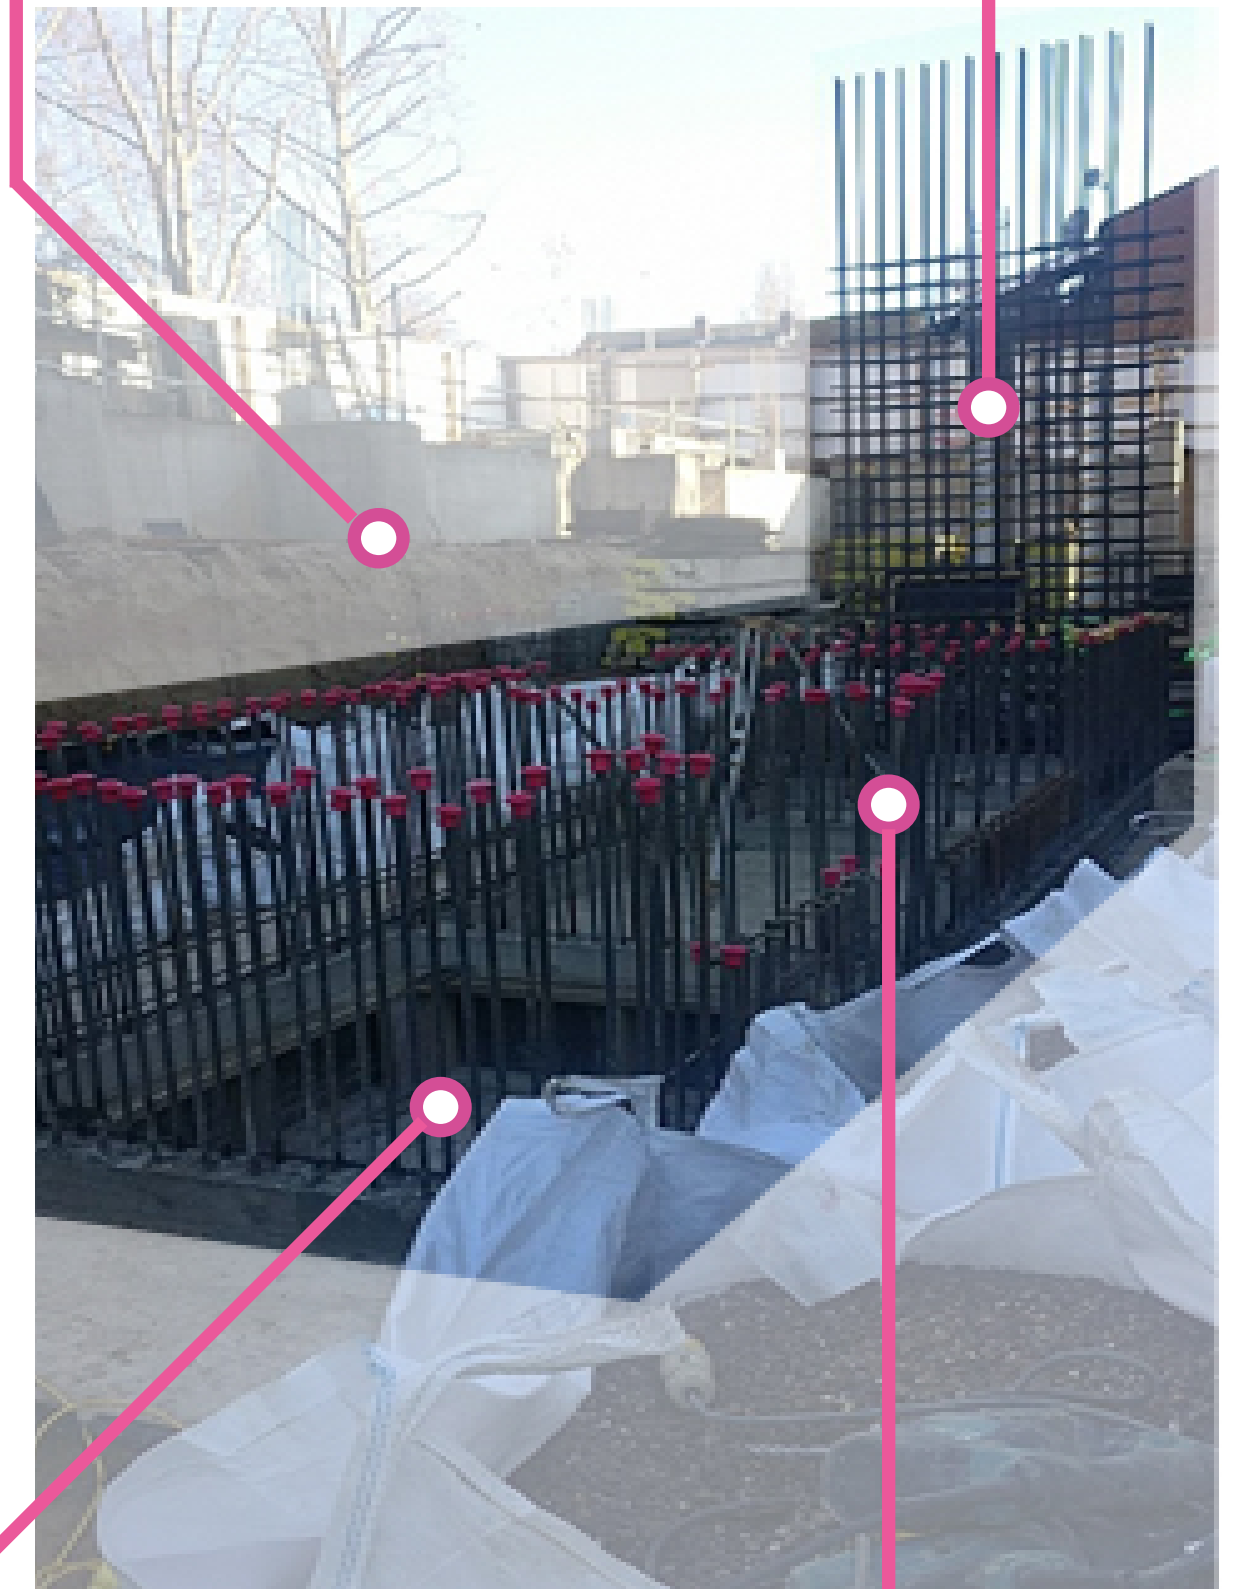
Fig 4.7: Rebar and Cap (Beeley, 2019).

Deeper recess for the lift shaft takes into account the mechanics and motor functions of the lift and the fact it must come flush with the floor. By burying the central hearth of the building it becomes a lot stronger, it becomes its own foundation.

The mesh system here works like a marker for the position of Dryden centre's ground floor. The logistic and method behind the convergence of these two buildings is the expansion of a community and set of values, allowing the pupil of Nottingham Trent to feel invited.

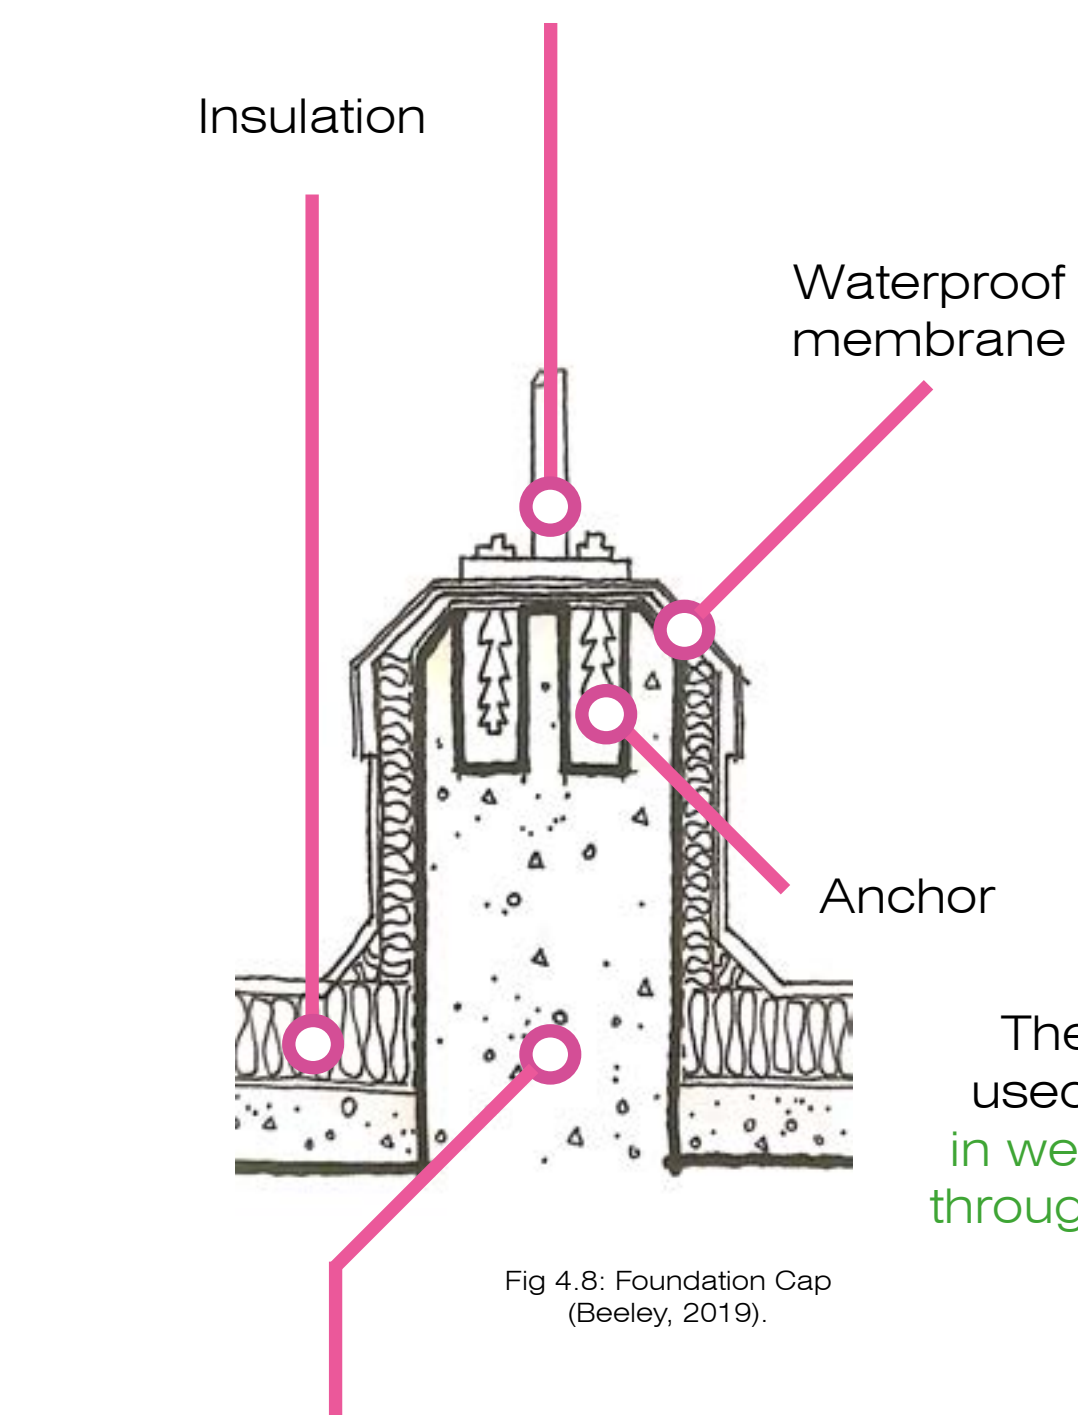
Fig 4.8: Foundation Cap (Beeley, 2019).

In this case, the capping of what could be seen as a conventional retaining wall, contains a ground plate bolted into its top, and another tier of rebar for continual growth.

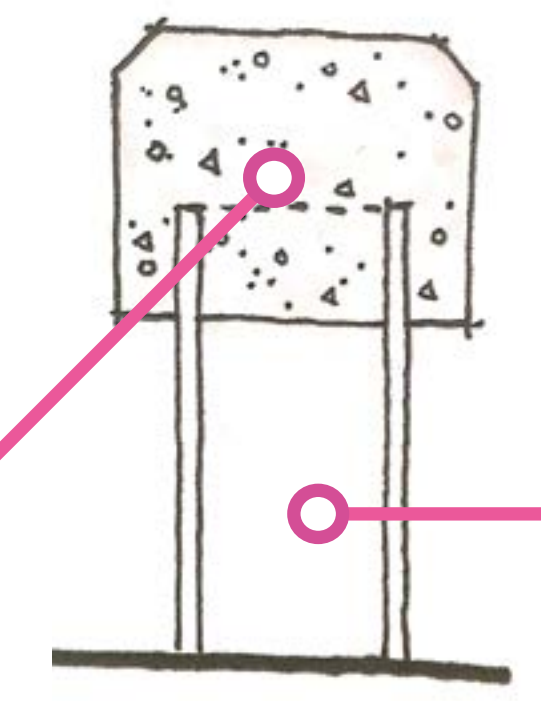
Rebar mesh atop a pile retaining wall.

Down-piping for the flow of water and drainage.

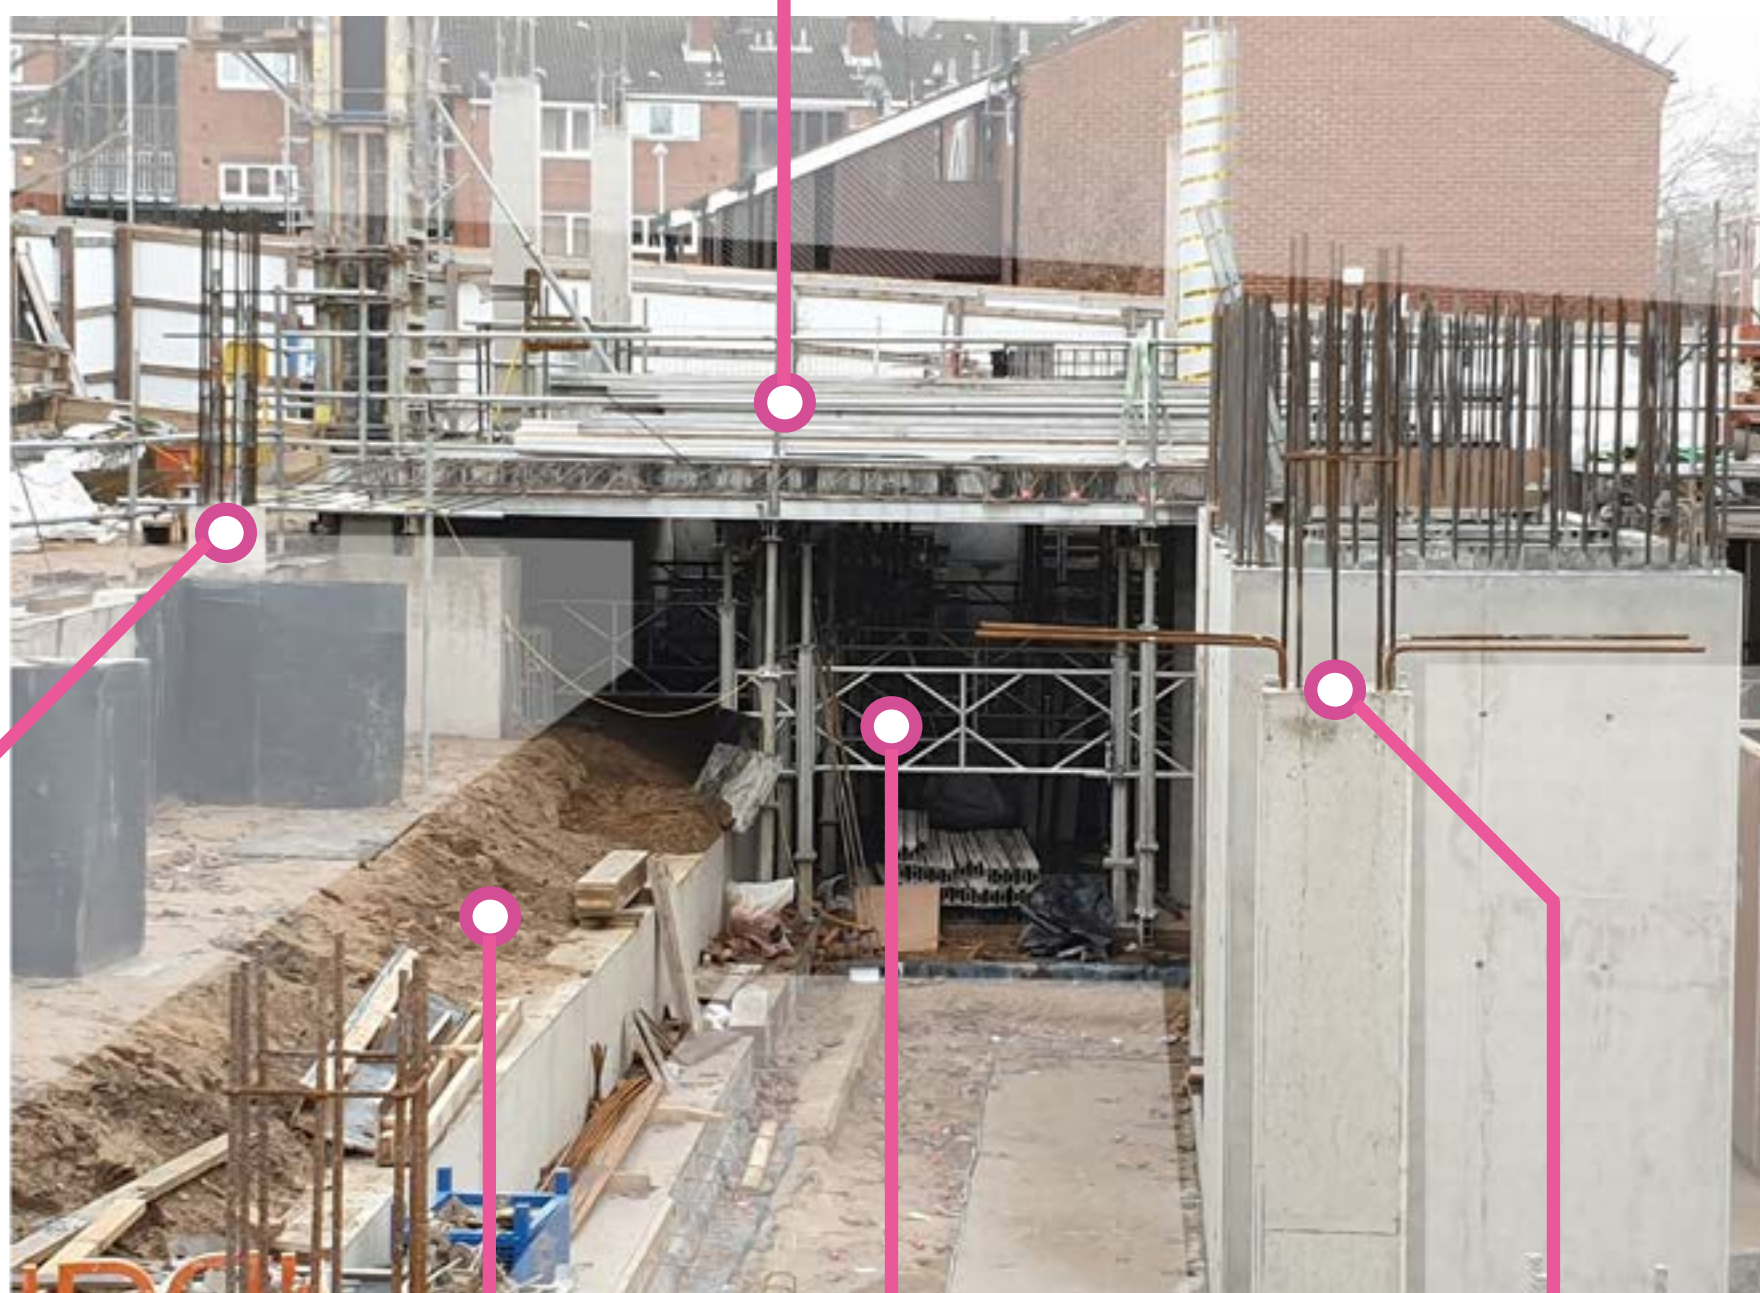
Fig 5.1: Steel and Floor Slab (Kentish-Brade, 2020).

Steel decking and makeshift wooden flooring

The columns that sit within the contiguous pile foundation wall are dry, and as such are strong enough to harbour the steel girders and columns to begin work on the first floor roof beside the footpath.

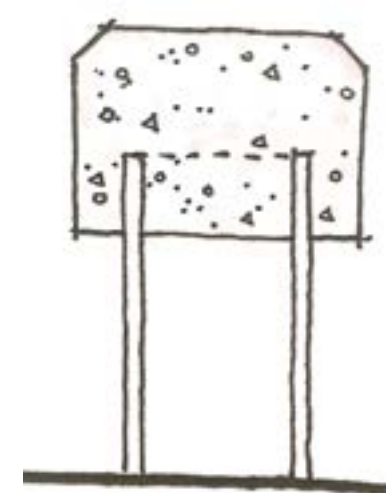
Fig 5.2: Simplified Cap (Beeley, 2019).

The pile work to the left of frame has now been completely encased in rebar reinforcement, and is ready to be poured and capped to distinguish a lip and flood-guard between the footpath on Dryden Street and the building itself.

Waterproof membrane

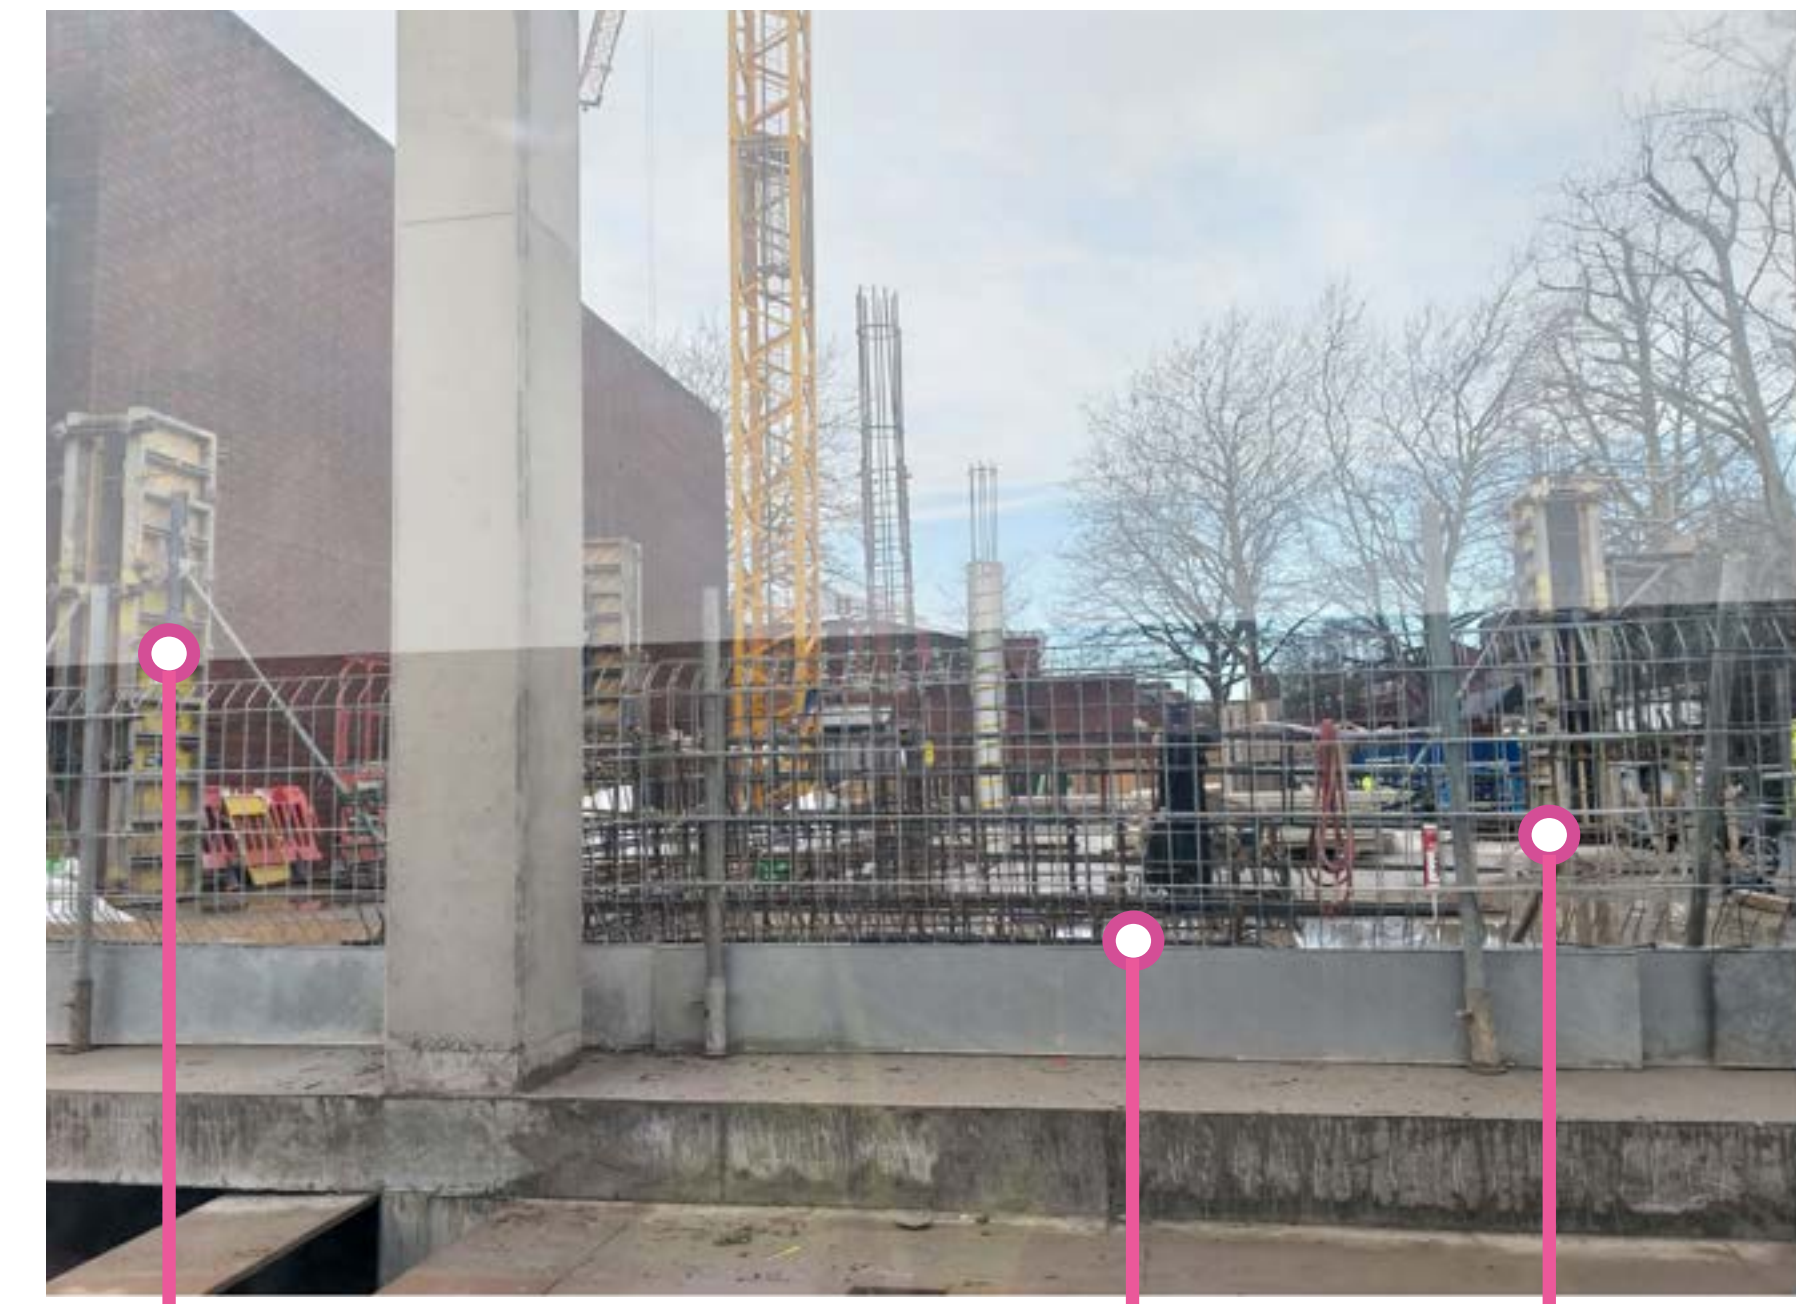
Fig 5.8: Mesh Walling (Kentish-Brade, 2020).

Top view looking down into the column cavity at further rings of rebar. The wall elements bind themselves into the infrastructure, binding around the same vertical rebars as the columns.

Individual bent rebar elements within the wall

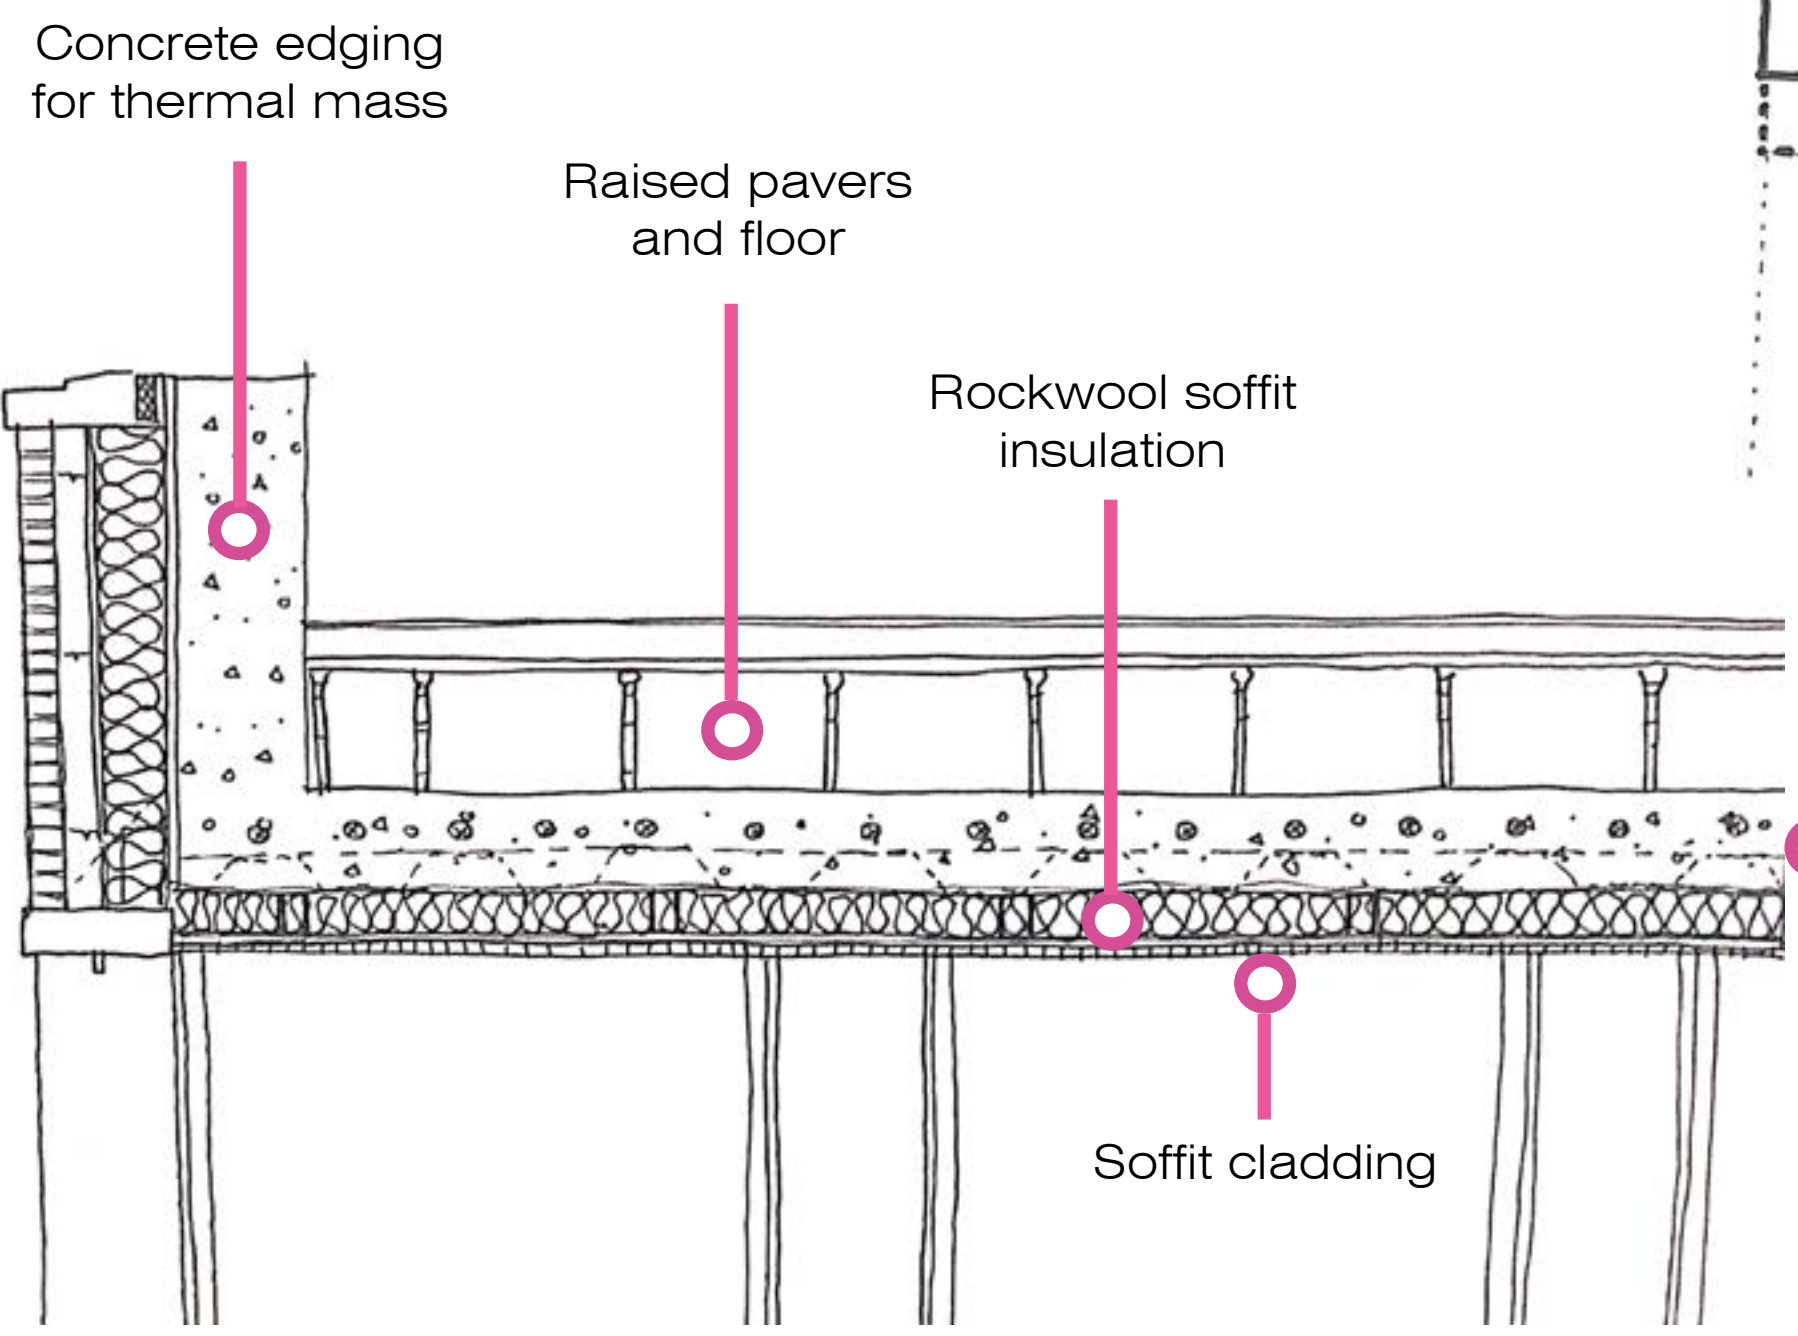
Fig 5.9: Flooring Section (Beeley, 2020).

Concrete atop a steel decking, steel beams below surrounded by insulation.

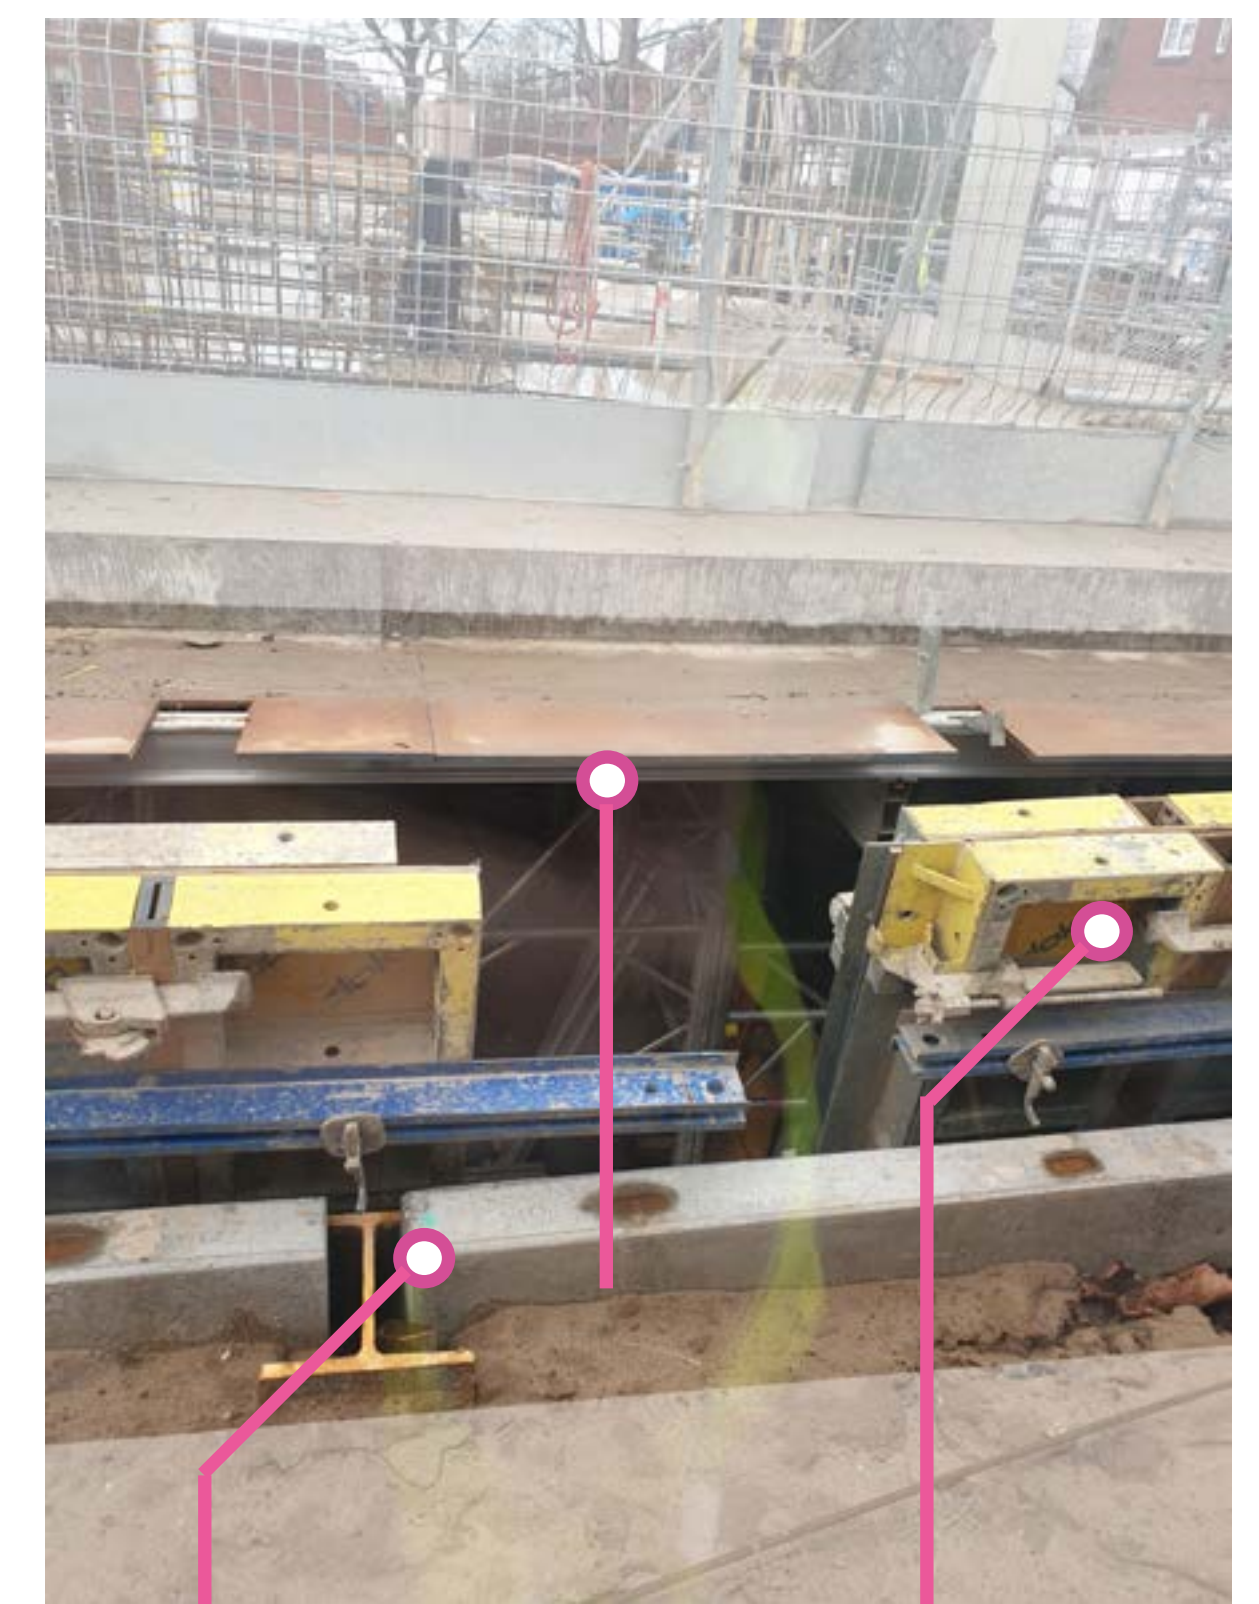
Fig 5.10: Flooring and Walls (Kentish-Brade, 2020).

Formwork panelling for various sizes of work. Detachable and interchangeable.

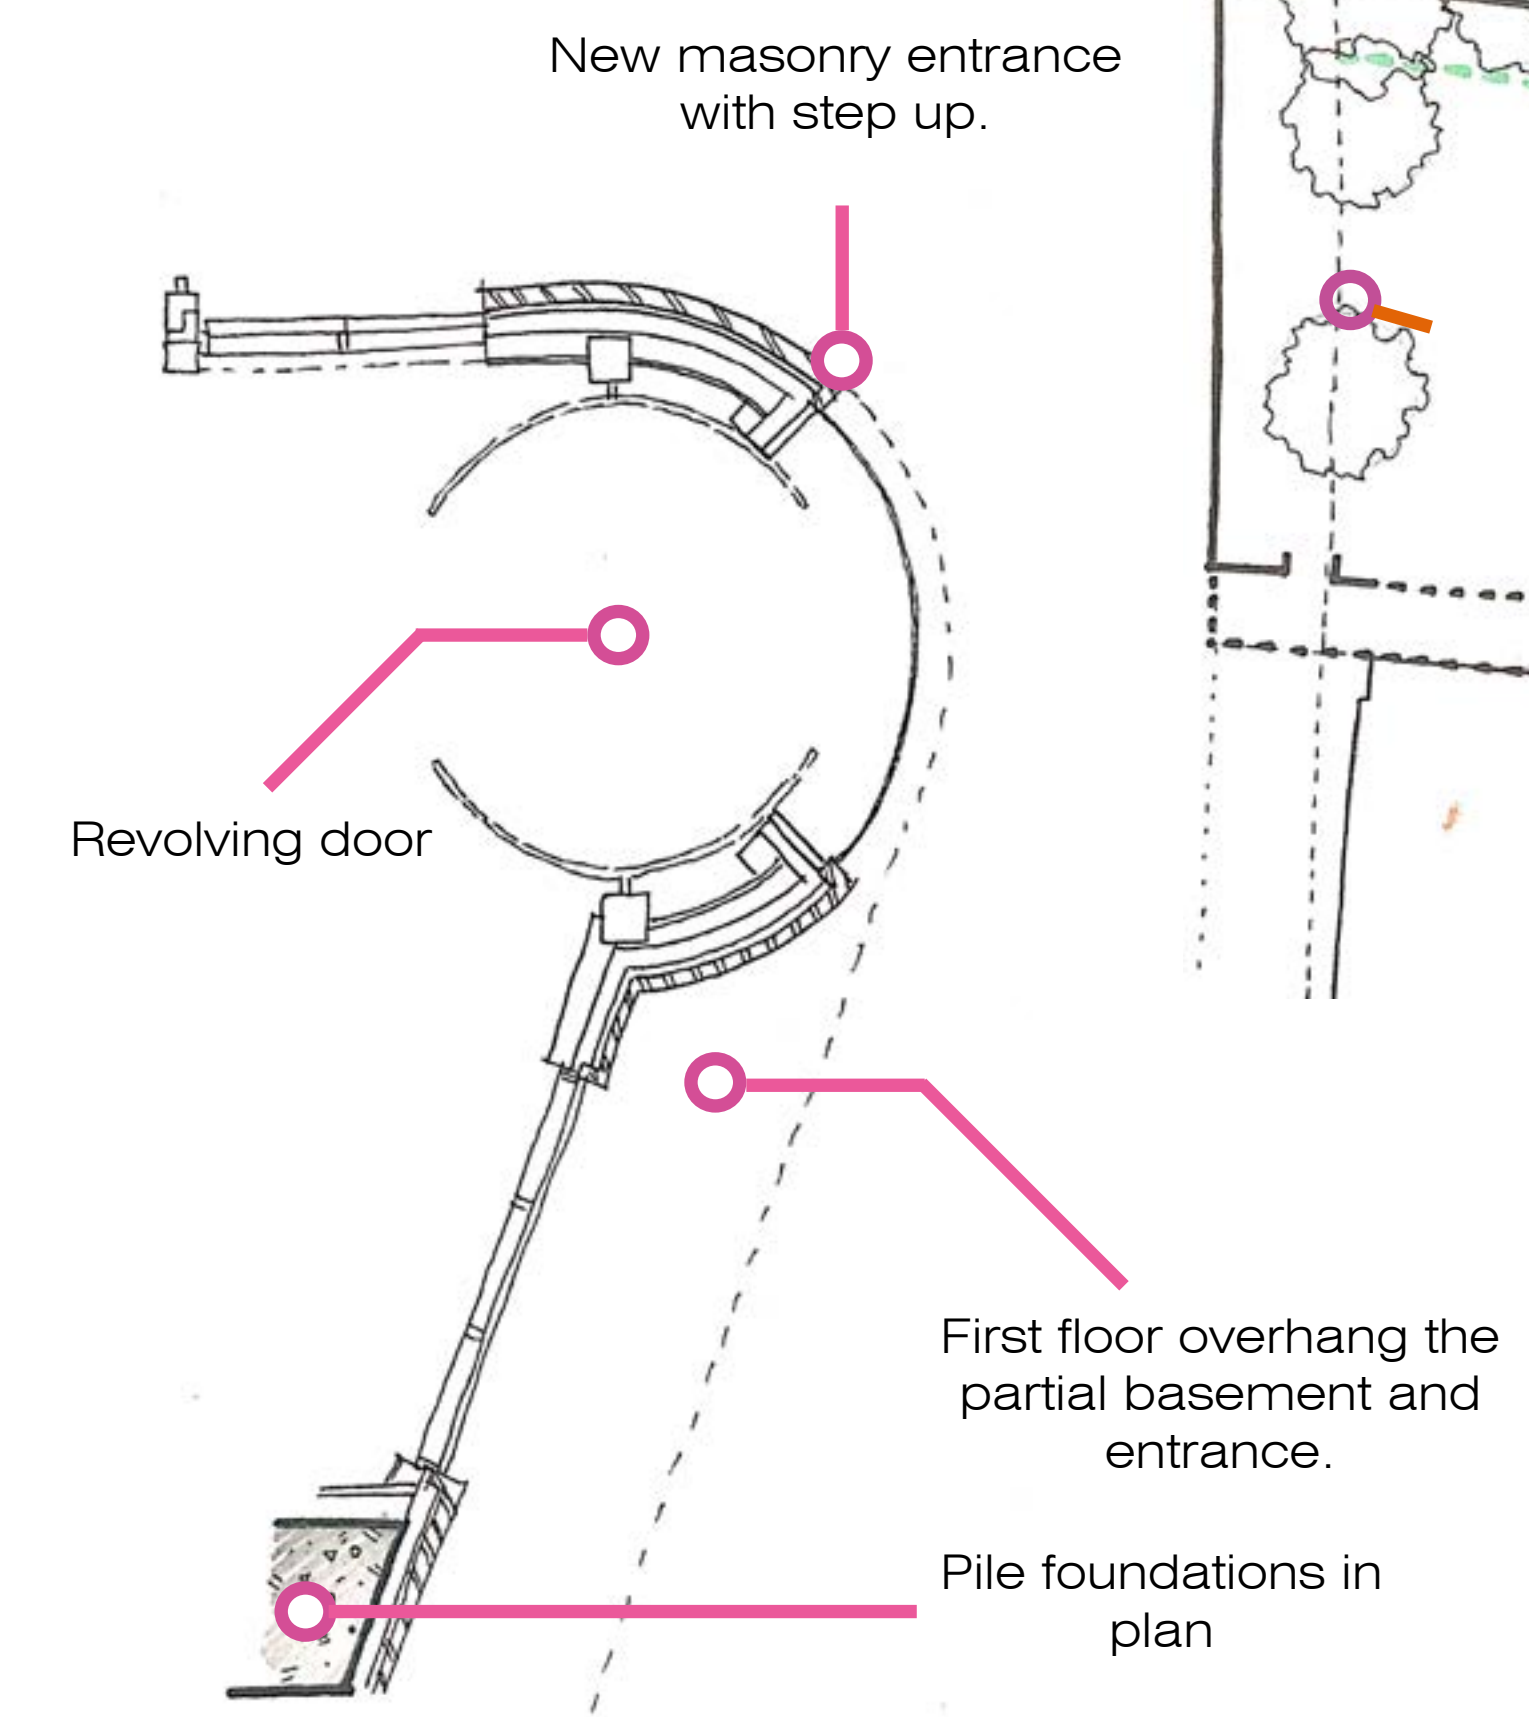
Fig 5.11: Revolving Door (Beeley, 2020).

The central workspace is ideal for visibility and access to this area of the site in which the intricacies of the revolving door are being considered.
