Technology and Environment in Architecture-

Site Diary

Nottingham Trent University- Enterprise and Innovation Centre

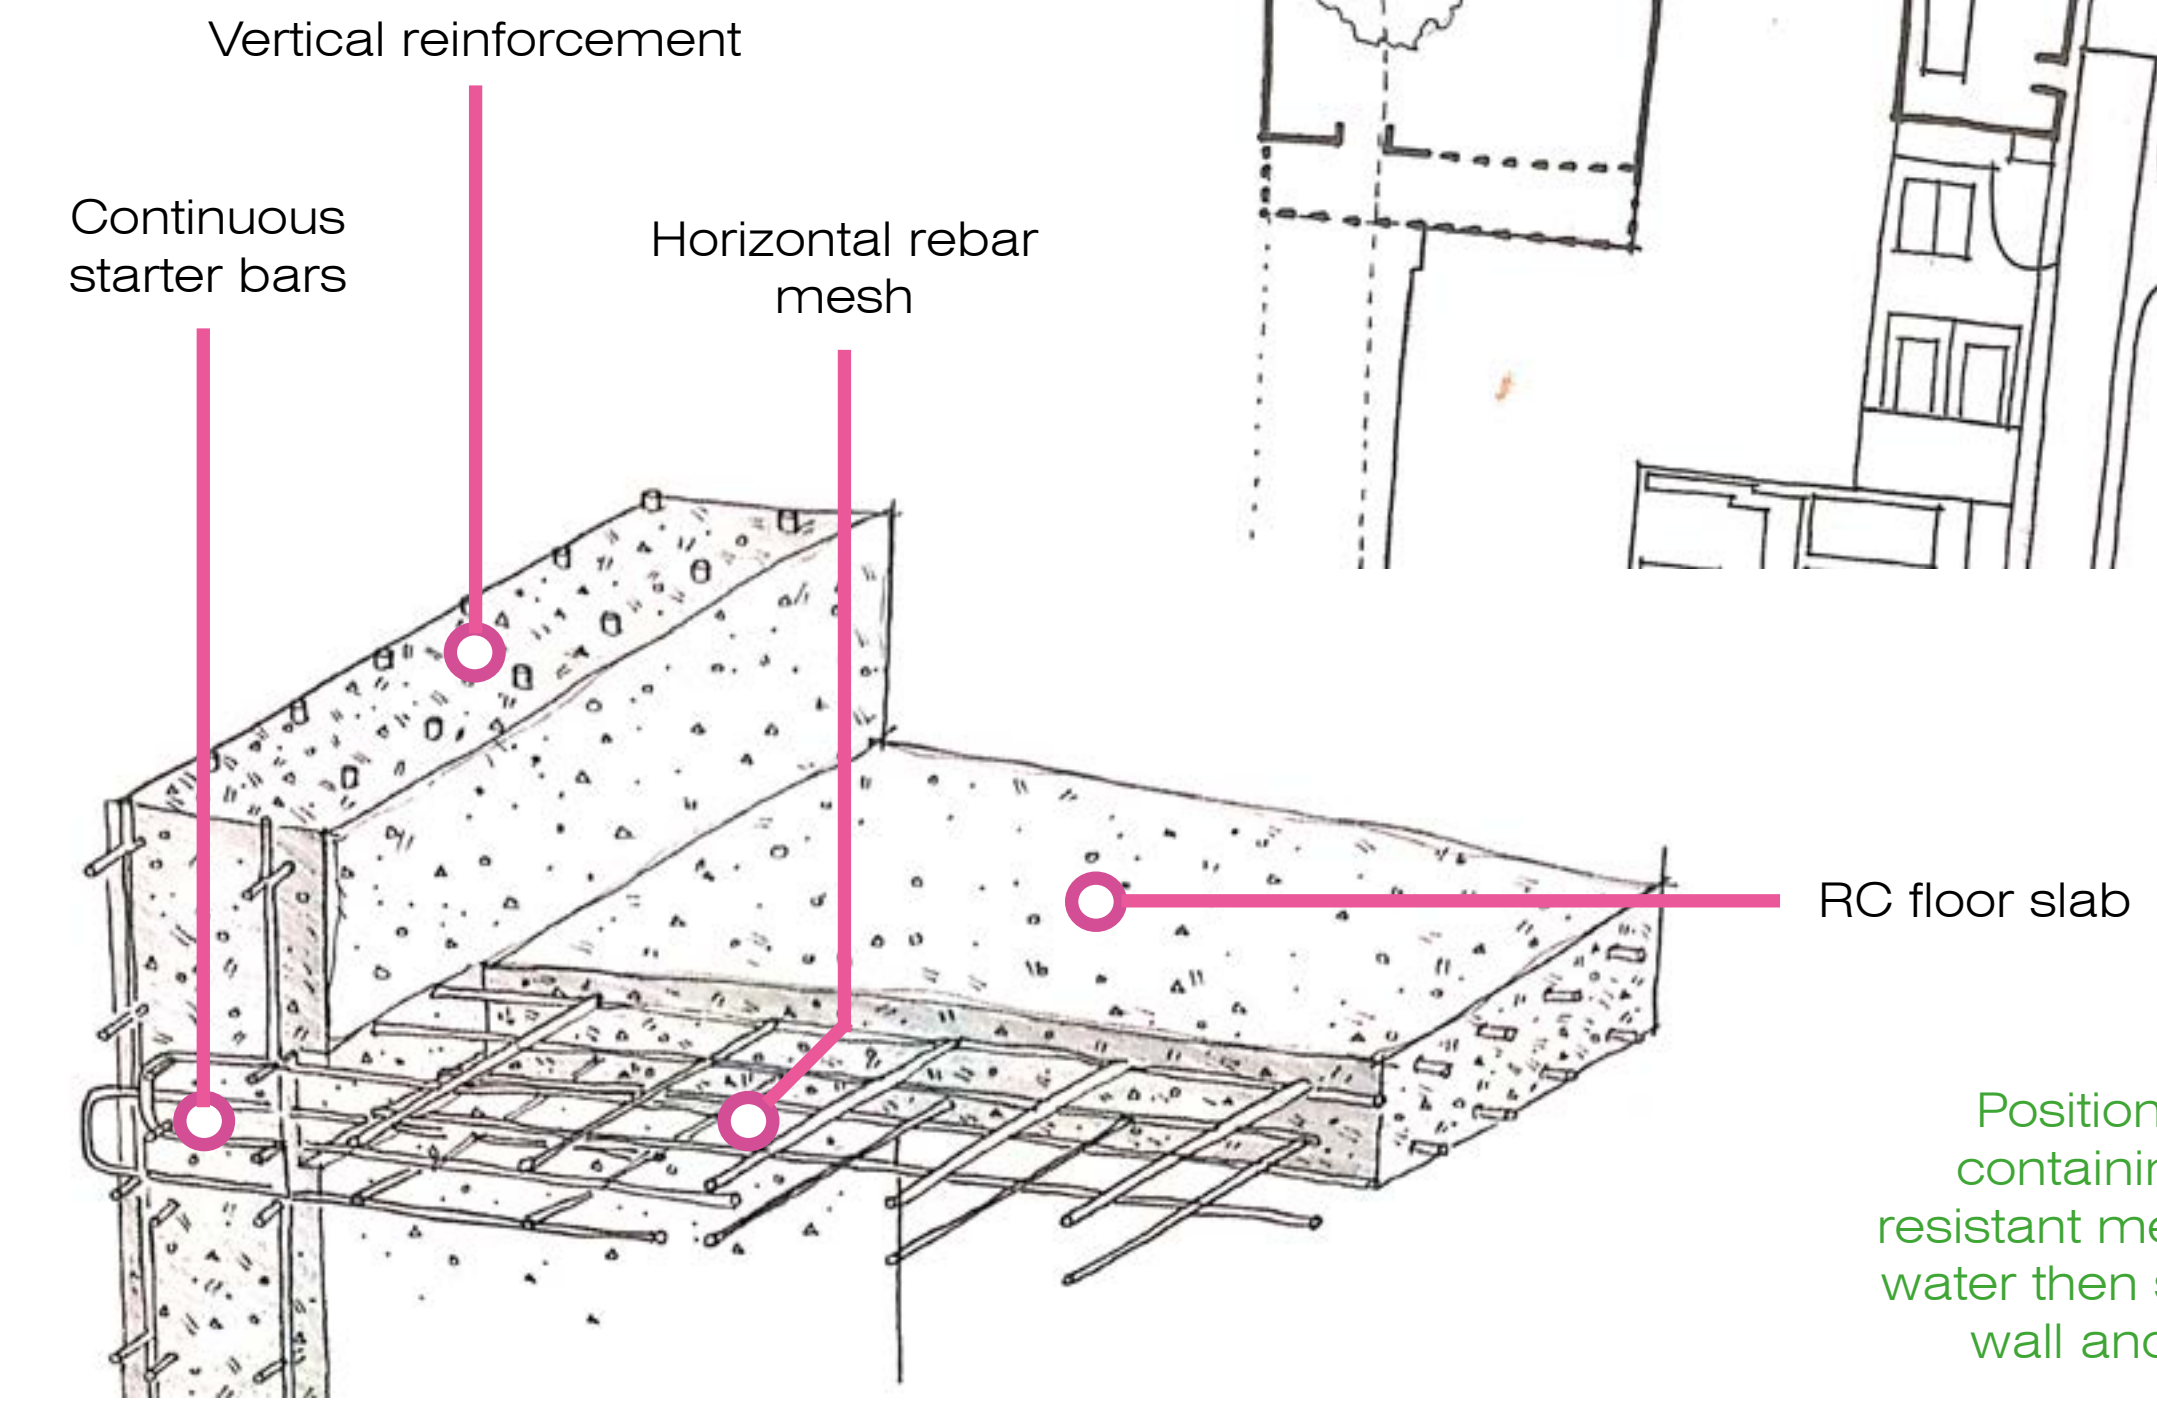
Fig 6.2: Starter Rebars (Beeley, 2020).

Looking deeper into the connections between the framework and foundations, I came across ways in concrete structures to fuse structural elements in different planes. The starter bars act like a supportive steel beam when poured atop of, its origins being inside the column or wall component, providing extra stability. The floor slabs are regularly held by a lattice of steel beams underneath and are arranged like a chequered print.

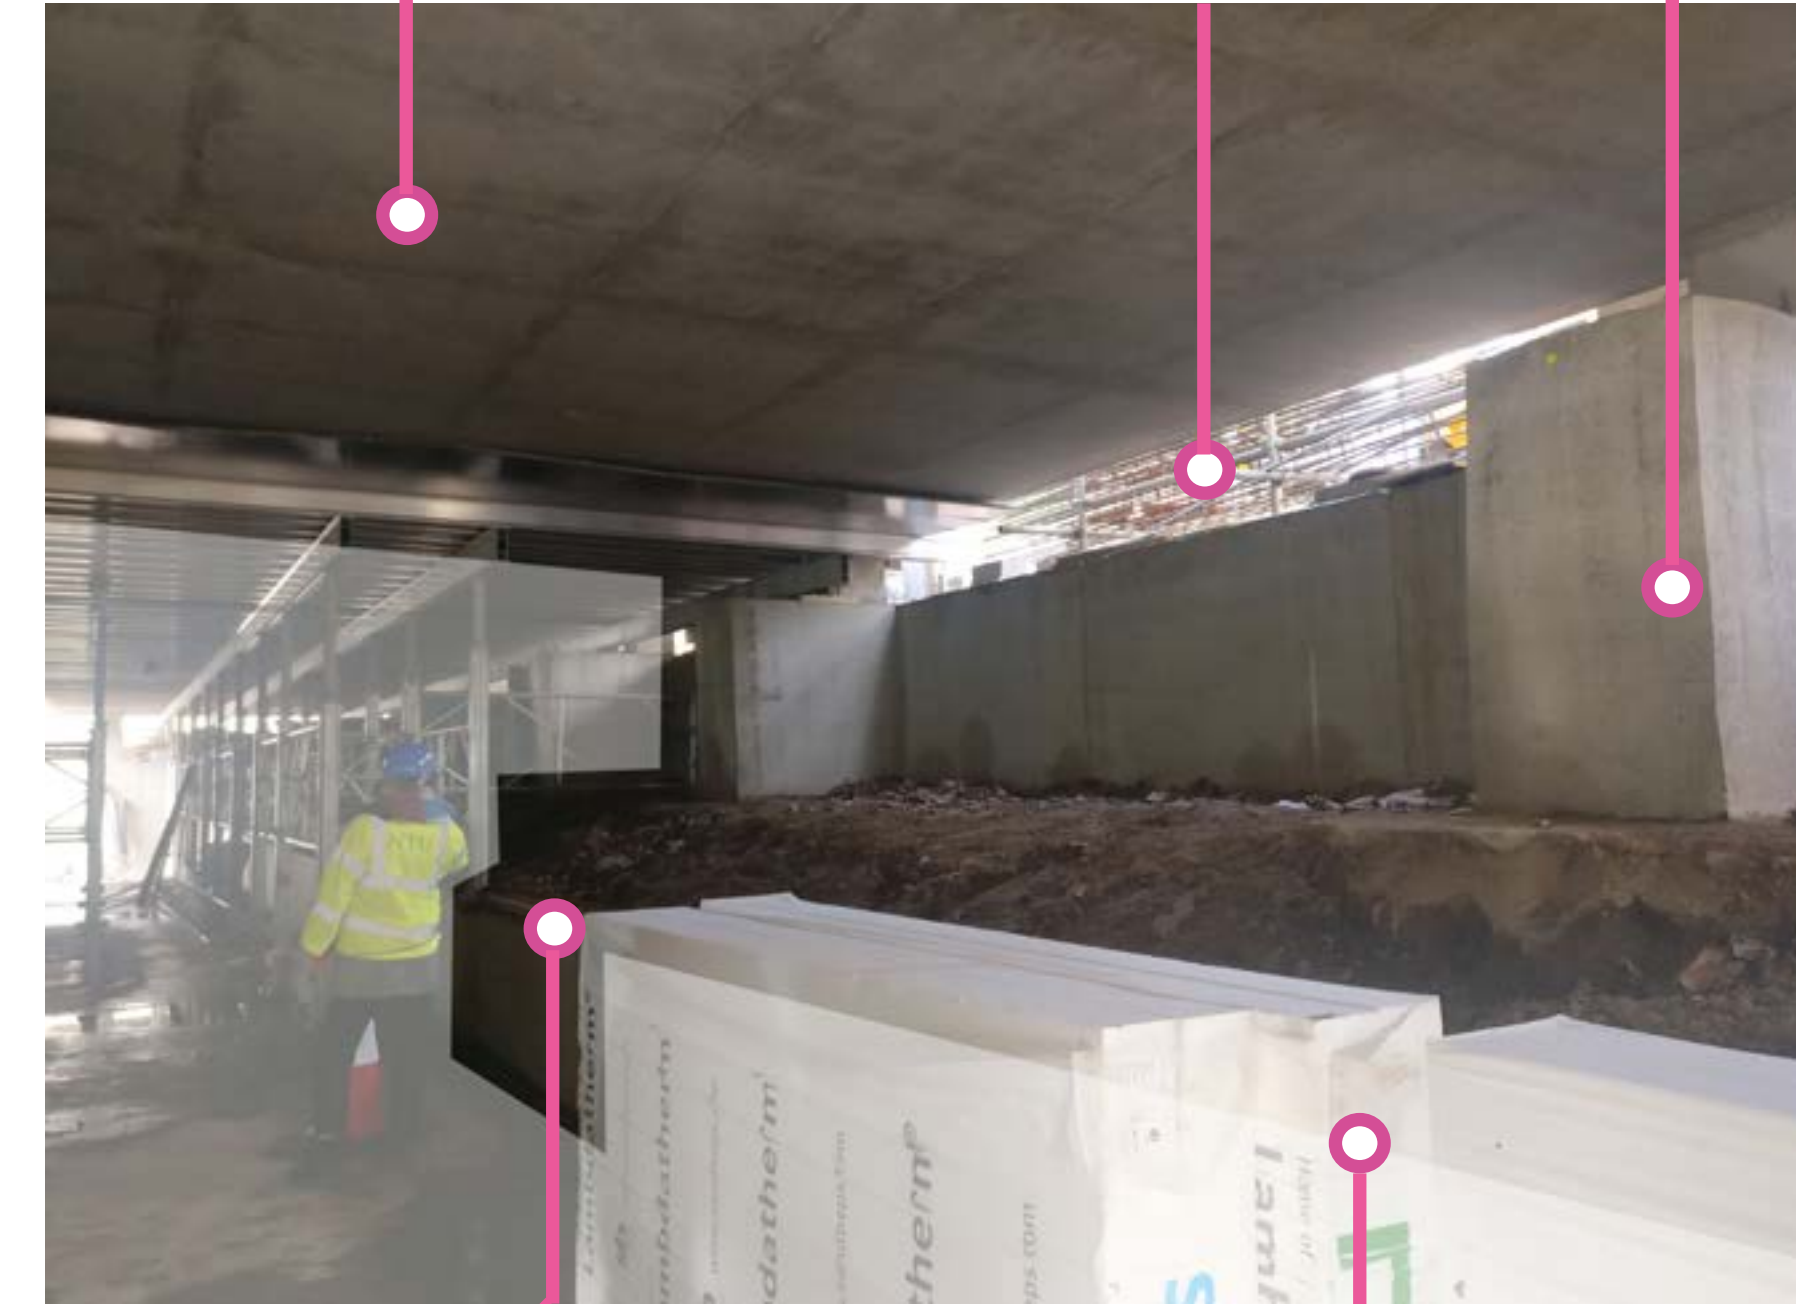
Fig 6.3: Earth Void (Beeley, 2020).

Unfinished ceiling, first floor base poured. Must be done by hand by concrete labourers.

Slit which will be covered and filled by insulation and grey brickwork, as a improvisational design continuation.

Contiguous pile foundation

Underfloor insulation, to be placed above the currently damp foundation slab. Internal works will be done including the fitting of the insulation in order to offset losses of time and get ahead in later aspects of work. This would first mean the area would have to be rid of its water, and made watertight, the main way in which water is entering is via the sloping void from the slit between the soffit and foundations above.

Positioning of internal blockwork containing insulation, with a water resistant membrane on the outside. The water then seeps into the ground by the wall and into a drainage system.

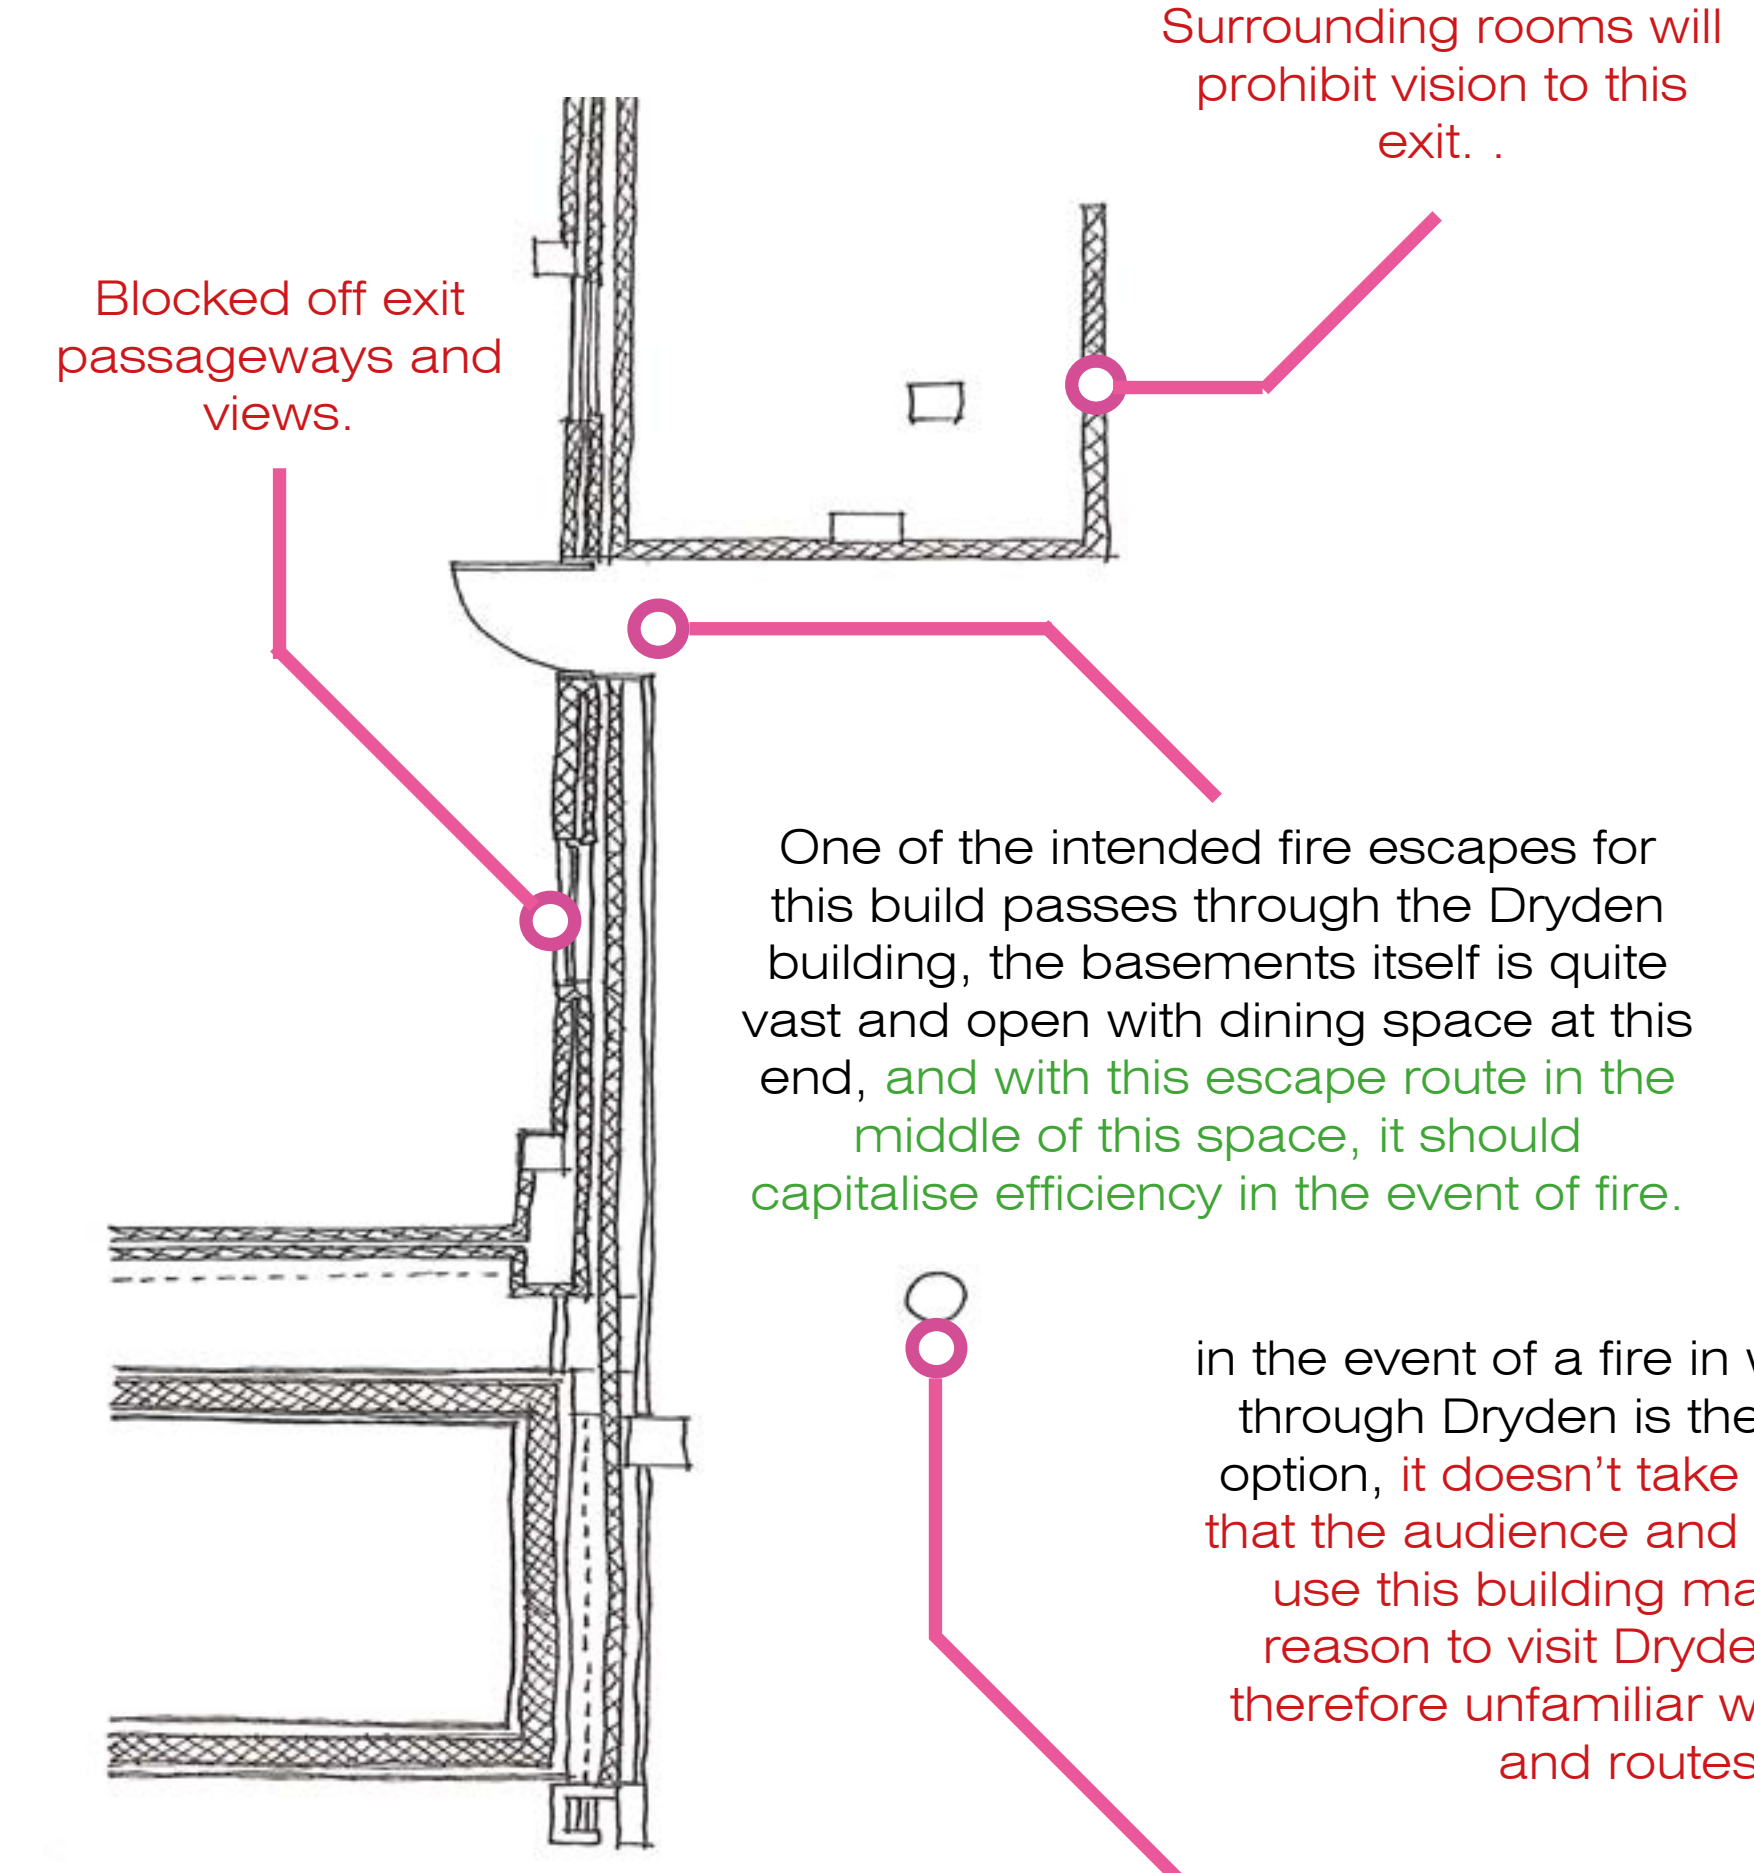
Fig 6.4: Dryden Detail (Beeley, 2020).

Site of asbestos in old Dryden staircase foundation.

Fire escape to Dryden

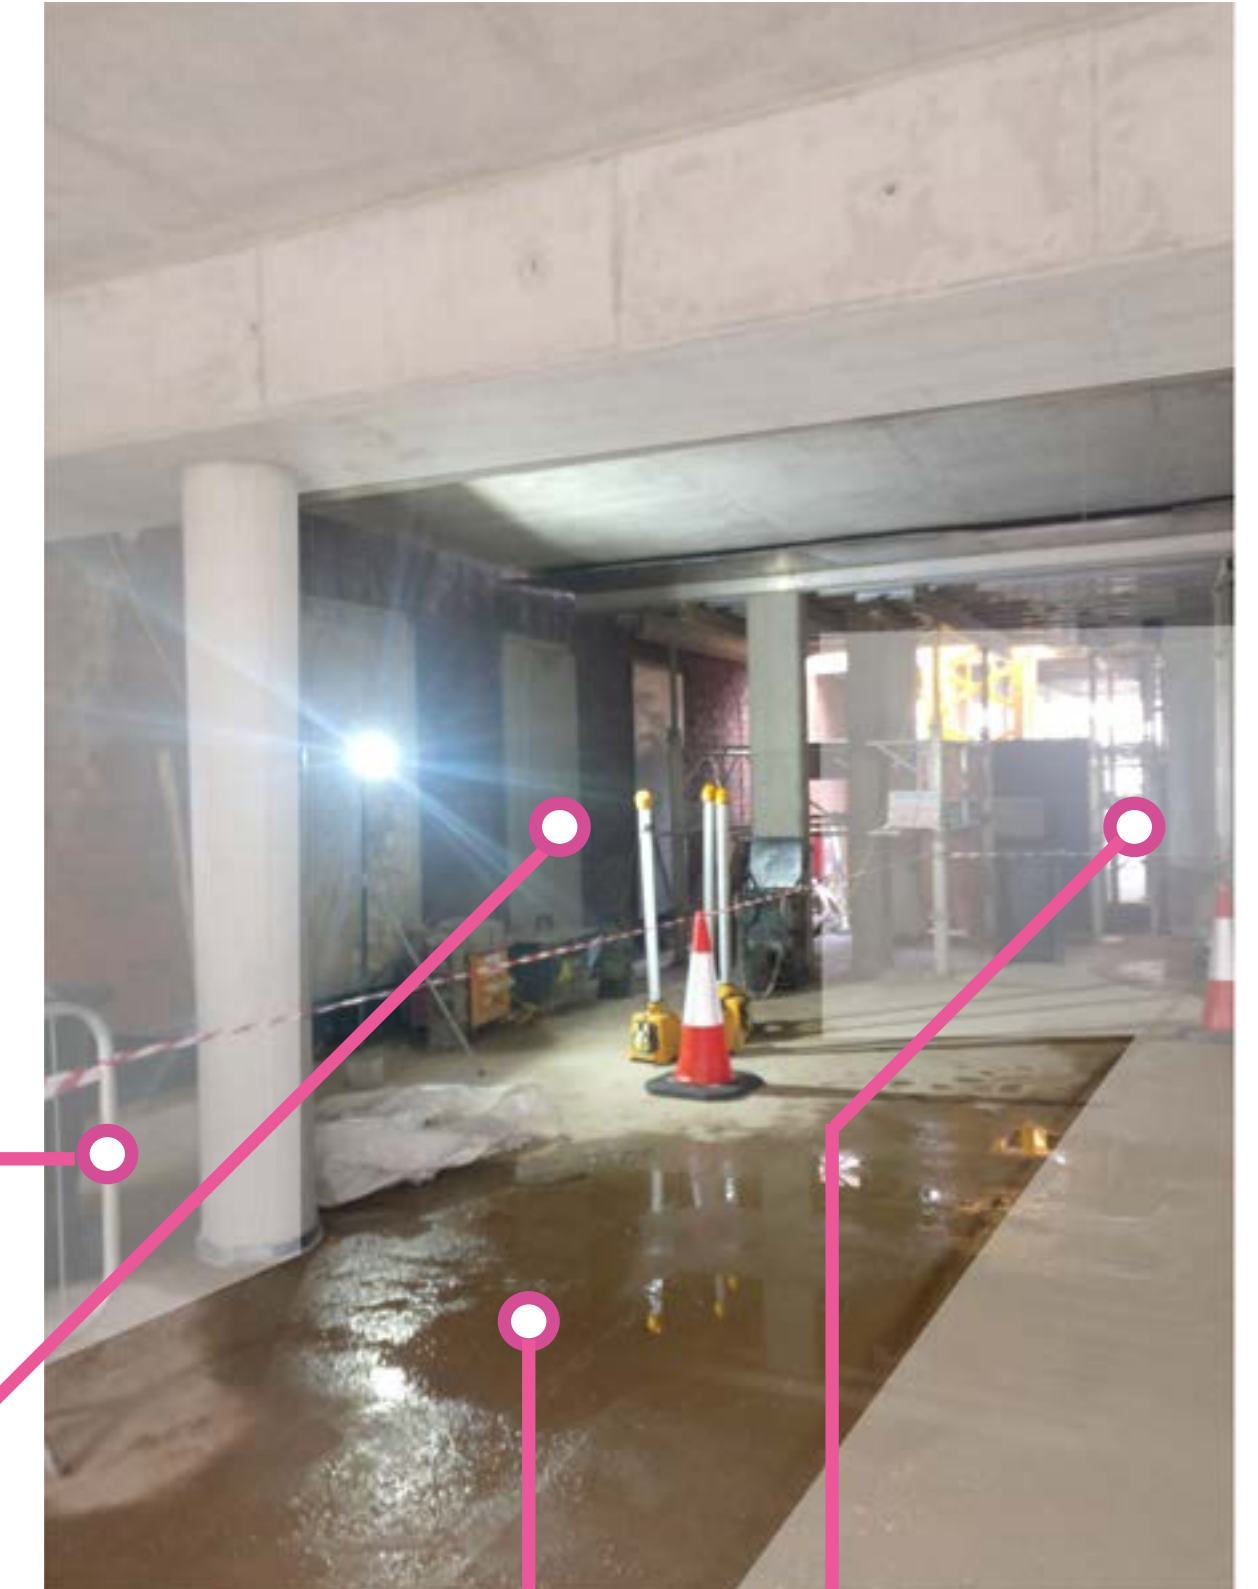
Fig 6.5: Dryden Fire Exit (Beeley, 2020).

Drainage is currently a small issue when the construction exposes materials such as waterproof concrete in their raw state. Although it's a positive the ground isn't absorbing it in..

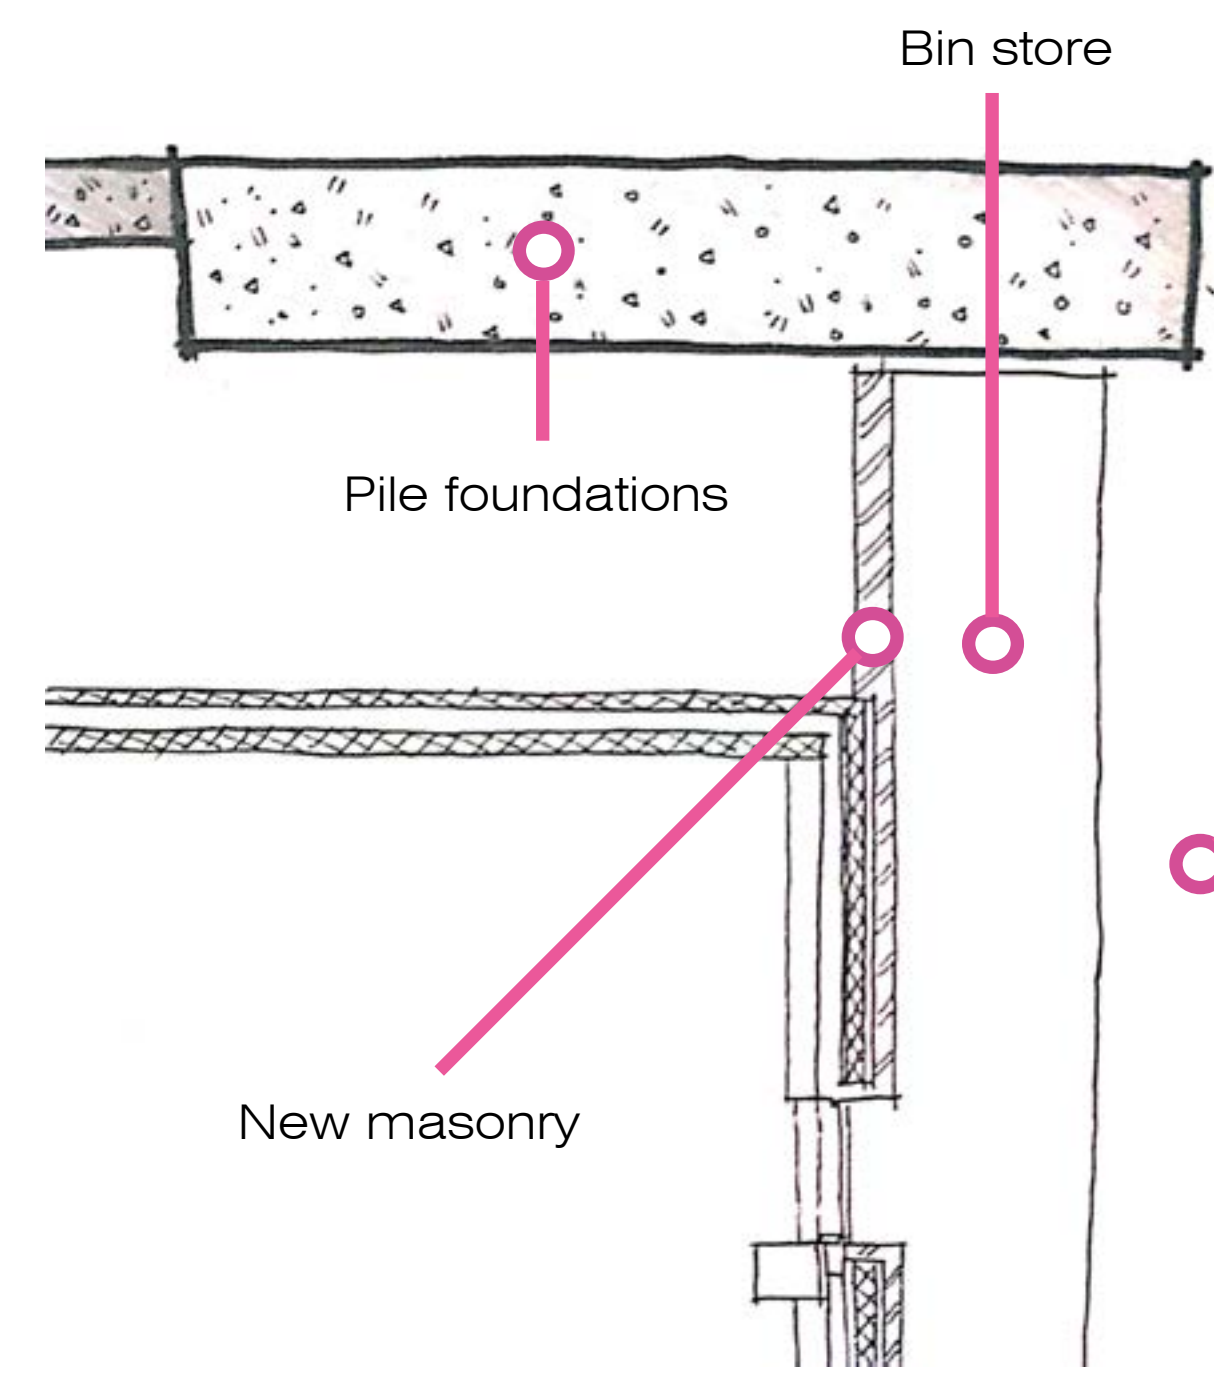
Fig 6.6: Back Alley (Beeley, 2020).

The urgency in completing this area as reported by the site manager stems from it essentially becoming a water basin. It is not the concrete I am concerned about, but the earth berm walls and exposed pile work that could slowly decay weakening the foundations, as a large pool sits just below it, seeping through the soil both downwards and horizontally. The addition of land drains will keep the earth firm for any masonry that goes on top.

The back alley space is sheltered by the second floor overhang.

The seminar space on this area's edge will house exposed blockwork and painted plaster and be carpeted. Therefore to add these finished the walls and floor alike must be dry.

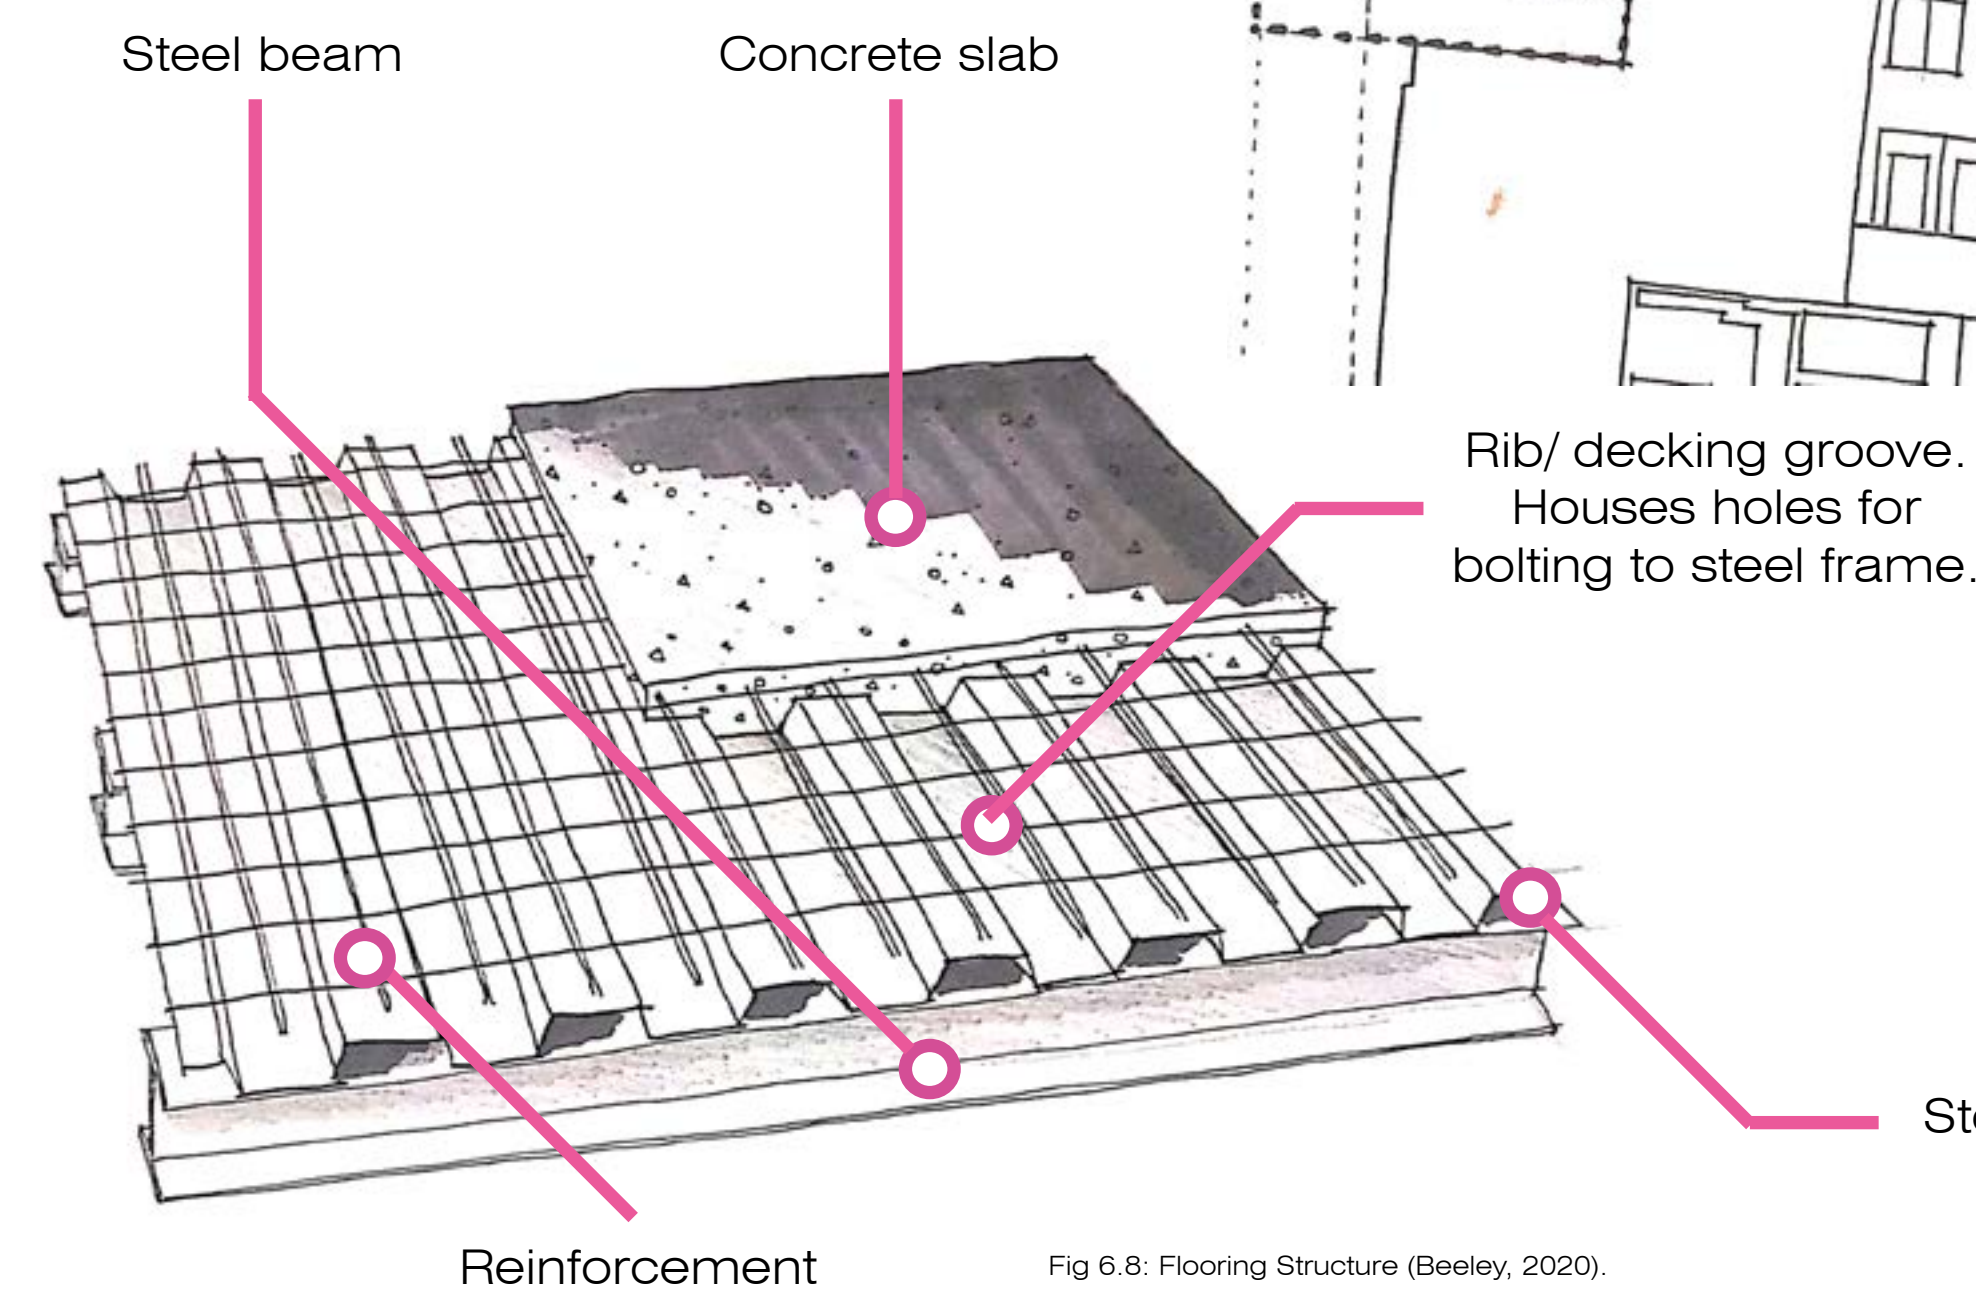
Fig 6.8: Flooring Structure (Beeley, 2020).

One of the most relevant parts of the construction in terms of the Revit tasks I also need to produce. Much like the rest of the construction, progress is being made from back to front, that way space is saved and access out of the site is uninhibited. The framework beyond the lift core as seen to the right of the picture has poured concrete slabs on top, but they still have one more week of curing before they can be walked on. It makes sense; as the traders and team have done in this case, to acclimatise on jobs you can do with set concrete elements. While others are still curing and areas are inaccessible.

Rib/ decking groove. Houses holes for bolting to steel frame.

Beams that sit atop of each-other and decrease area needed to be covered by individual slabs are also perpendicular for strength.

Grid-like support beams between the columns prevent accidents in the workplace involving the dislodging of scaffolding columns. As these such columns aren't permanent on site or to the build. Due to the increasing amount of workers on site compared to other visits, care must be taken in navigating them.

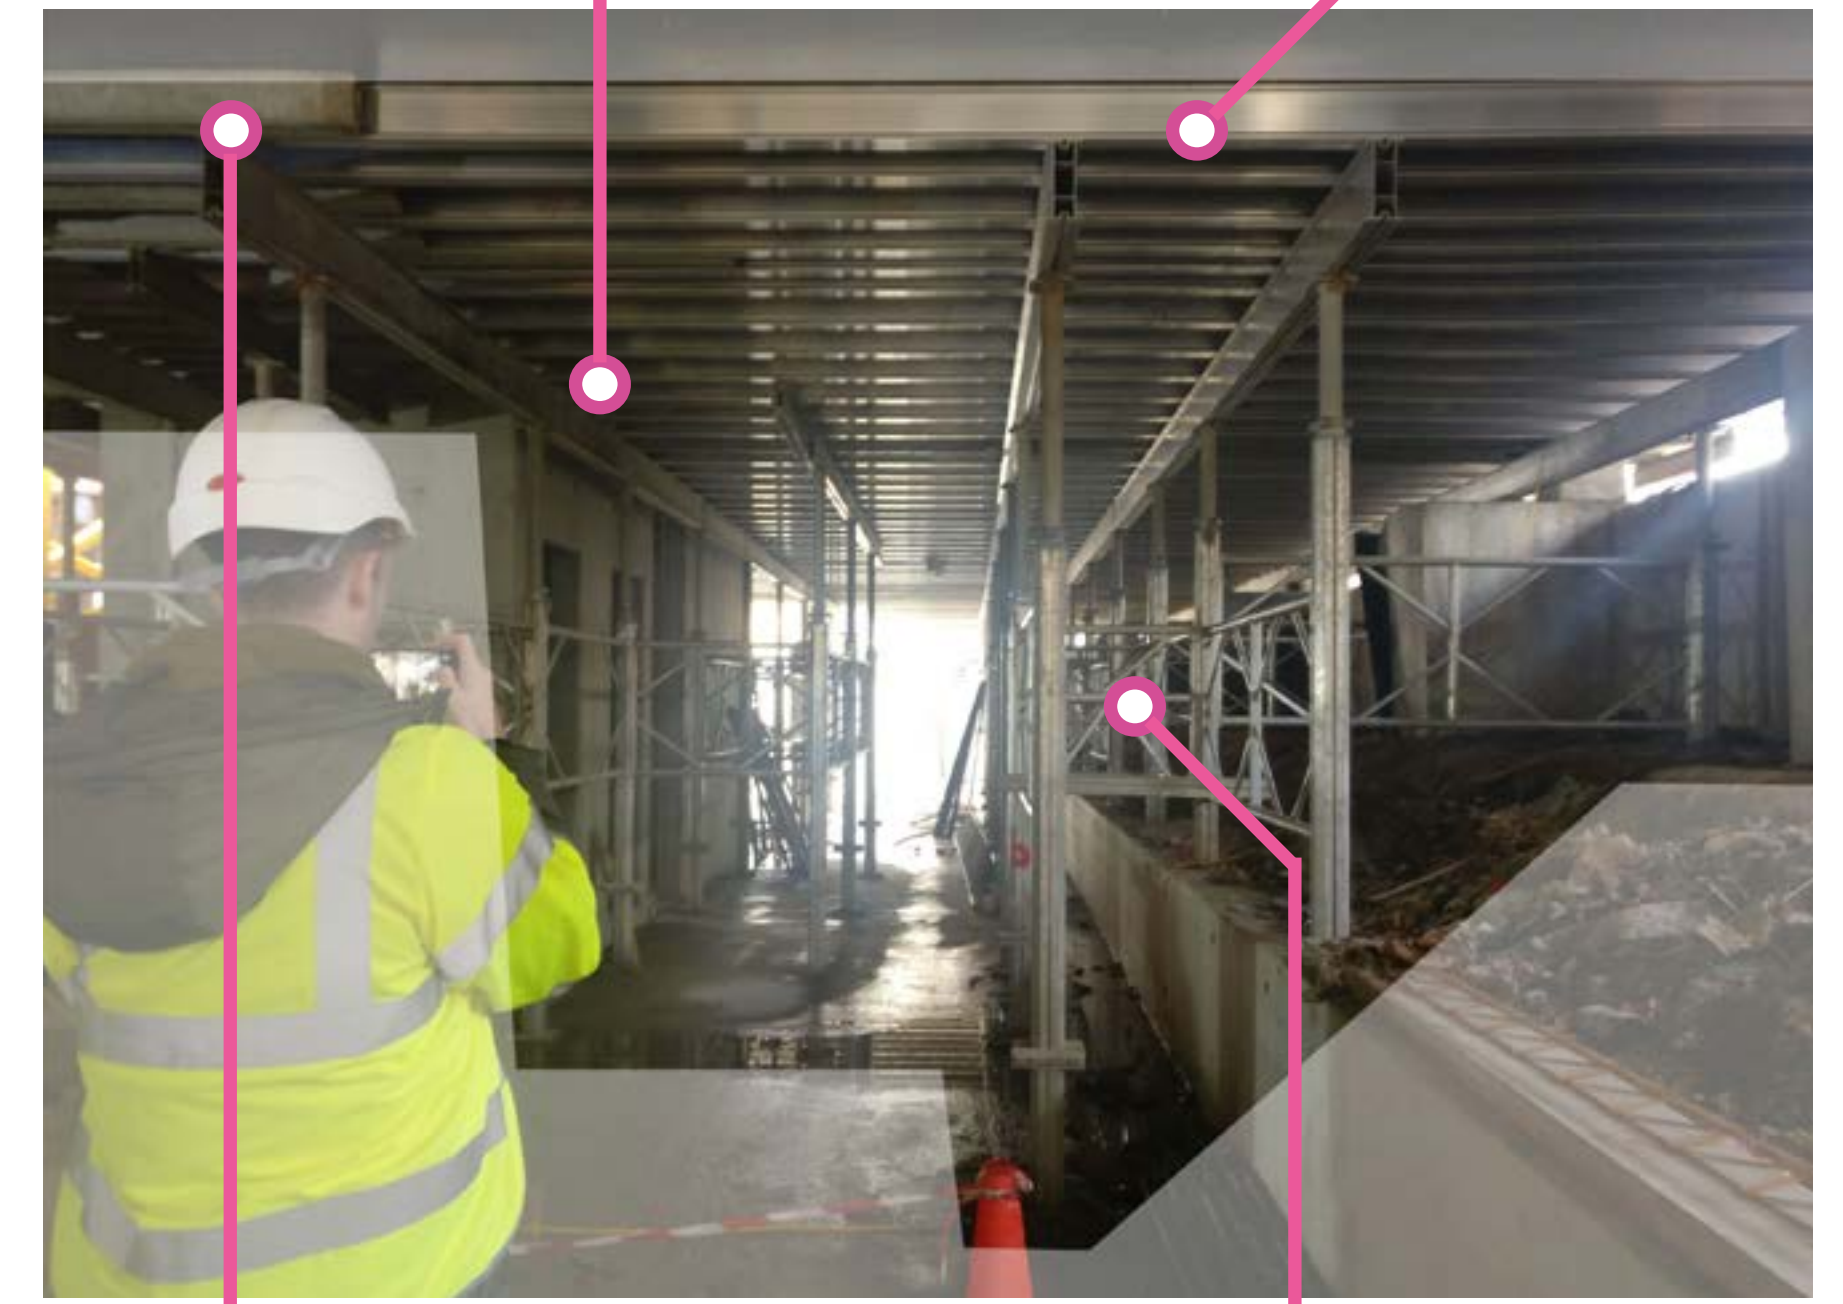
Fig 6.9: Steel Decking (Beeley, 2020).

The steel decking runs perpendicular to the direction of travel of the steel scaffolds.

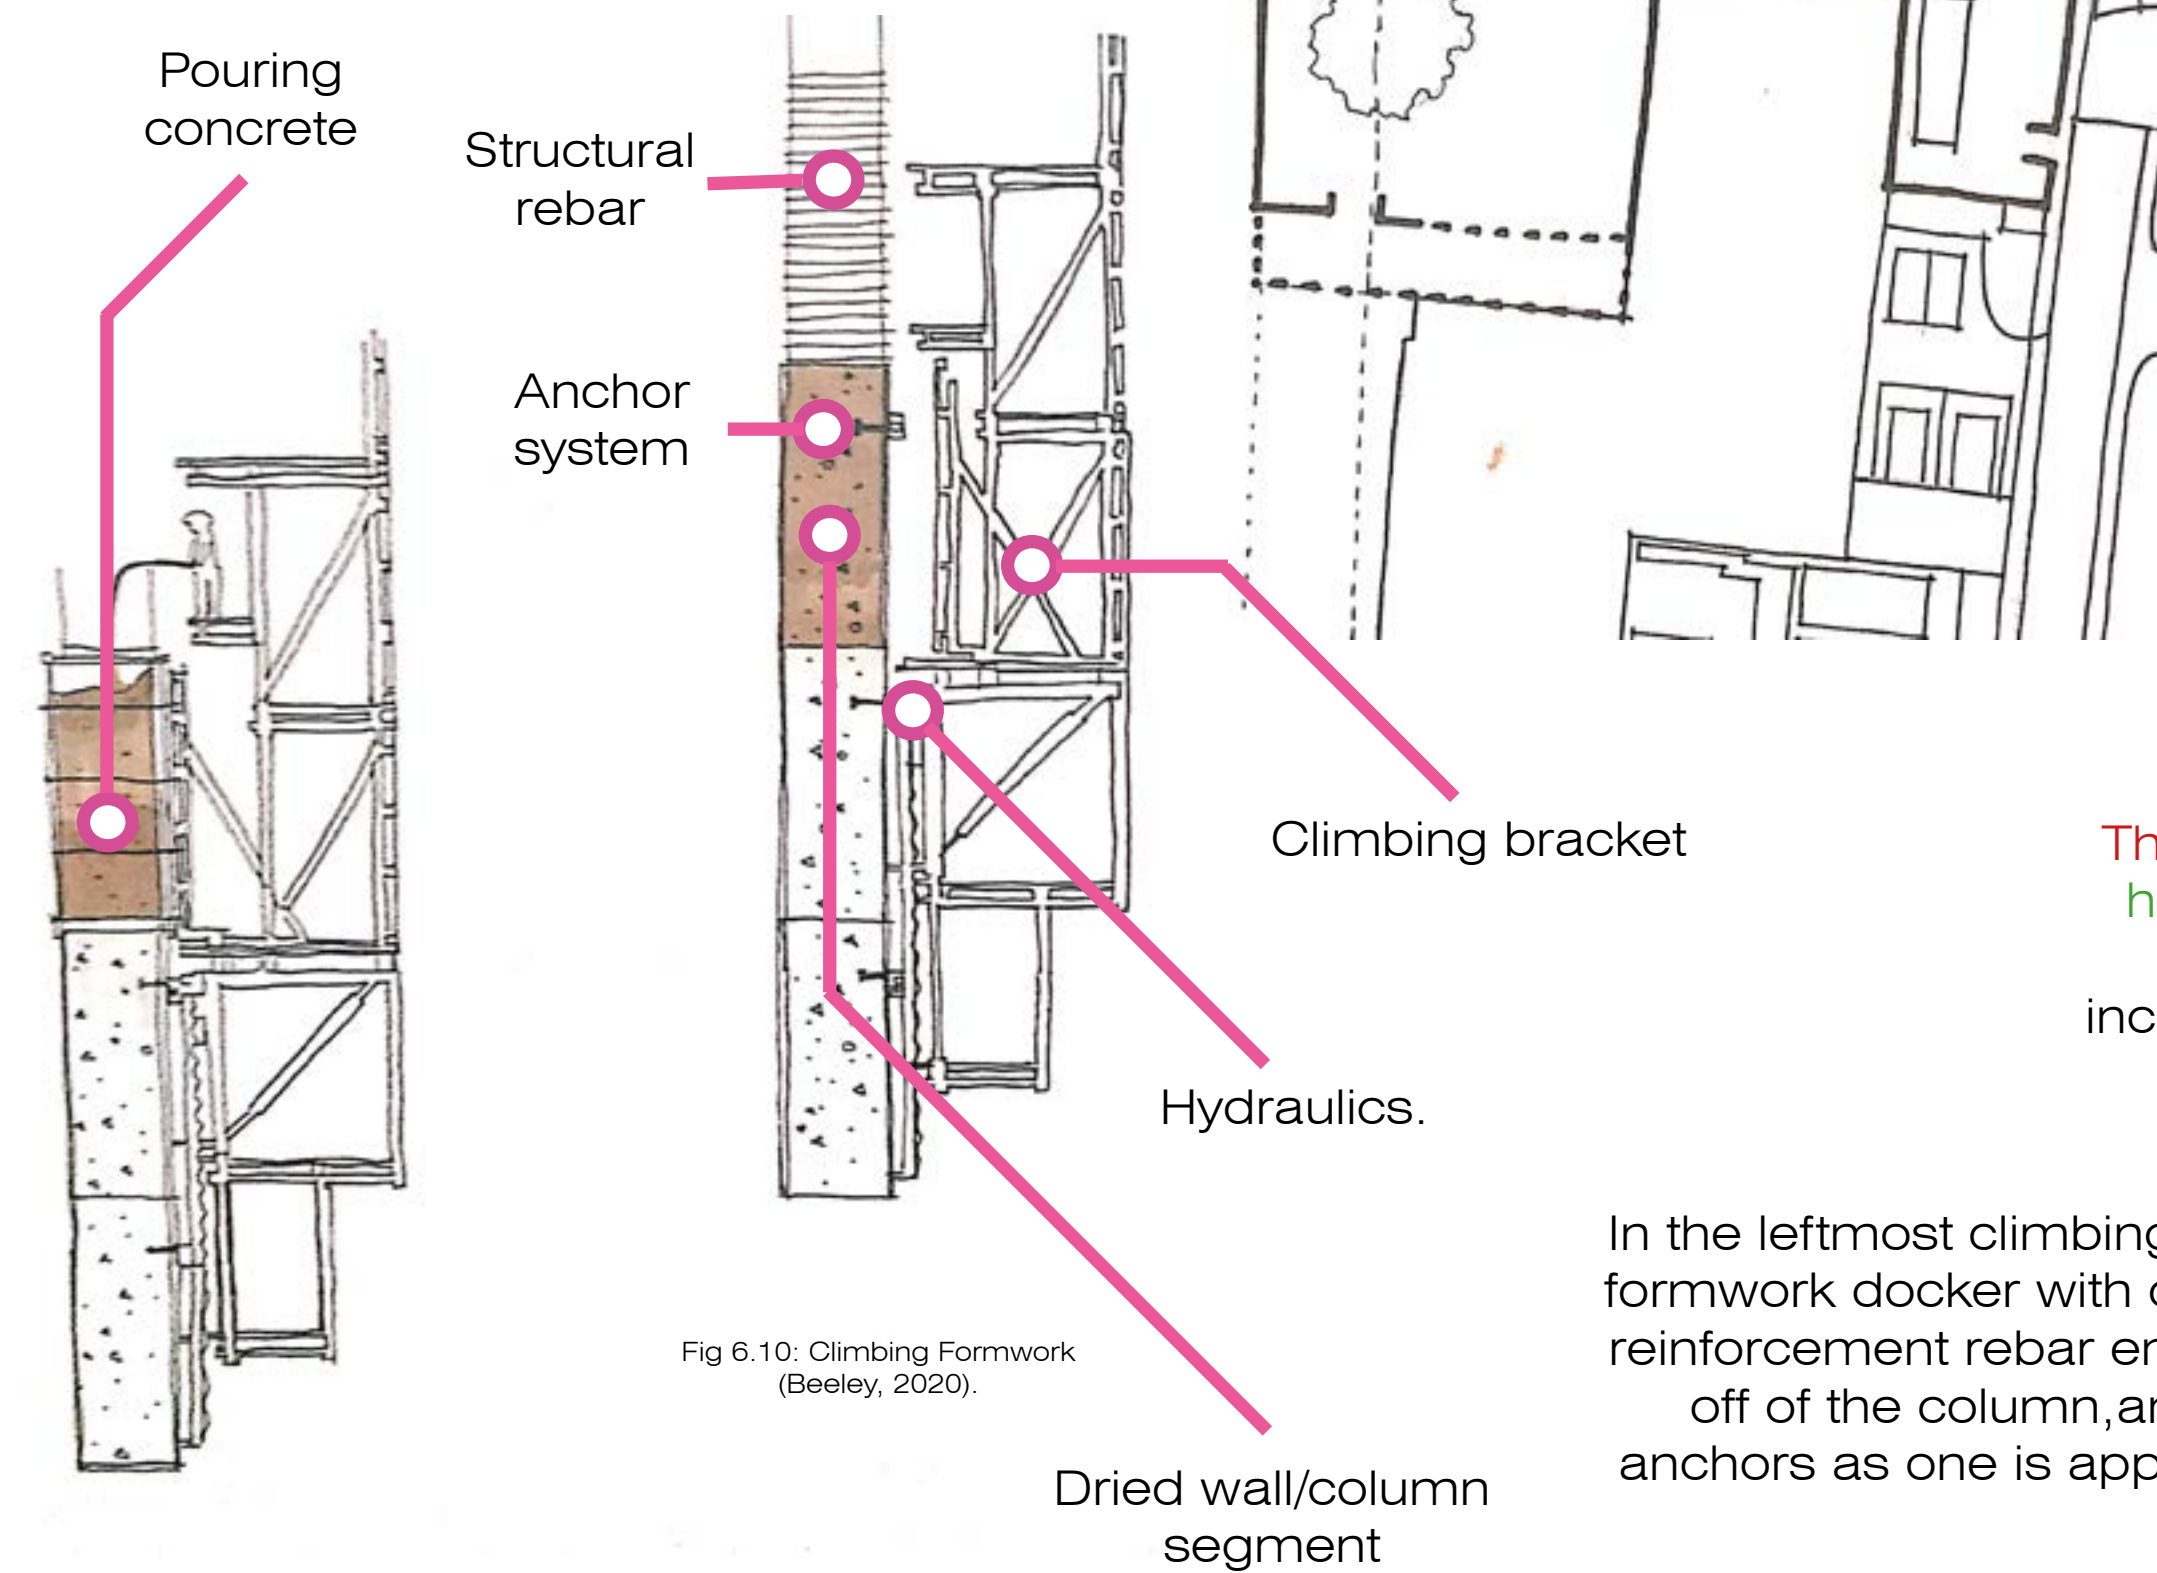
There are a few variants of climbing formwork within this build that are especially prominent on this visit. The first being the square and circular columns that retain their position through all floors of the building. The process of removal or shuttering and the raising of it to the next level with the crane, to then remould the next part of the column is different to the example below used on free-standing structures, and is much easier.

In the leftmost climbing formwork diagram, upon filling a formwork docker with concrete and allowing it to set with reinforcement rebar encased within, the docker is pulled off of the column, and the structure is rolled up the anchors as one is applied atop the highest set element.
