Technology and Environment in Architecture-

Site Diary

Nottingham Trent University- Enterprise and Innovation Centre

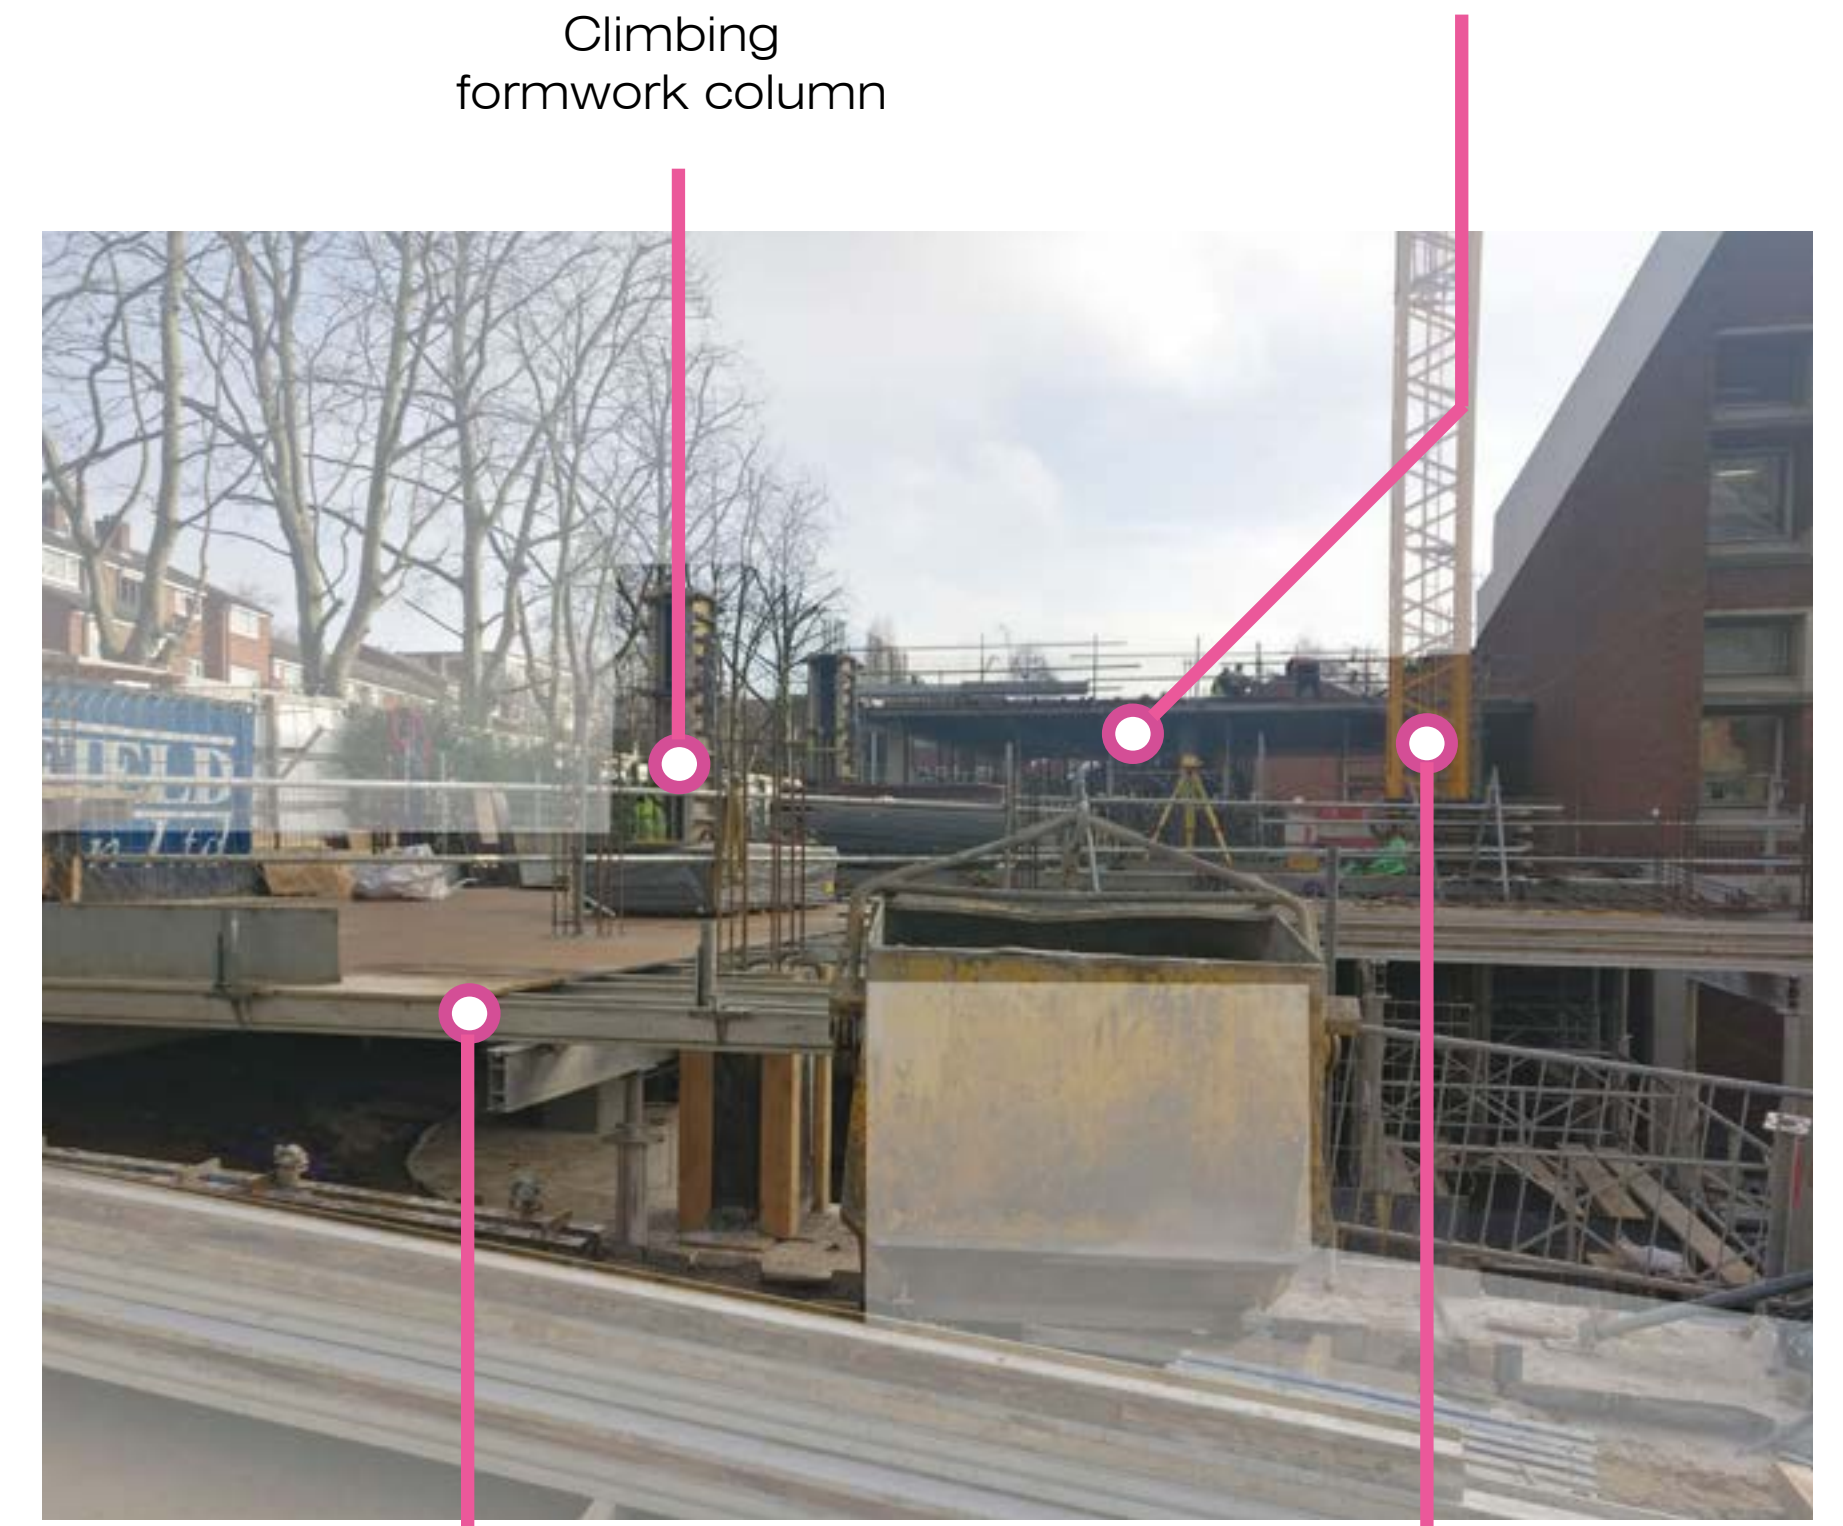
Second floor roofing elements in progress. The aim being to begin roof and external cladding after the ground floor interior is almost completed, the structure being totally finished within the next ten weeks.

The unfinished first floor at the front of the site, houses wooden boards to use as planks for traversal at this level, this may also be incorporated into the scheme as a basis for the soffit and ceiling below.

Not necessarily an example of formwork, but the crane is erected in pieces that top each-other, loaded by another crane, unsuitable for fitting within the site due to it's size in relation to the site.
